MASTER PLAN

DILLARD RANCH

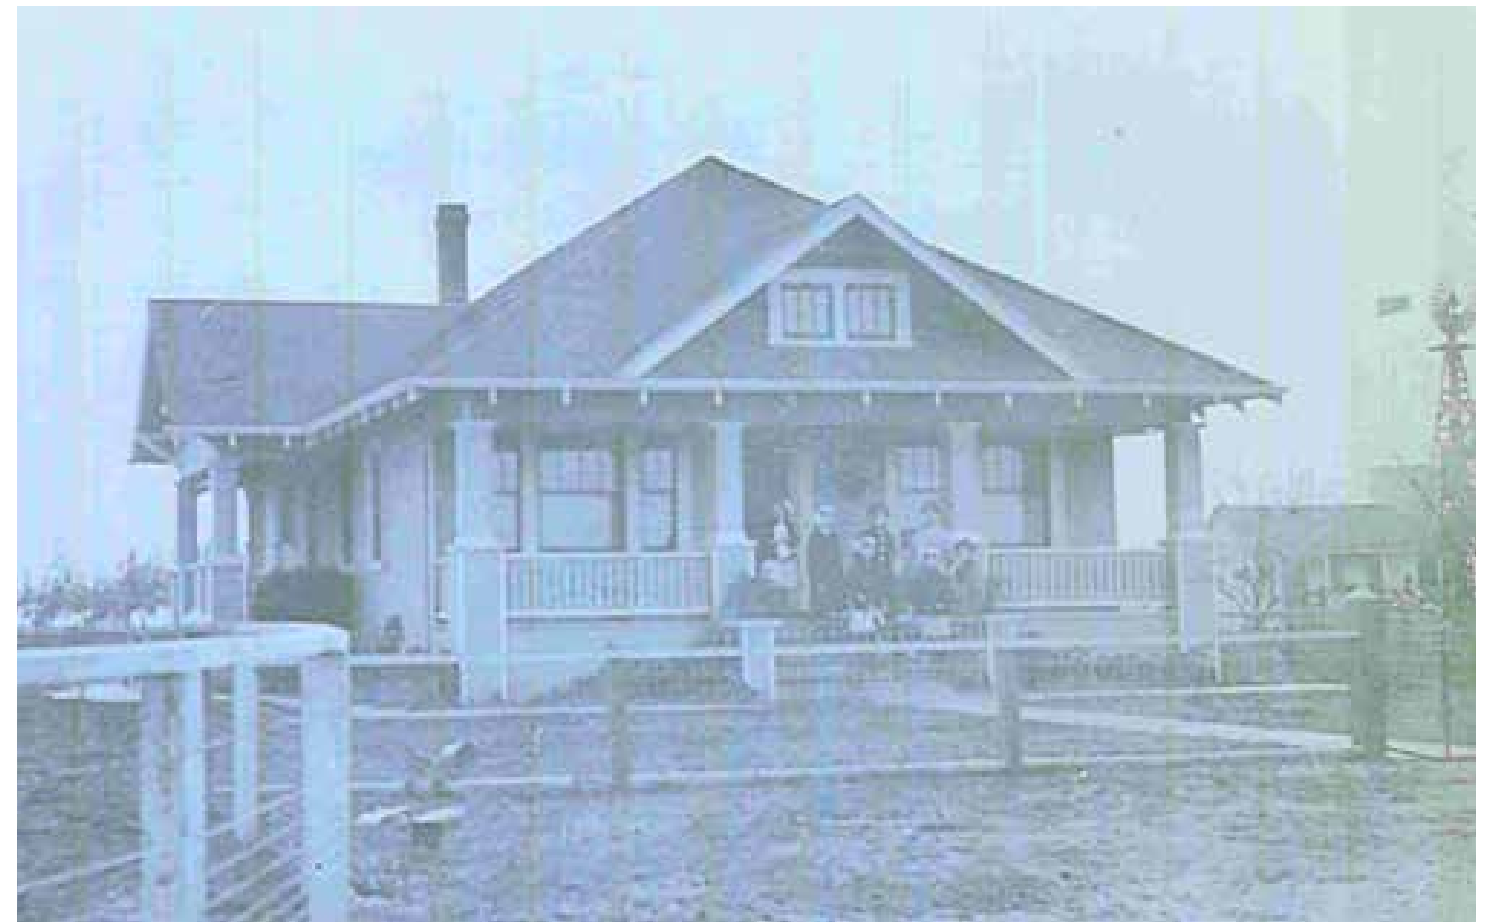
Figure 2: Undated photo taken around the turn of the twentieth century, with the ranch house at center and additional buildings within Dillard Ranch in the background. Source: Wilton History Group.

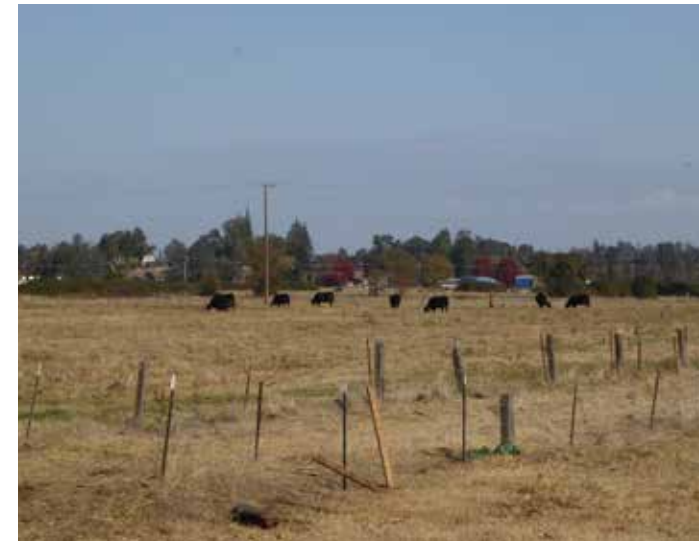
Figure 4: Cattle grazing at Dillard Ranch.

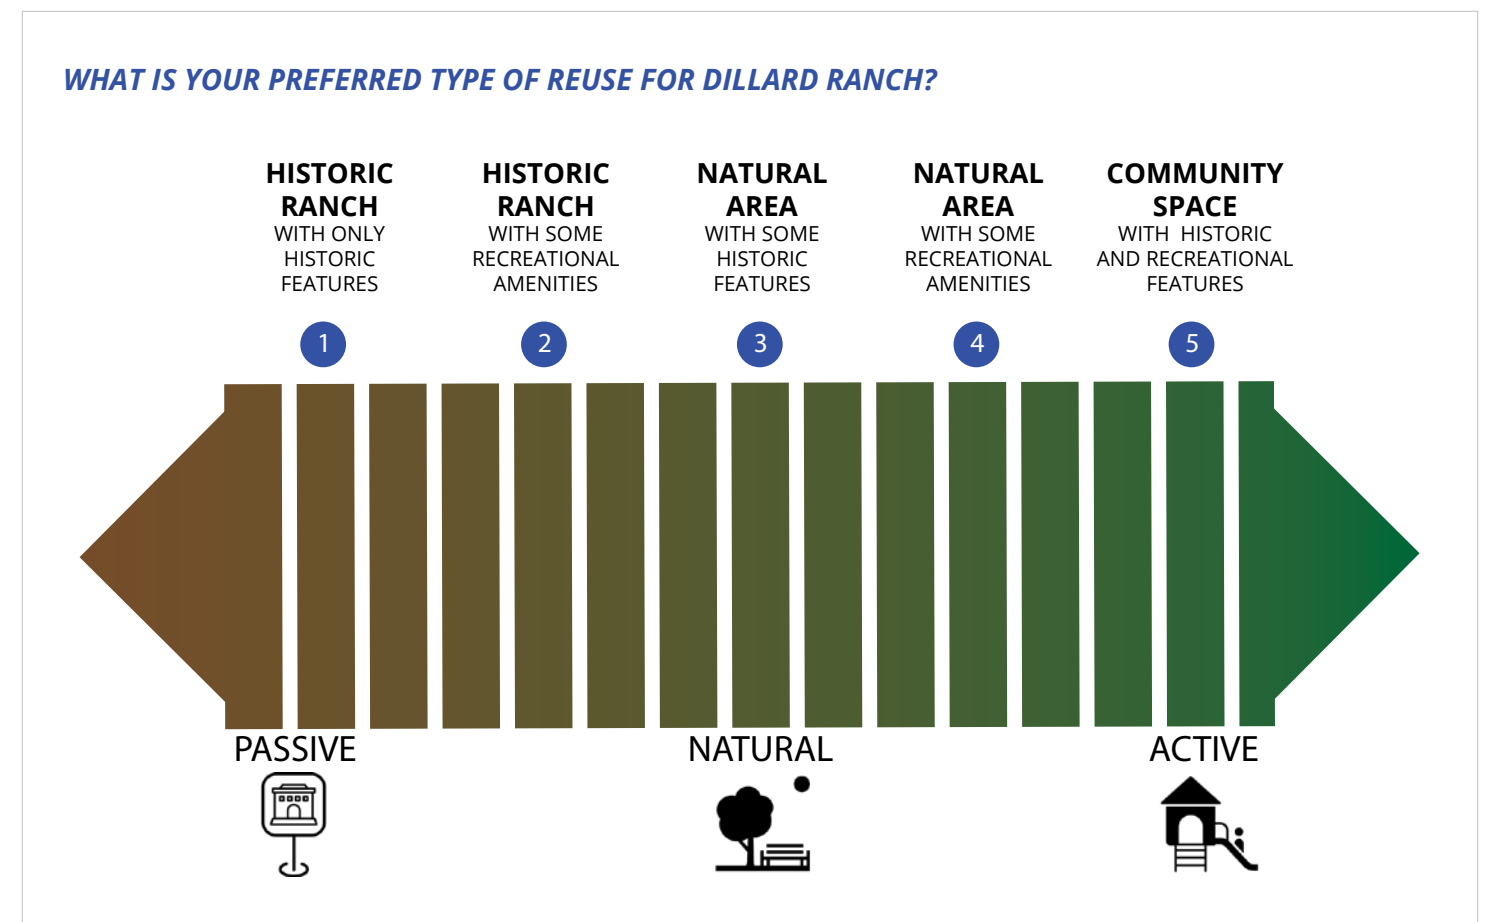
Figure 12: Community members considered a range of options for the reuse of Dillard Ranch.

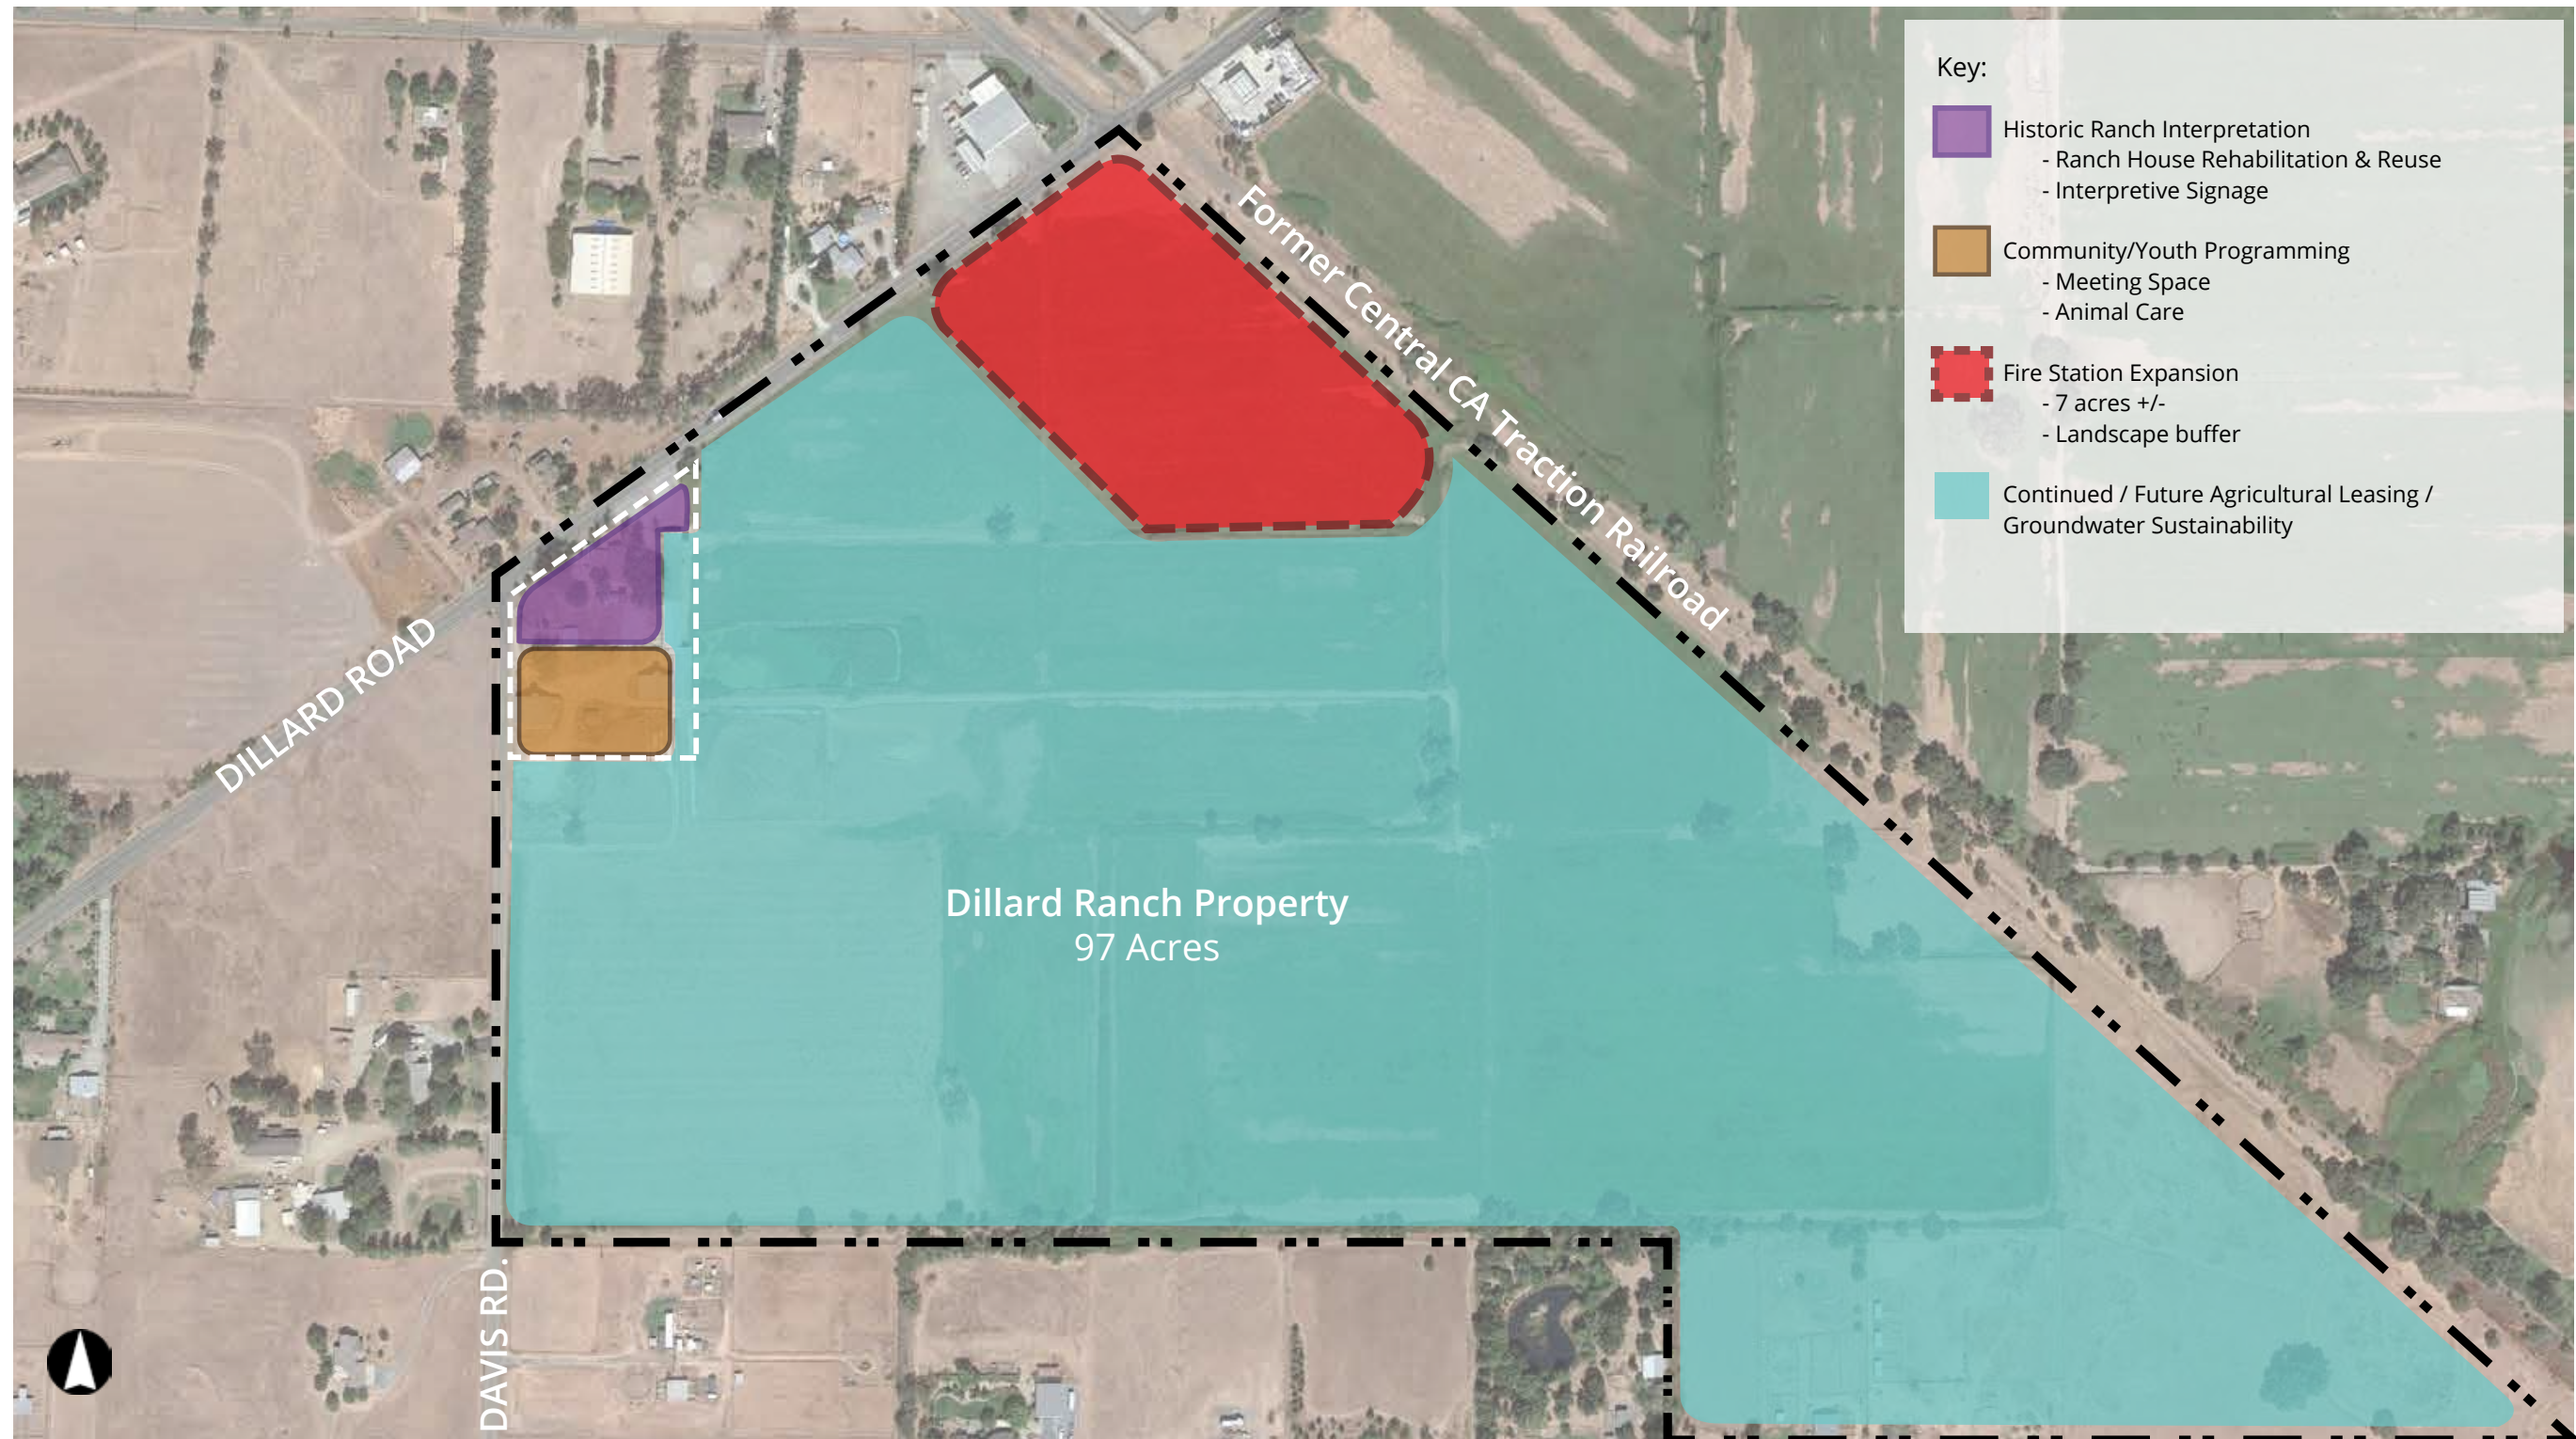
Figure 13: Conceptual land use recommendations.

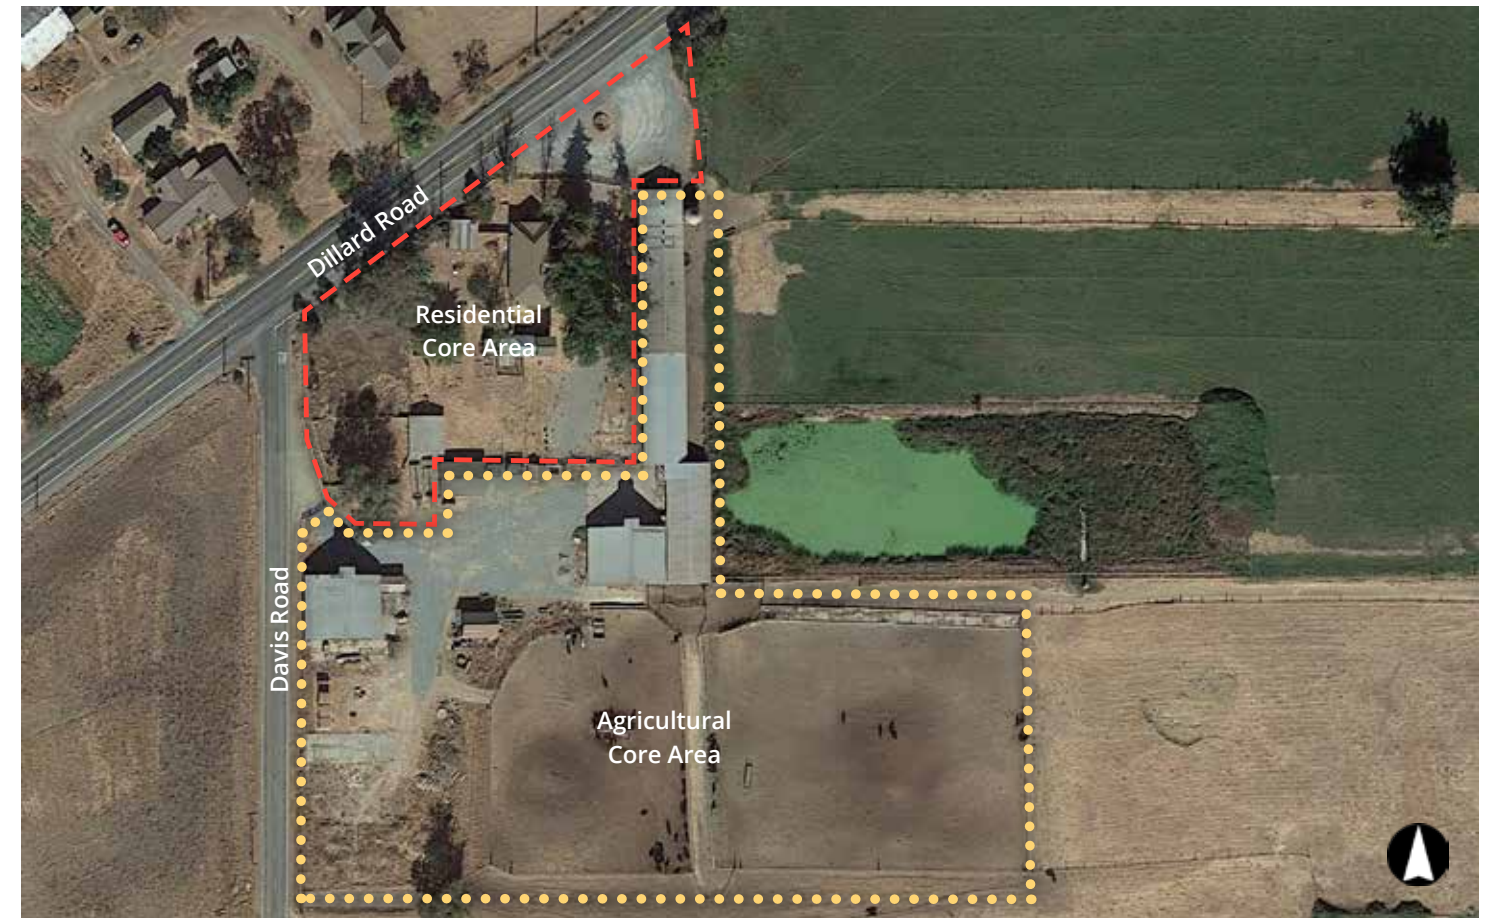
Historic Residential Core Area:

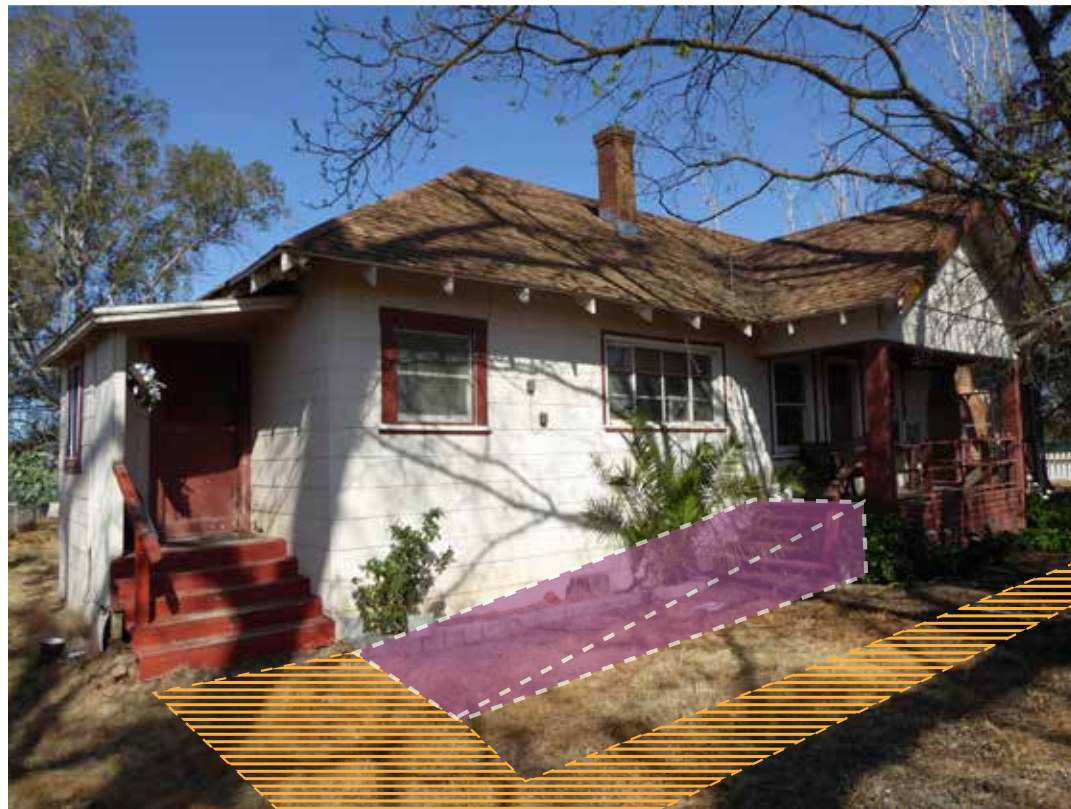
Figure 18: Possible location of an accessible ramp at the south facade of the Ranch House.

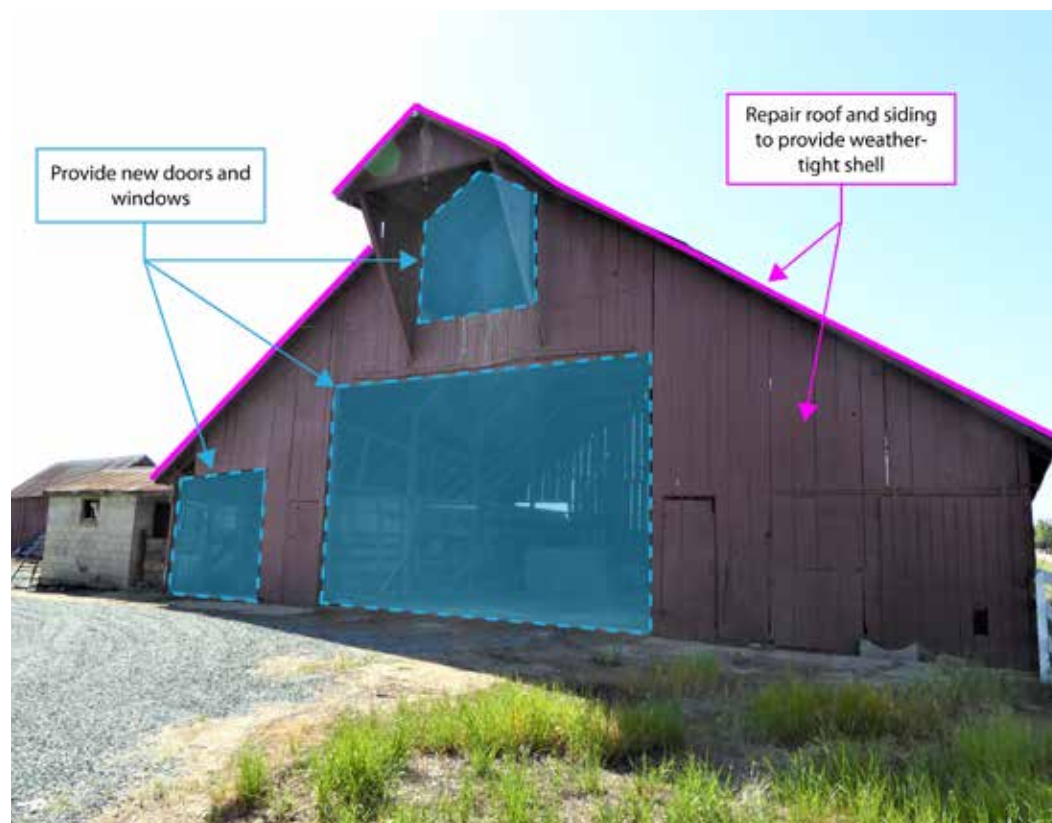
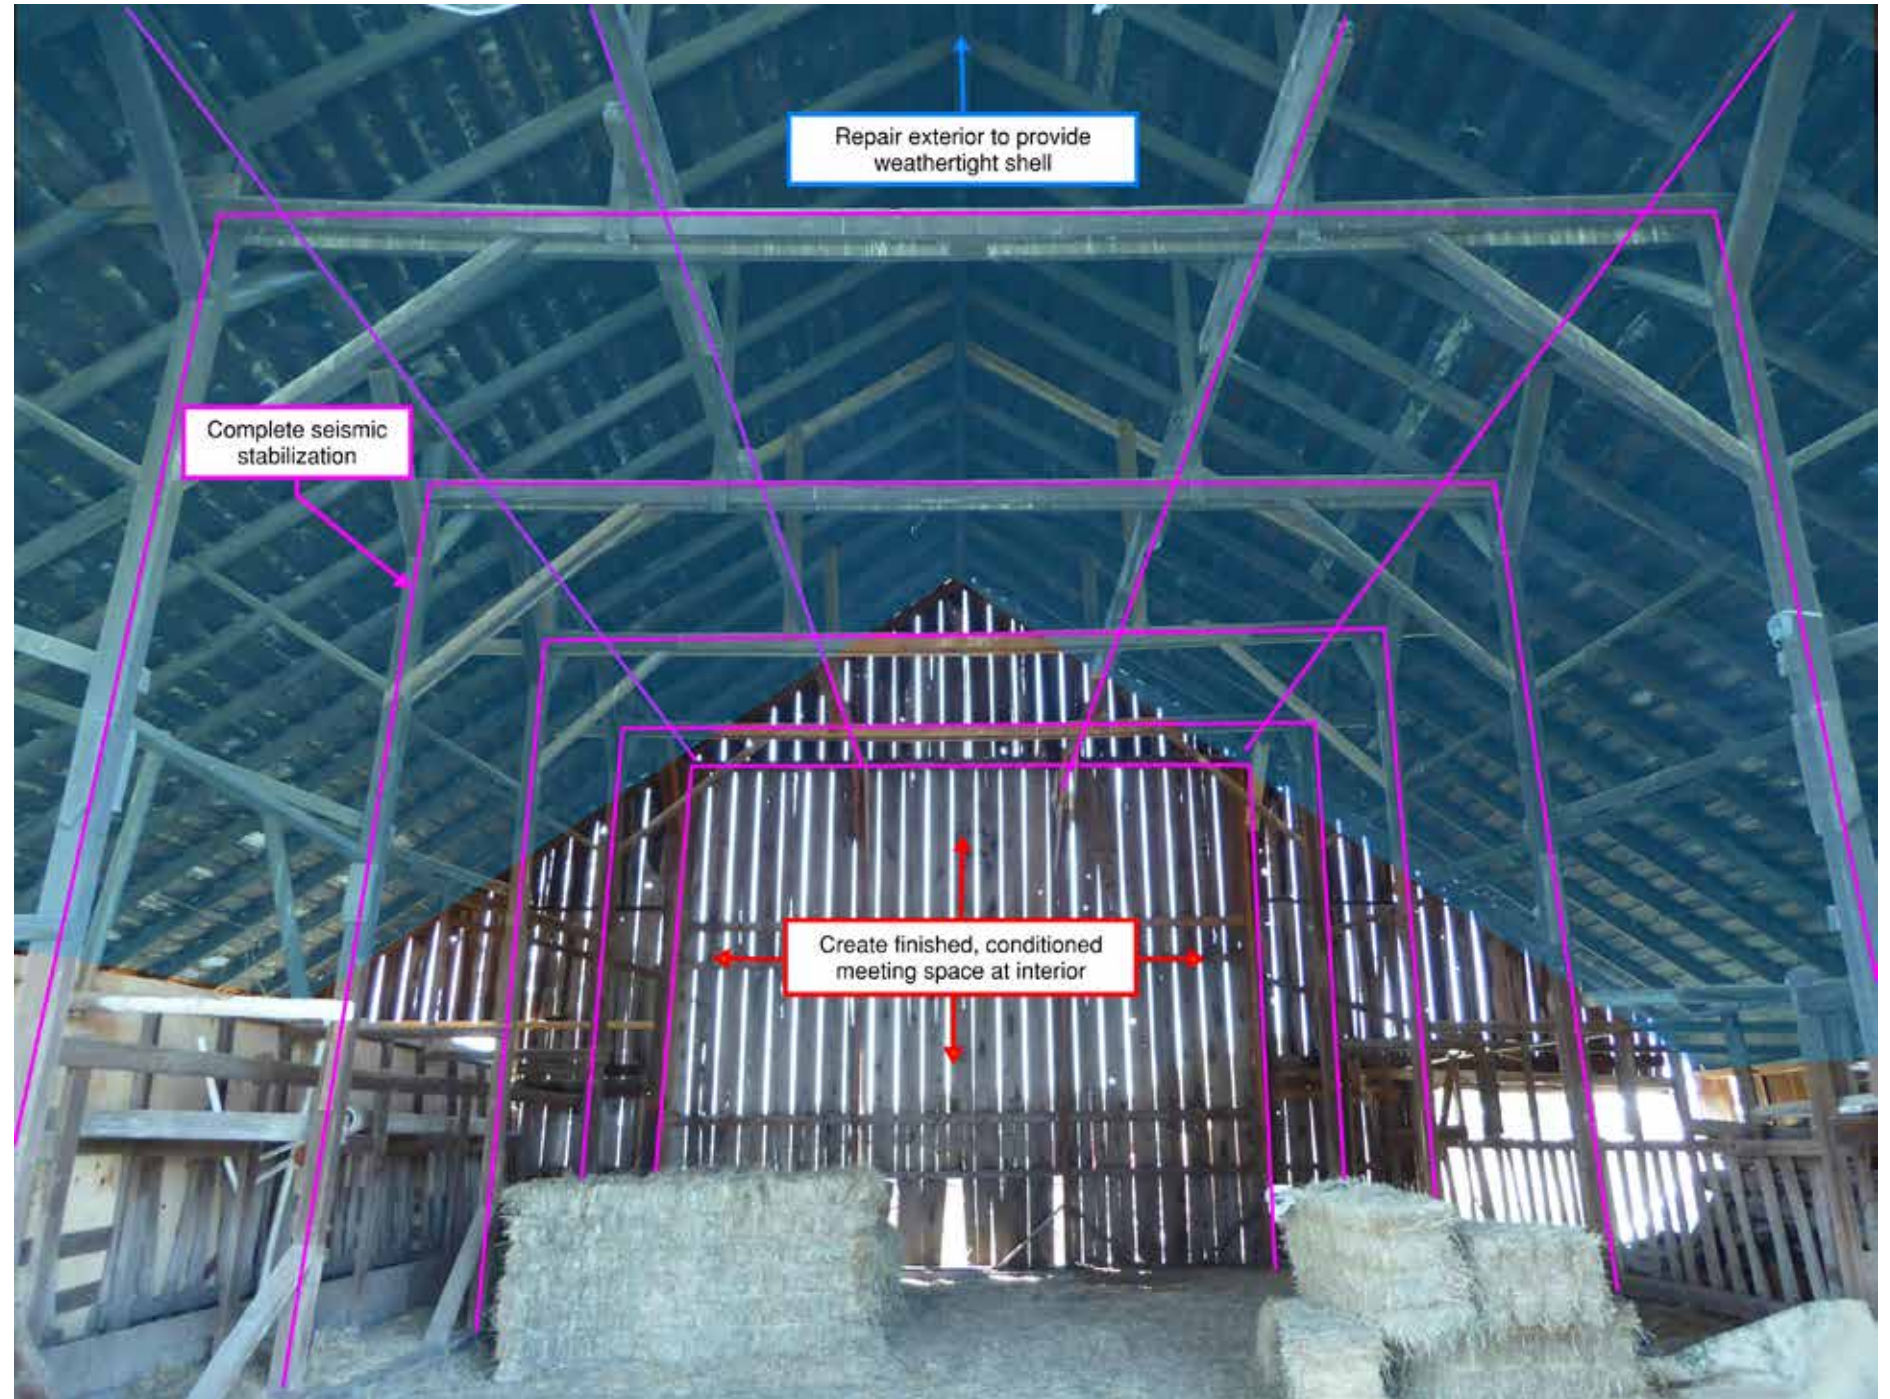
Figure 20: Schematic diagrams of work to rehabilitate Hay Barn 1.

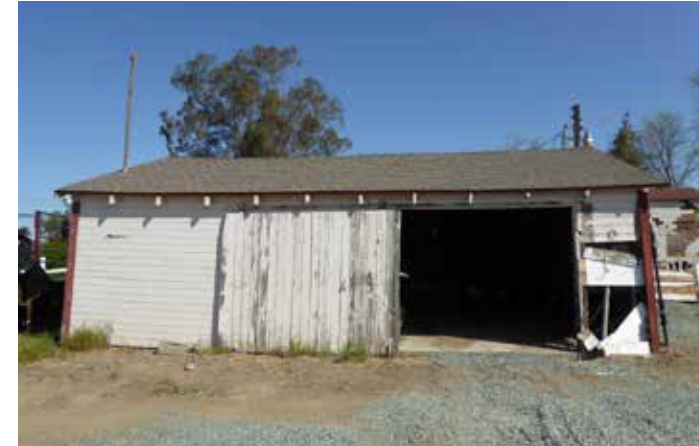
Figure 21: The Storage Shed to be replaced by a new public restroom.

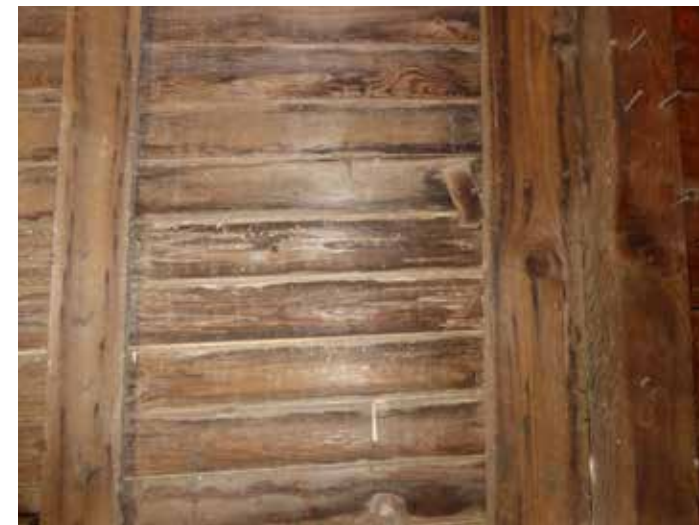
Figure 22: Salvage and reuse wood siding of the Storage Shed and incorporate into the new restroom building where feasible.

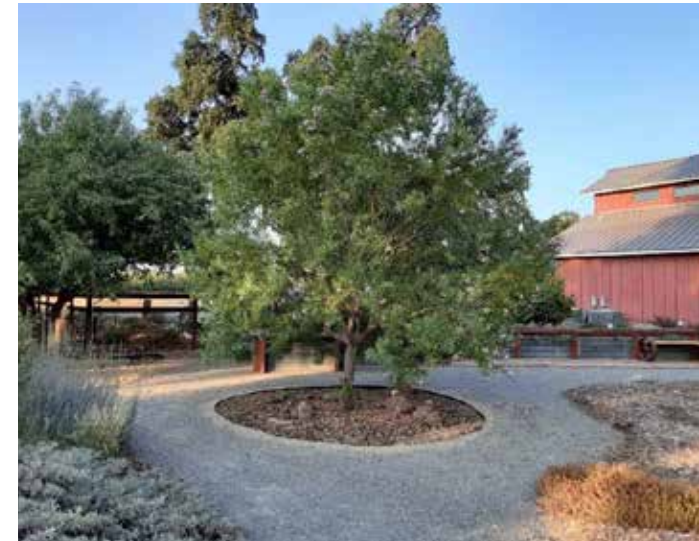
Figure 28: Tree island for turnaround.

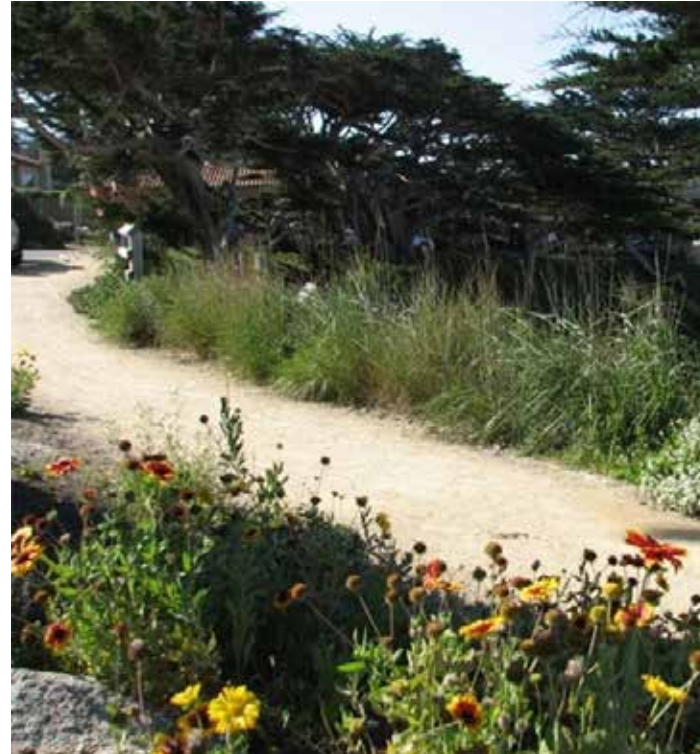
Figure 43: Decomposed granite pathway and plantings.

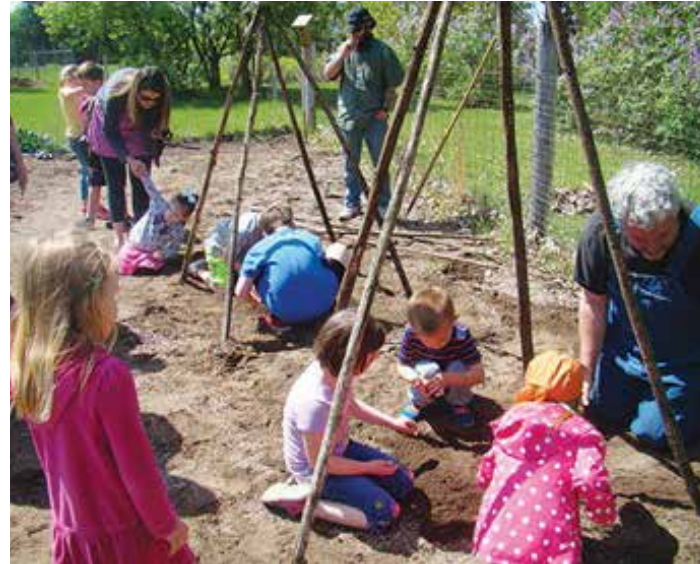
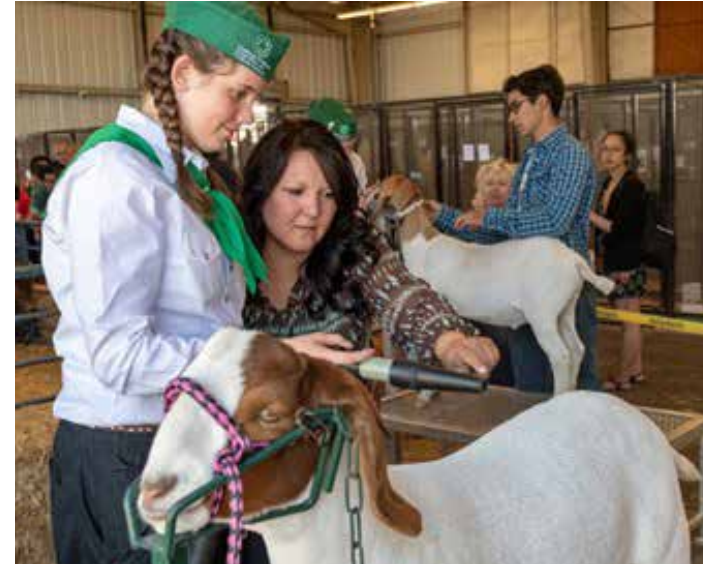
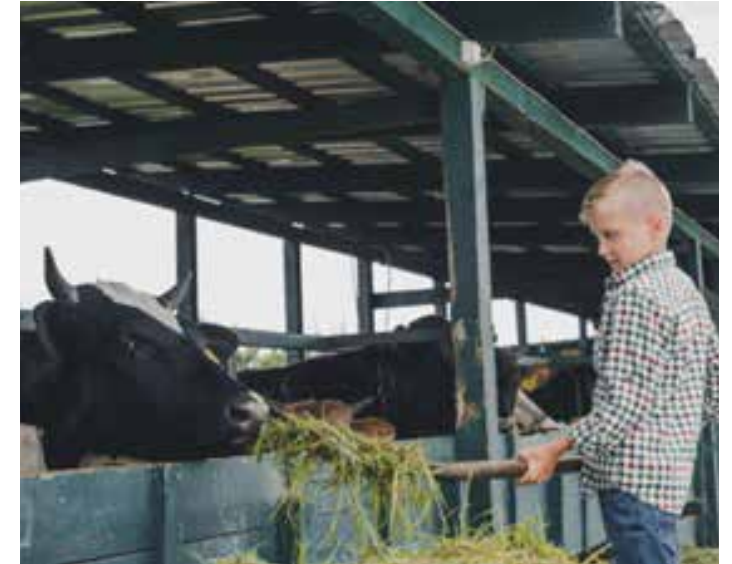
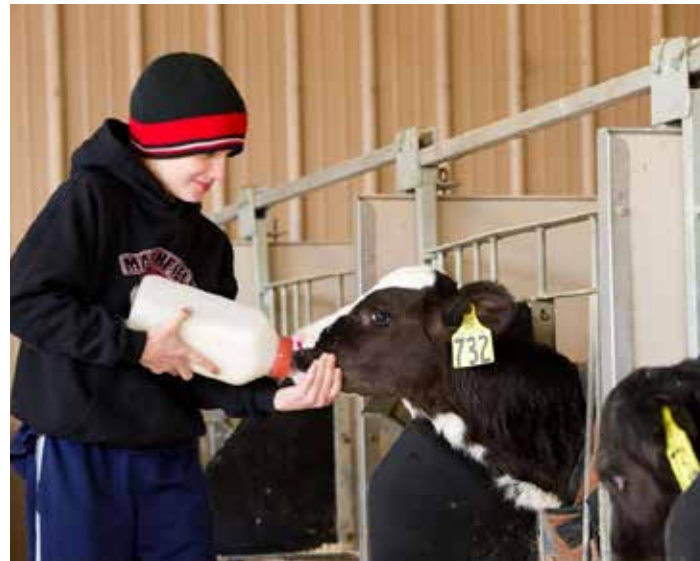
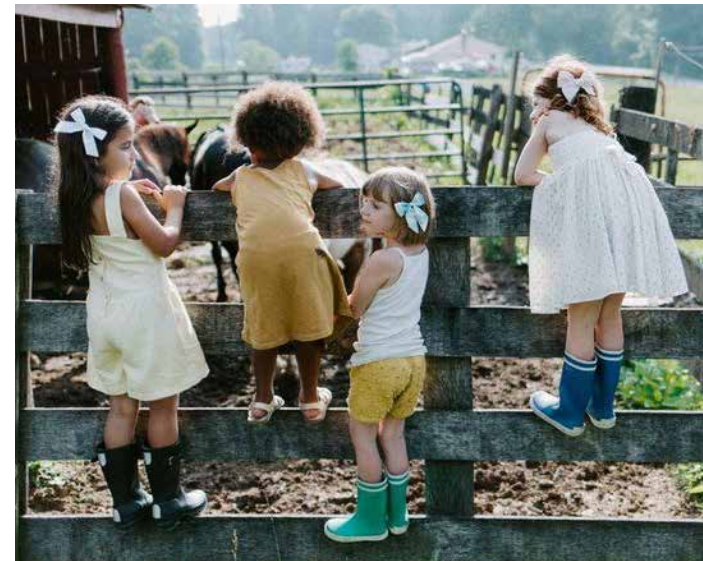
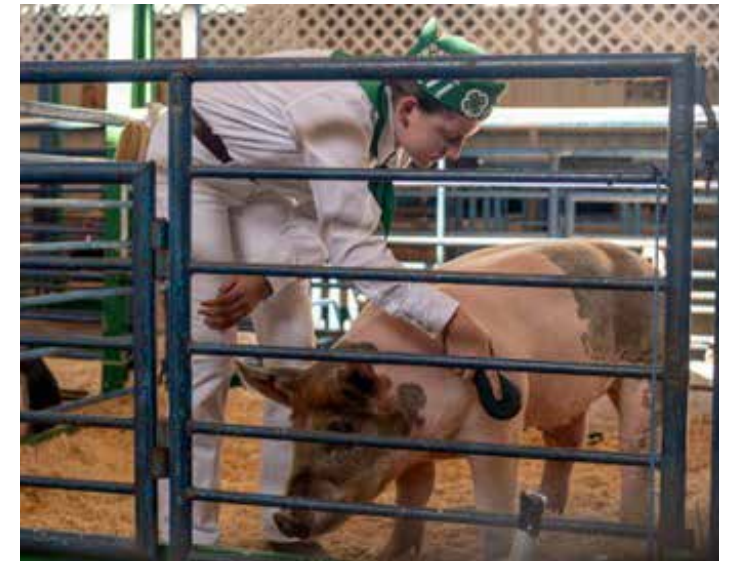
Figure 48: The agricultural core area of Dillard Ranch is envisioned for community use, shared with local youth programming groups to provide children with hands-on experience in agricultural and farming-related activities.

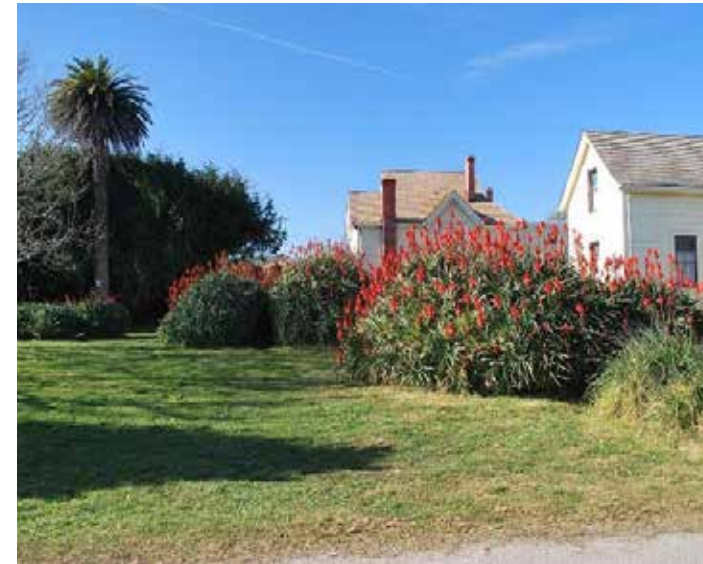
Figure 66: Loose shrub plantings.

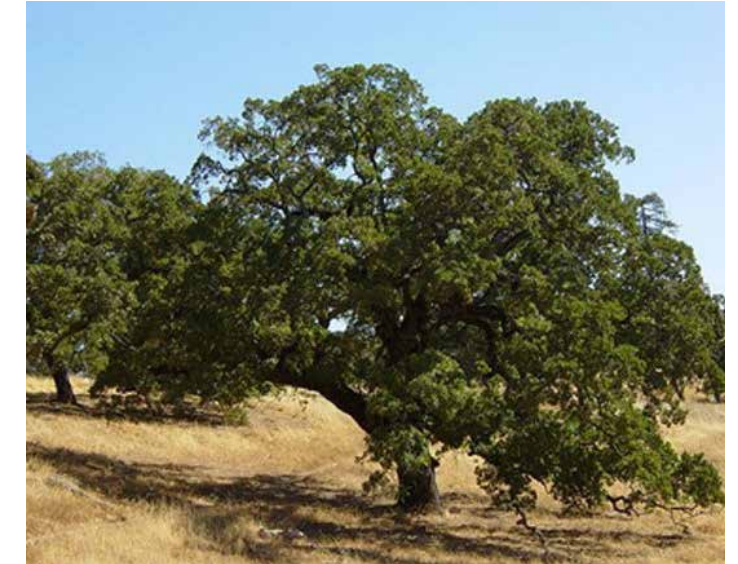
Figure 67: California native oaks.

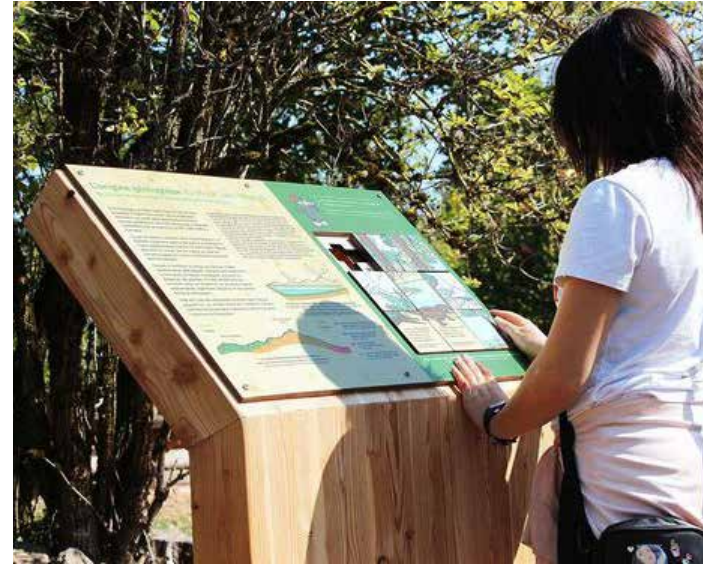
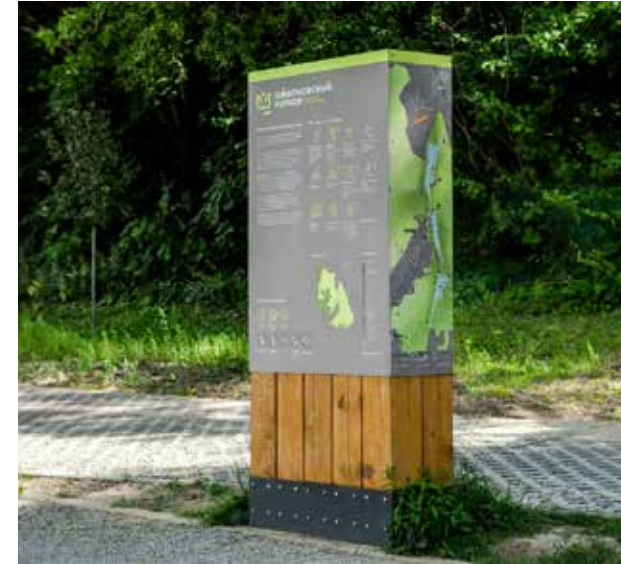
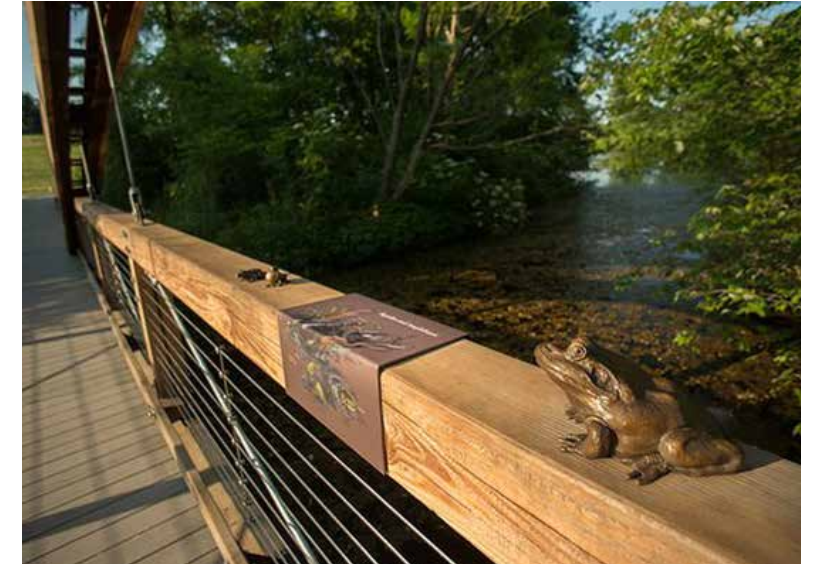
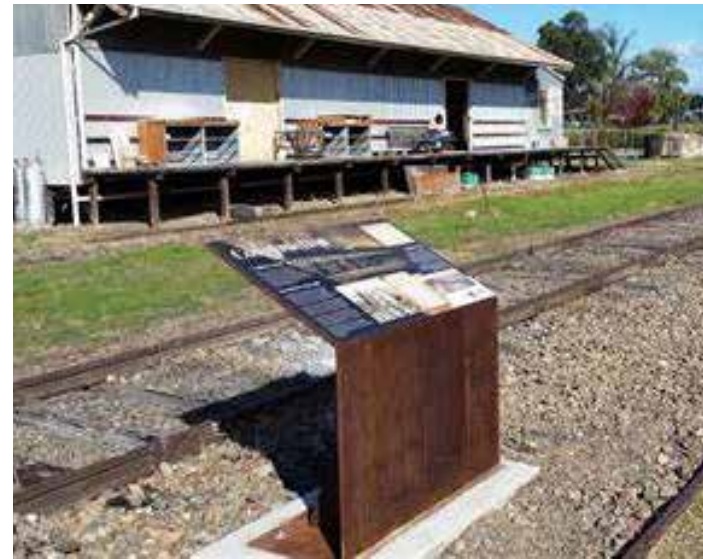
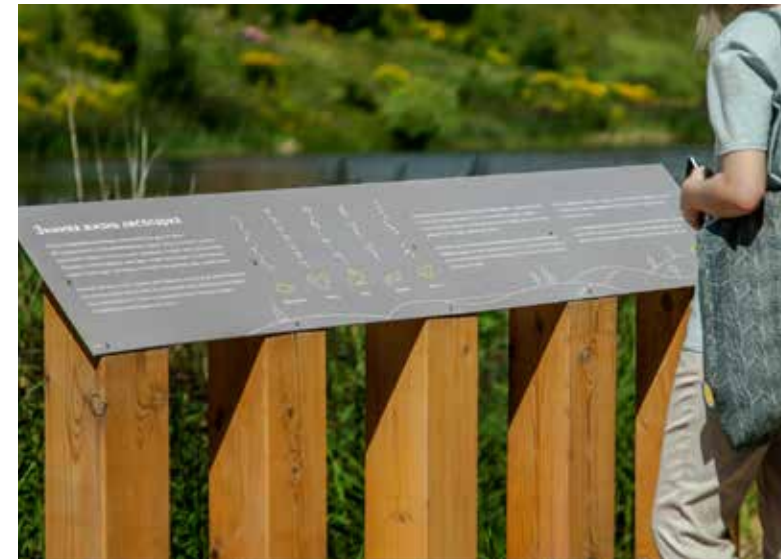
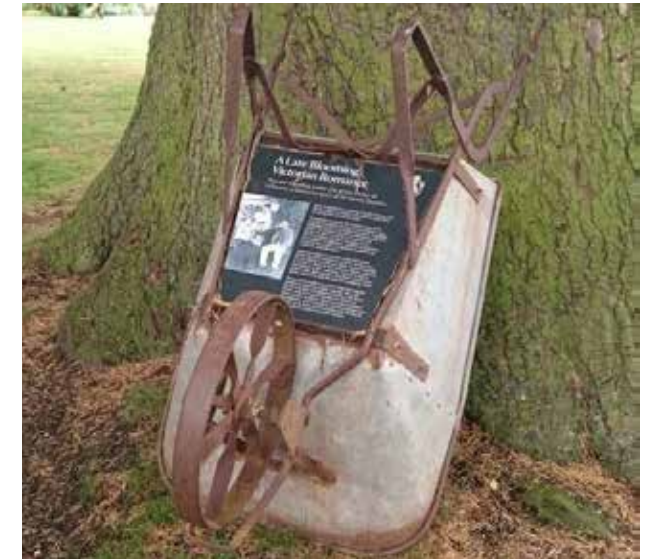
Figure 69: Examples of different types of weathered steel and/or wood interpretive display signage.

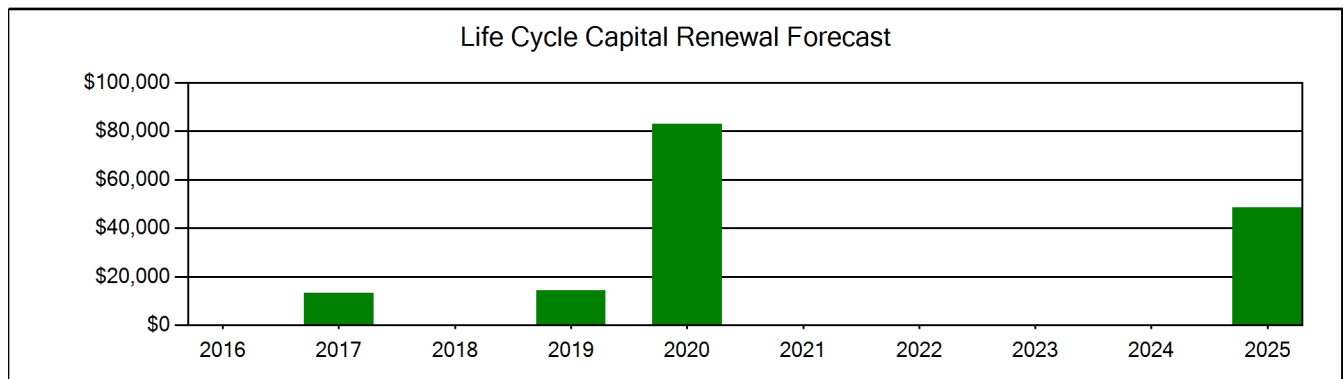
Dillard Ranch - Dillard Ranch - Barn #1 Condition Assessment

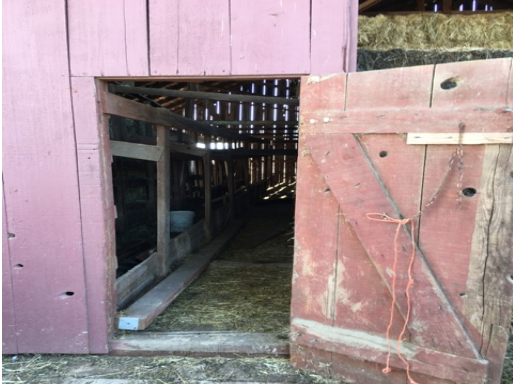
Dillard Ranch - Barn1 - Exterior Door

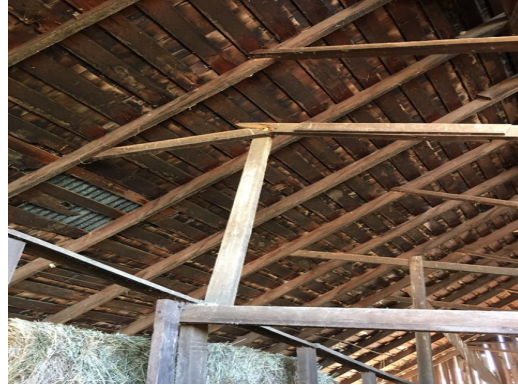
Dillard Ranch - Barn1 - Broken Roof Support

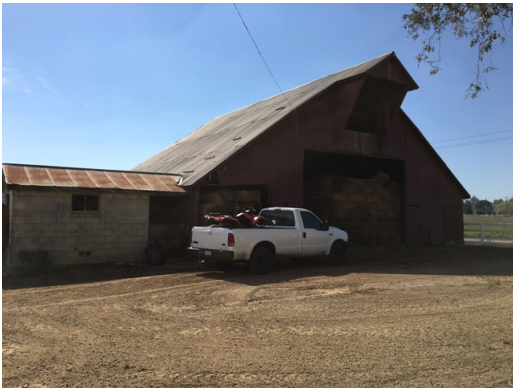
Dillard Ranch - Barn1 - Elevation

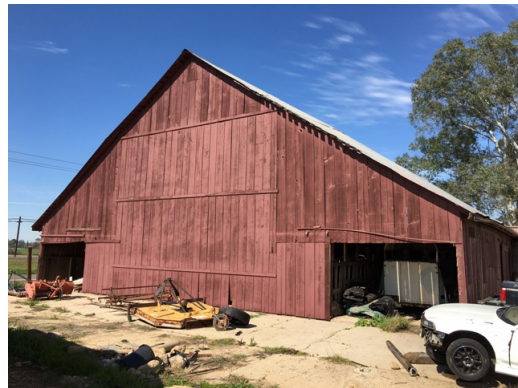
Dillard Ranch - Barn1 - Rear Elevation

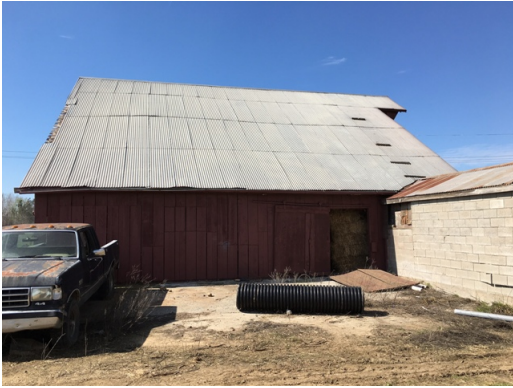
Dillard Ranch - Barn1 - Roof

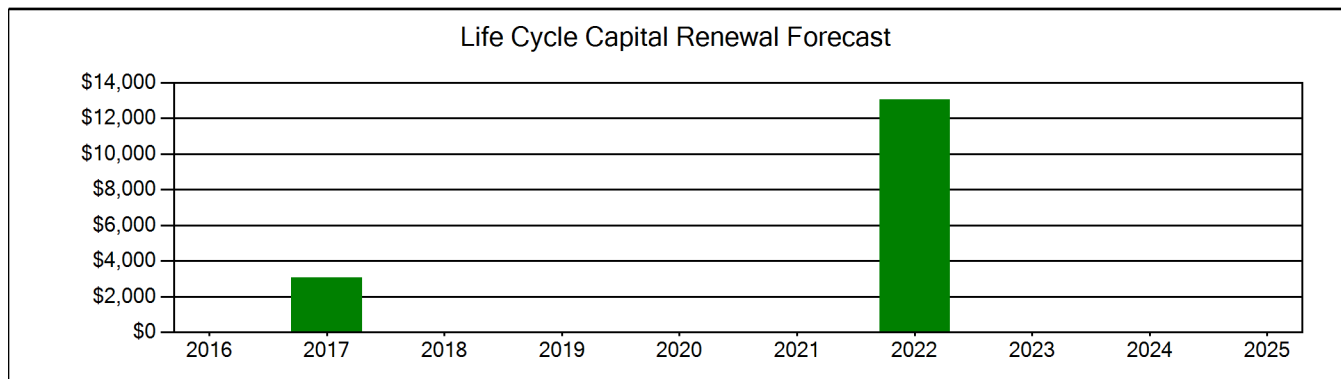
Dillard Ranch - Dillard Ranch - Barn #2 Condition Assessment

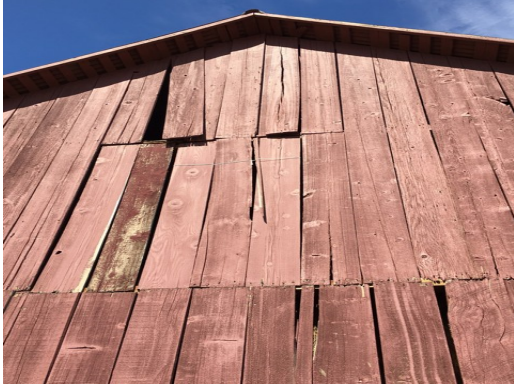
Dillard Ranch - Barn2 - Exterior Detail

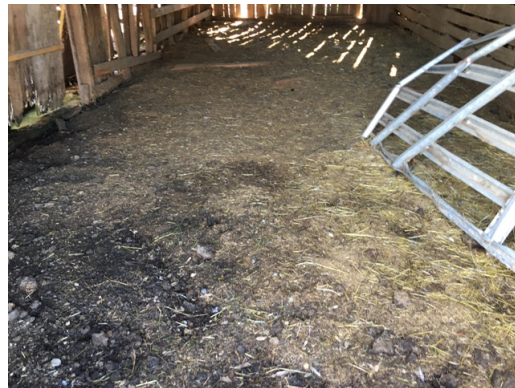
Dillard Ranch - Barn2 - Dirt Floor

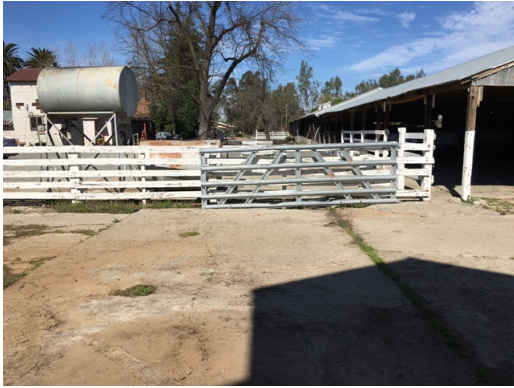
Dillard Ranch - Barn2 - Pavement

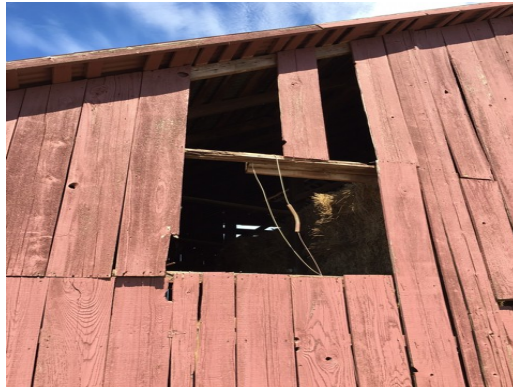
Dillard Ranch - Barn2 - Missing Panels

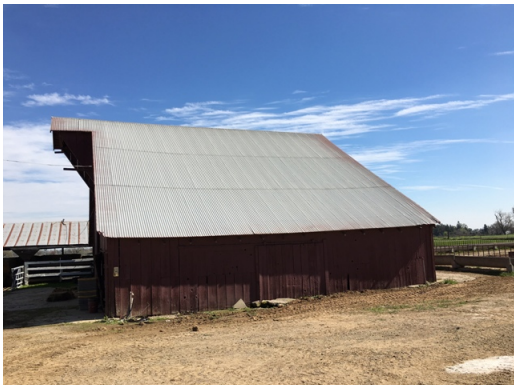
Dillard Ranch - Barn2 - Roof
