MASTER PLAN

DILLARD RANCH

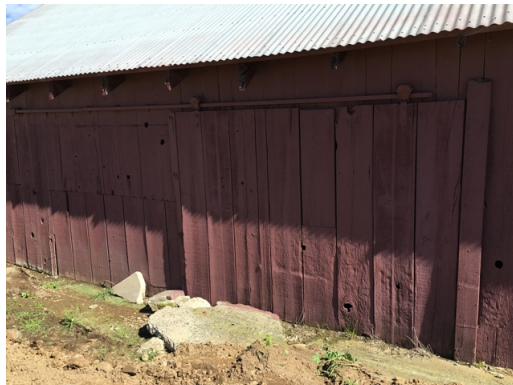
Dillard Ranch - Barn2 - Sliding Door

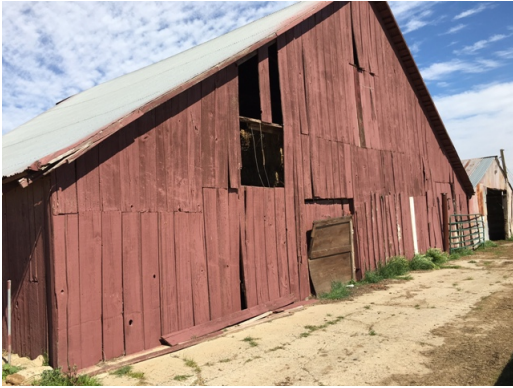
Dillard Ranch - Barn2 - South Elevation

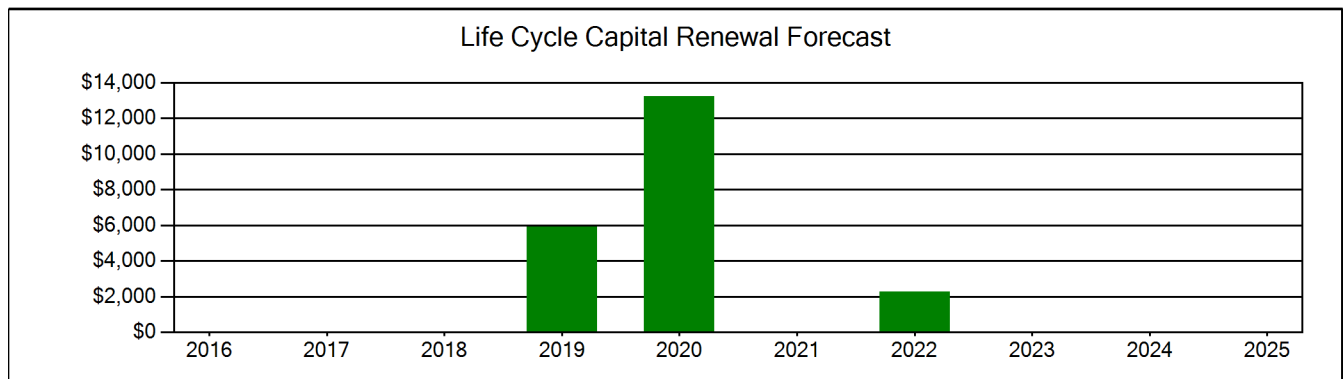
Dillard Ranch - Dillard Ranch - Garage Condition Assessment

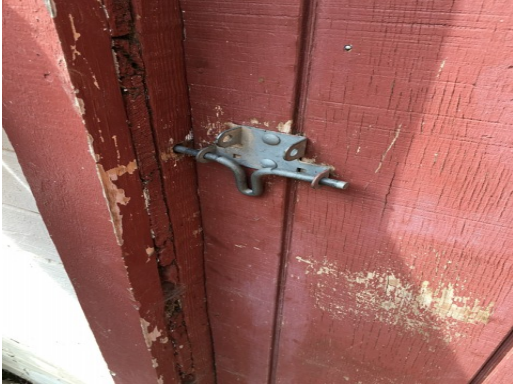
Dillard Ranch - Garage - Door Hardware

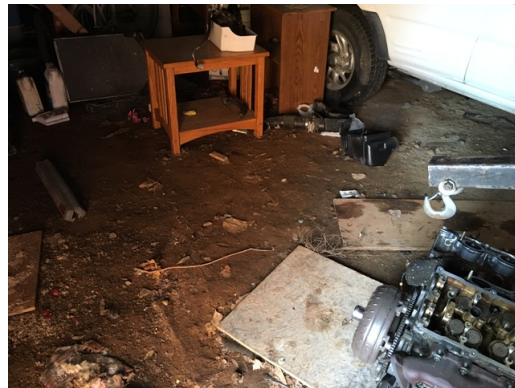
Dillard Ranch - Garage - Floor

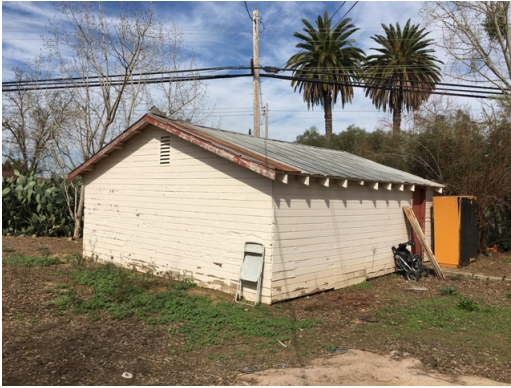
Dillard Ranch - Garage - Southwest Exterior

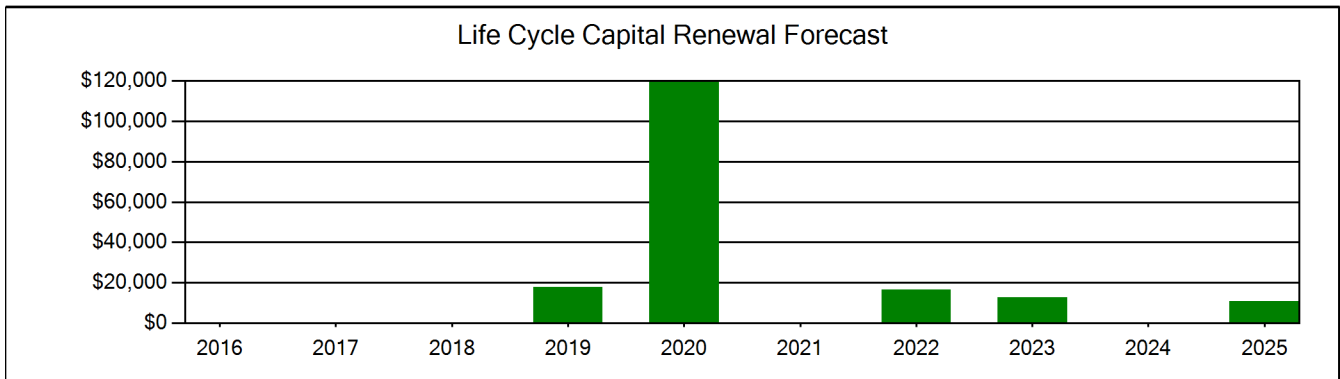
Dillard Ranch - Dillard Ranch - House Condition Assessment

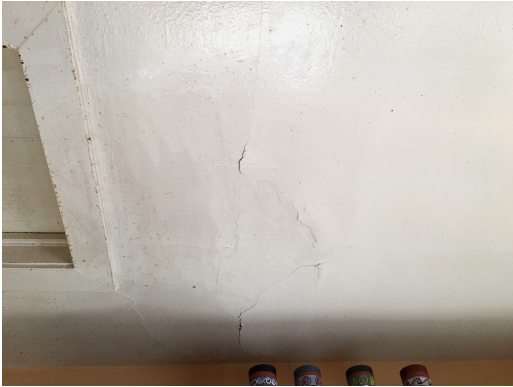
Dillard Ranch - House - Kitchen Ceiling

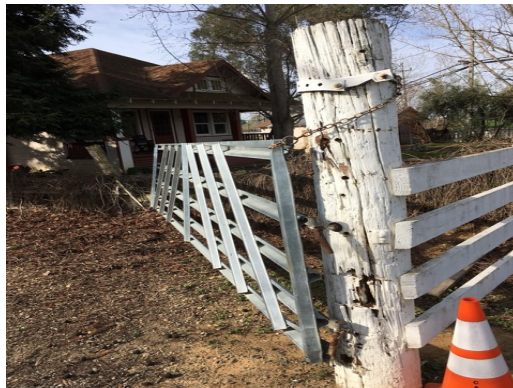
Dillard Ranch - House - Drive Gate

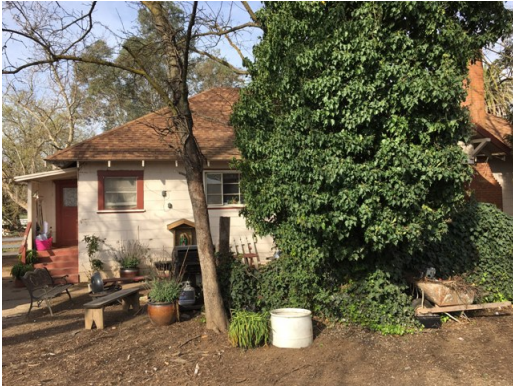
Dillard Ranch - House - East Landscaping

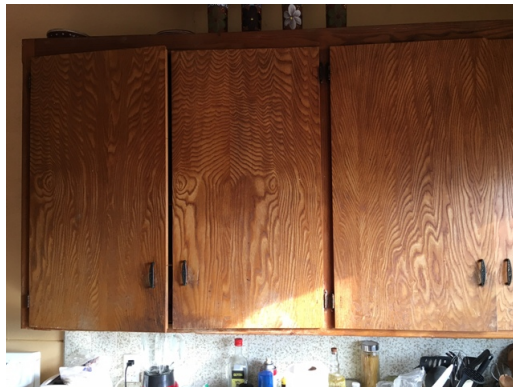
Dillard Ranch - House - Kitchen Cabinets

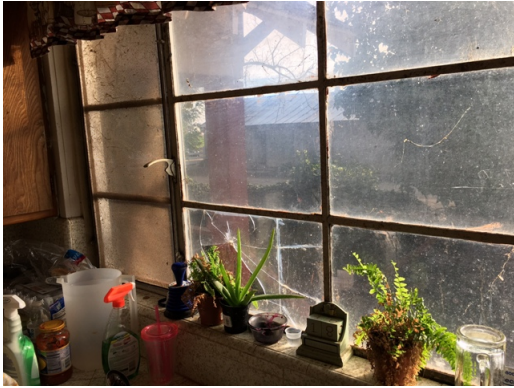
Dillard Ranch - House - Kitchen Window

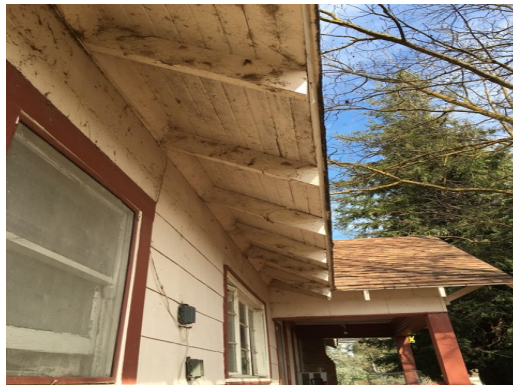
Dillard Ranch - House - Soffit

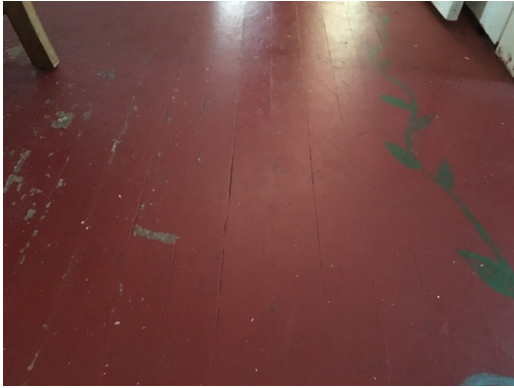
Dillard Ranch - House - Wood Floor

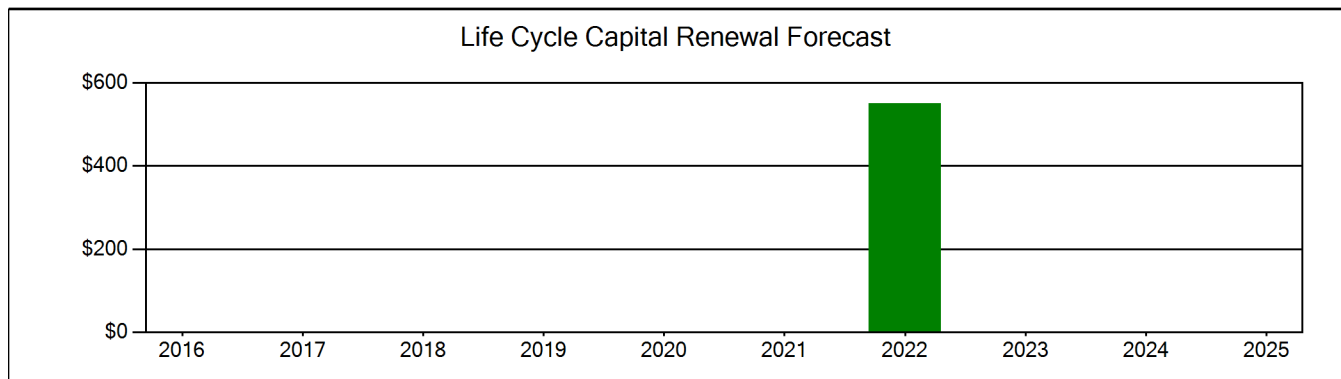
Dillard Ranch - Dillard Ranch - Outbuilding #1 Condition Assessment

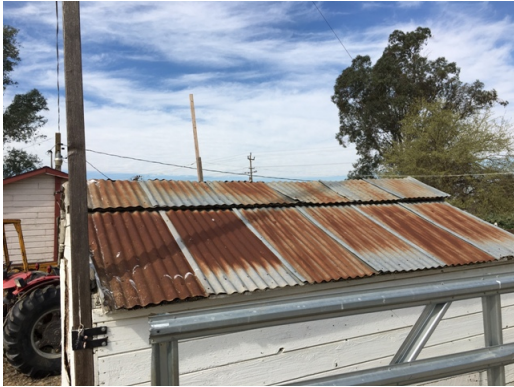
Dillard Ranch - Outbuilding1 - Roof

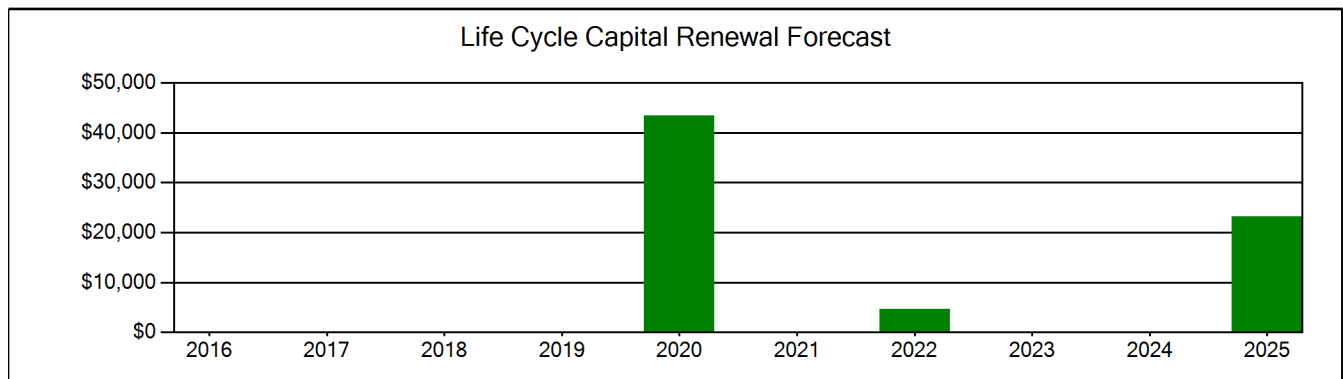
Dillard Ranch - Dillard Ranch - Outbuilding #2 Condition Assessment

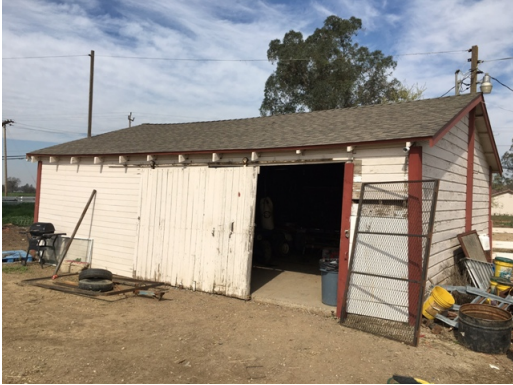
Dillard Ranch - Outbuilding2 - Elevation

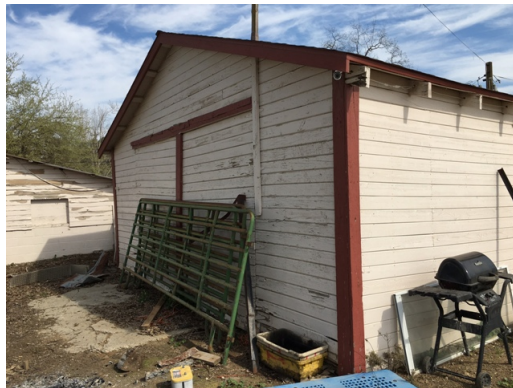
Dillard Ranch - Outbuilding2 - East Exterior

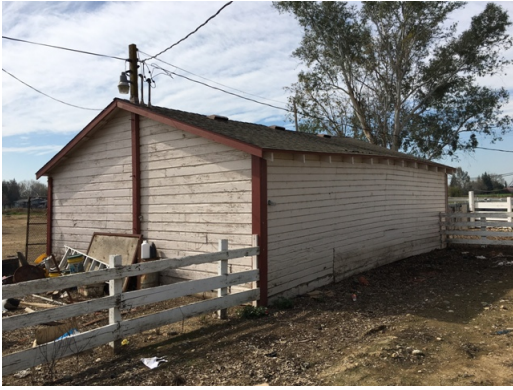
Dillard Ranch - Outbuilding2 - Northwest Exterior

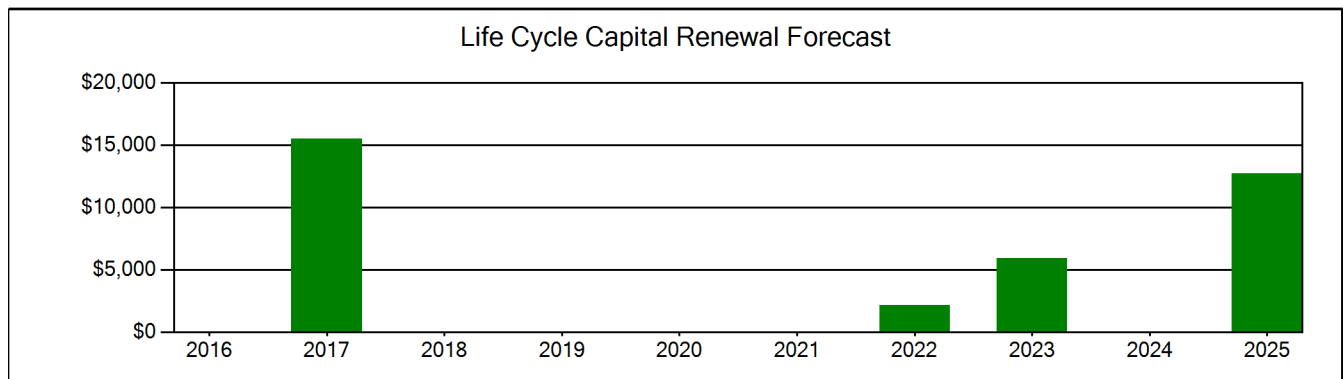
Dillard Ranch - Dillard Ranch - Outbuilding #3 Condition Assessment

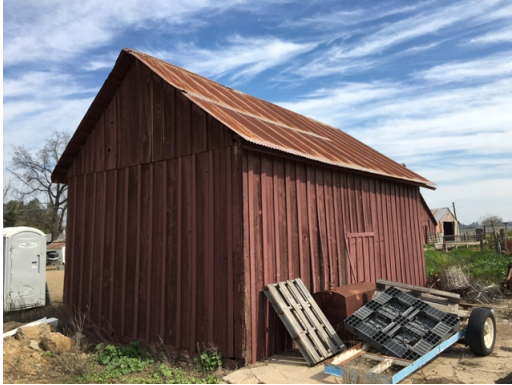
Dillard Ranch - Outbuilding3 - Elevation

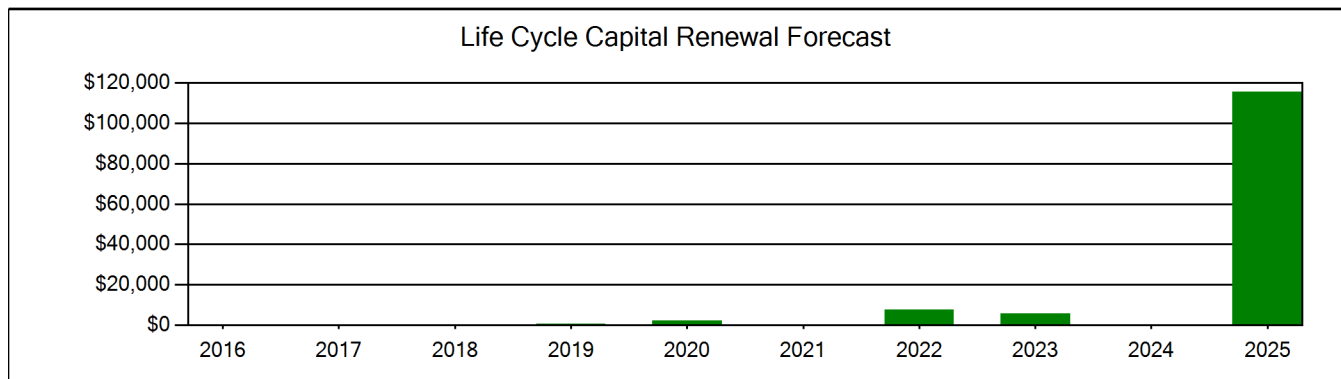
Dillard Ranch - Dillard Ranch - Outbuilding & Shed Condition
Assessment

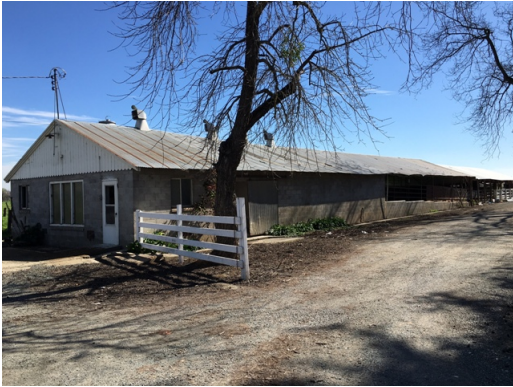
Dillard Ranch - Outbuilding Shed - Elevation

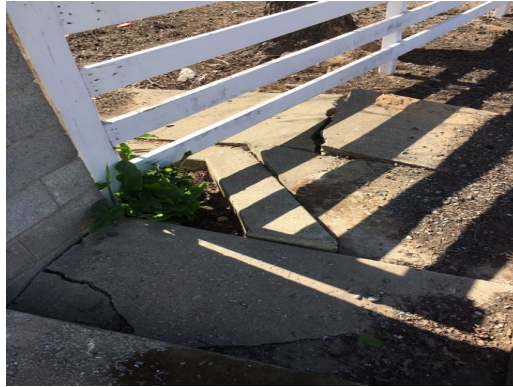
Dillard Ranch - Outbuilding Shed - Concrete Path Damage

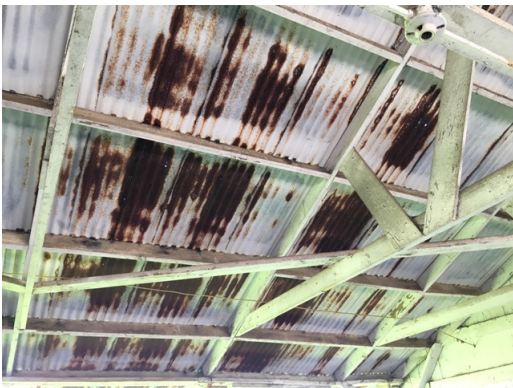
Dillard Ranch - Outbuilding Shed - Rusted Roof

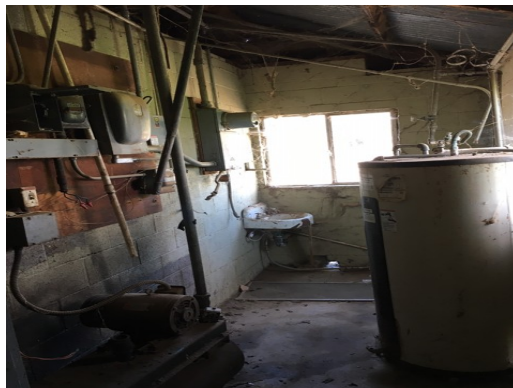
Dillard Ranch - Outbuilding Shed - Equipment Room

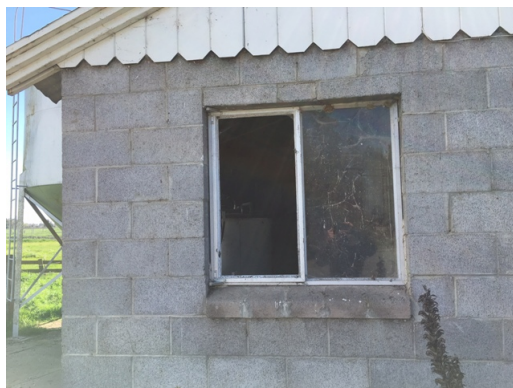
Dillard Ranch - Outbuilding Shed - Missing Window

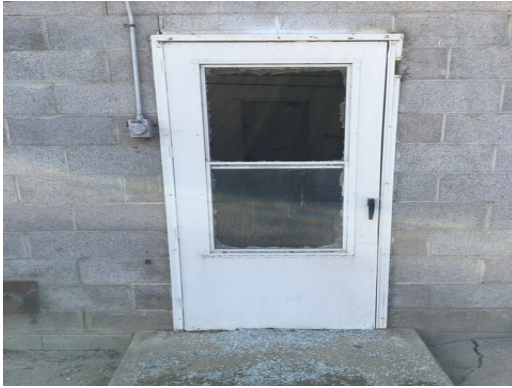
Dillard Ranch - Outbuilding Shed - Exterior Door

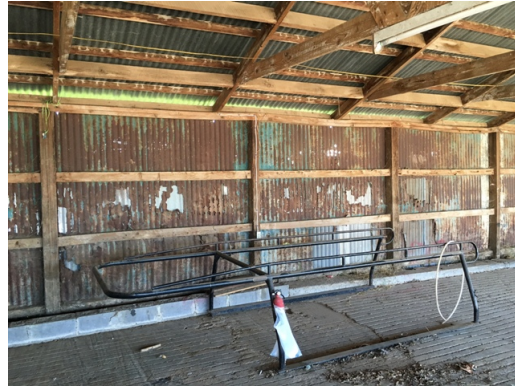
Dillard Ranch - Outbuilding Shed - Rusted Walls

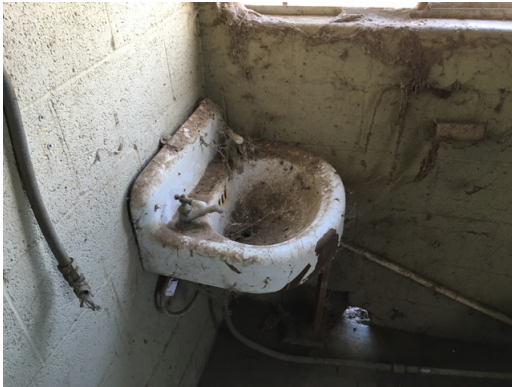
Dillard Ranch - Outbuilding Shed - Sink

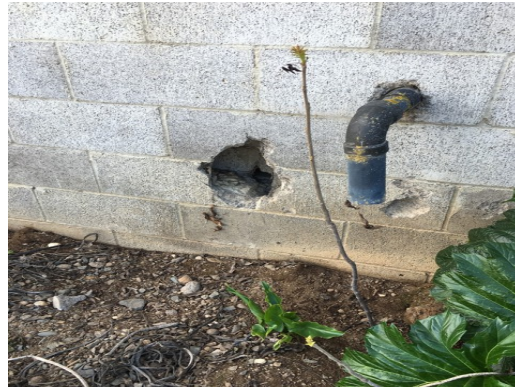
Dillard Ranch - Outbuilding Shed - Exterior Wall Damage

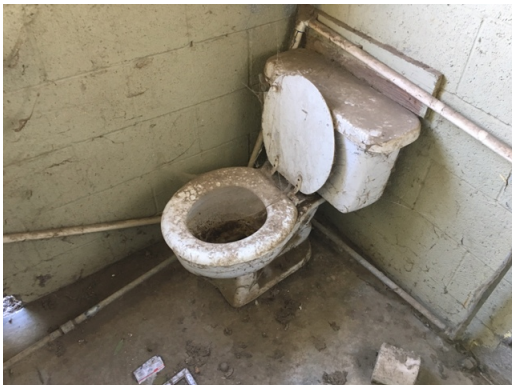
Dillard Ranch - Outbuilding Shed - Toilet

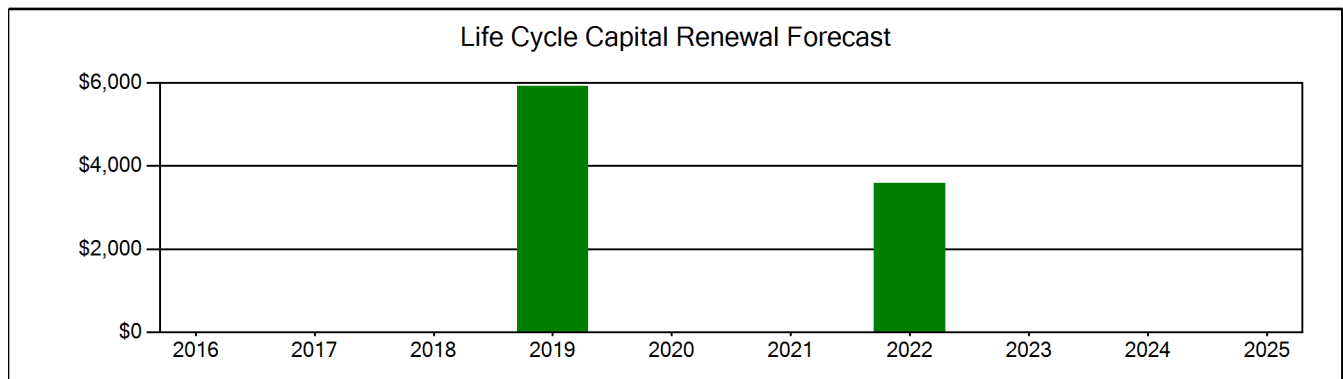
Dillard Ranch - Dillard Ranch - Shed #1 Condition Assessment

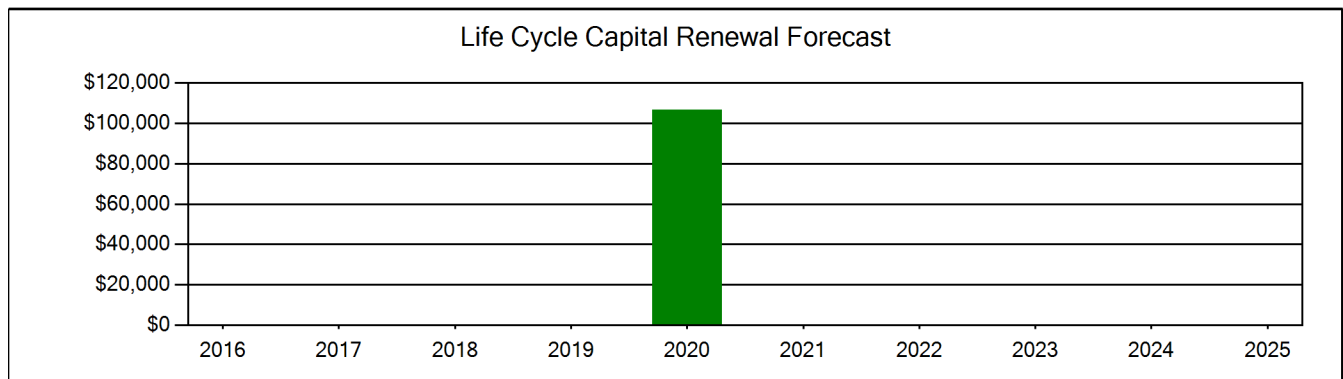
Dillard Ranch - Dillard Ranch - Shed #2 Condition Assessment

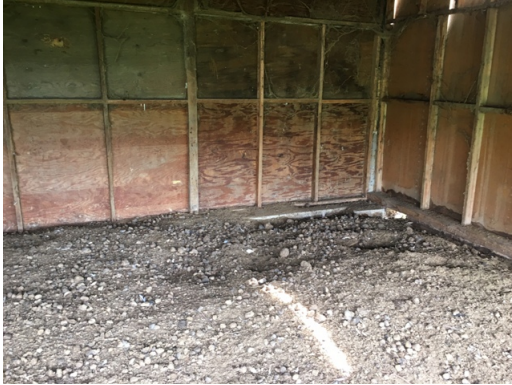
Dillard Ranch - Shed1 - Floor

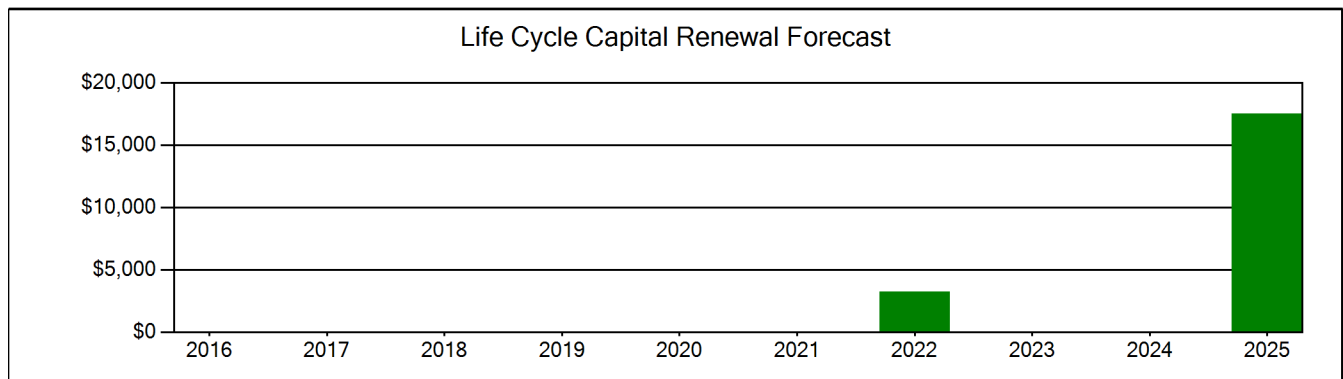
Dillard Ranch - Dillard Ranch - Well & pump Condition Assessment

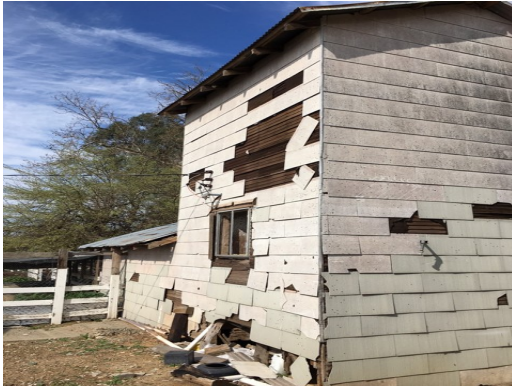
Dillard Ranch - Well Pump - Southeast Exterior

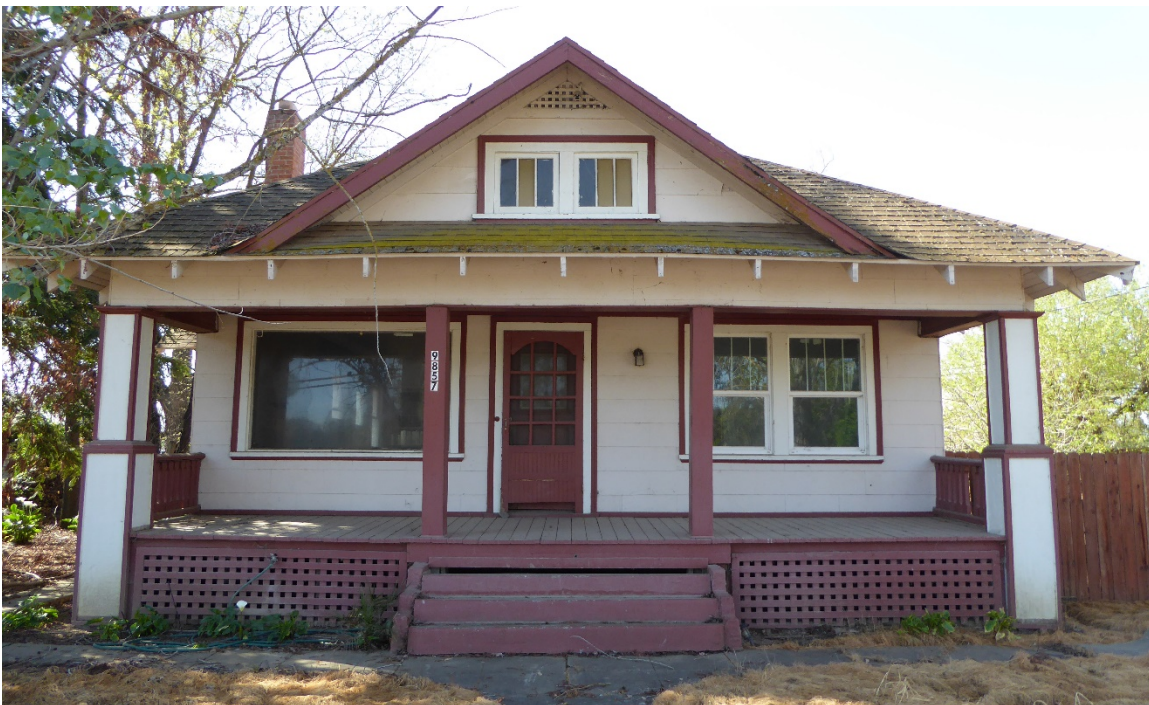
Figure 3: Primary façade of the ranch house.

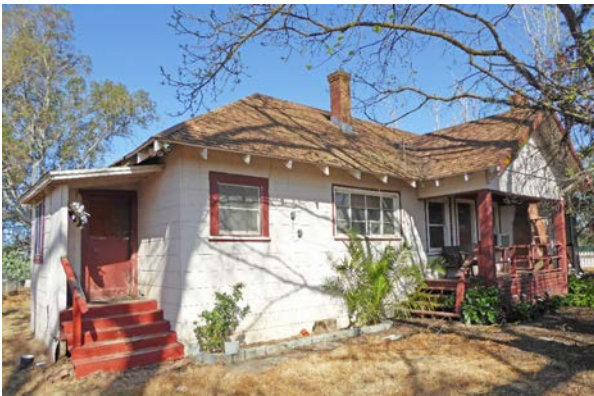
Figure 4: East façade of the ranch house. 2019

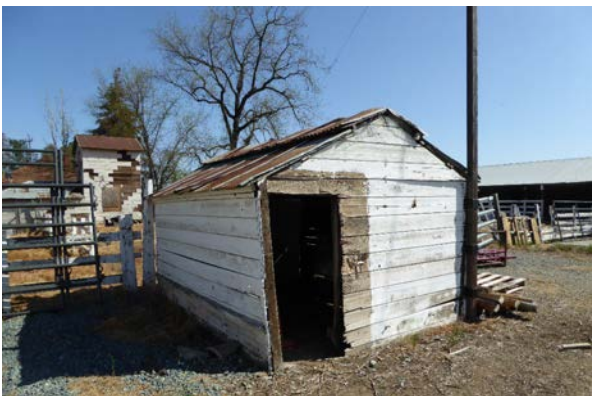
Figure 23: South façade of the small storage shed, looking northeast.

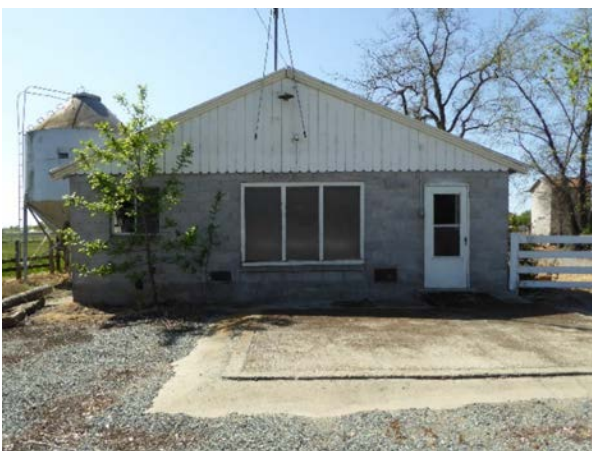
Figure 29: Primary (north) facade, looking south.

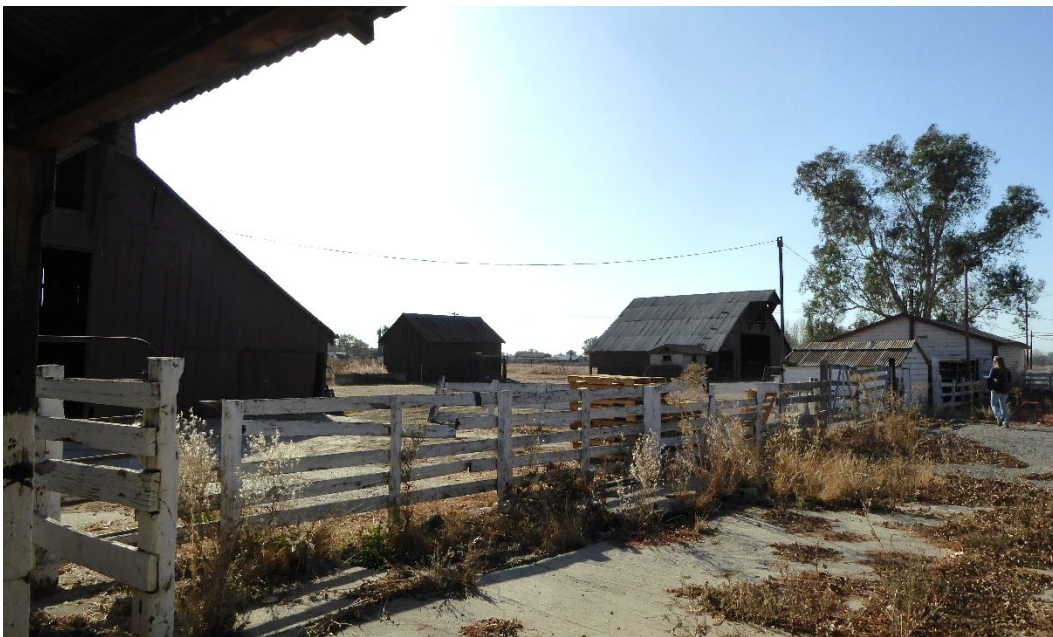
Figure 40: Looking southwest from the Dairy Barn, immediately north of hay barn 2. Remnants of wood rail fencing are found at this location.

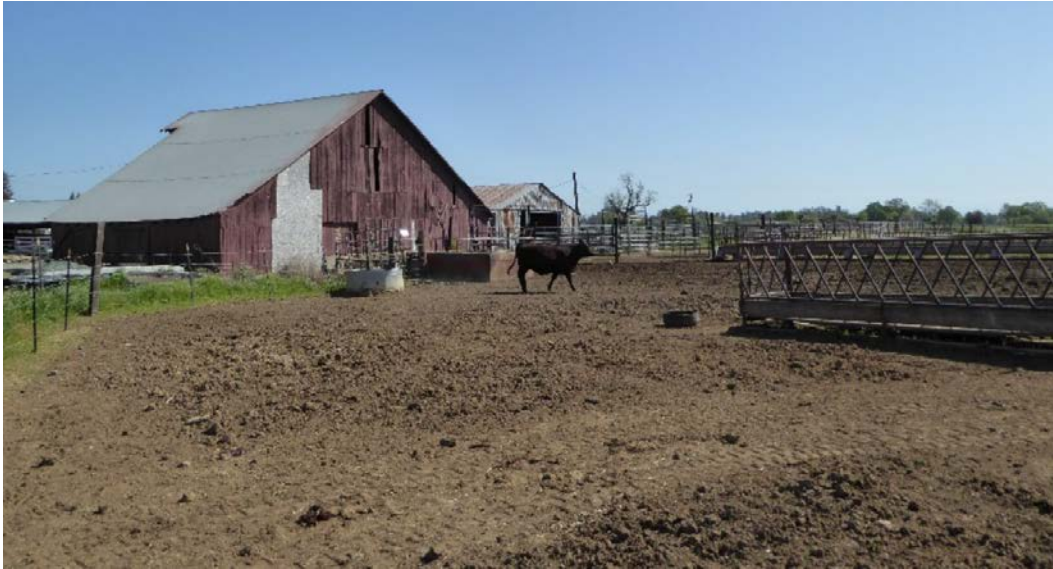
Figure 41: View of cattle corral, looking northeast toward hay barn 2.

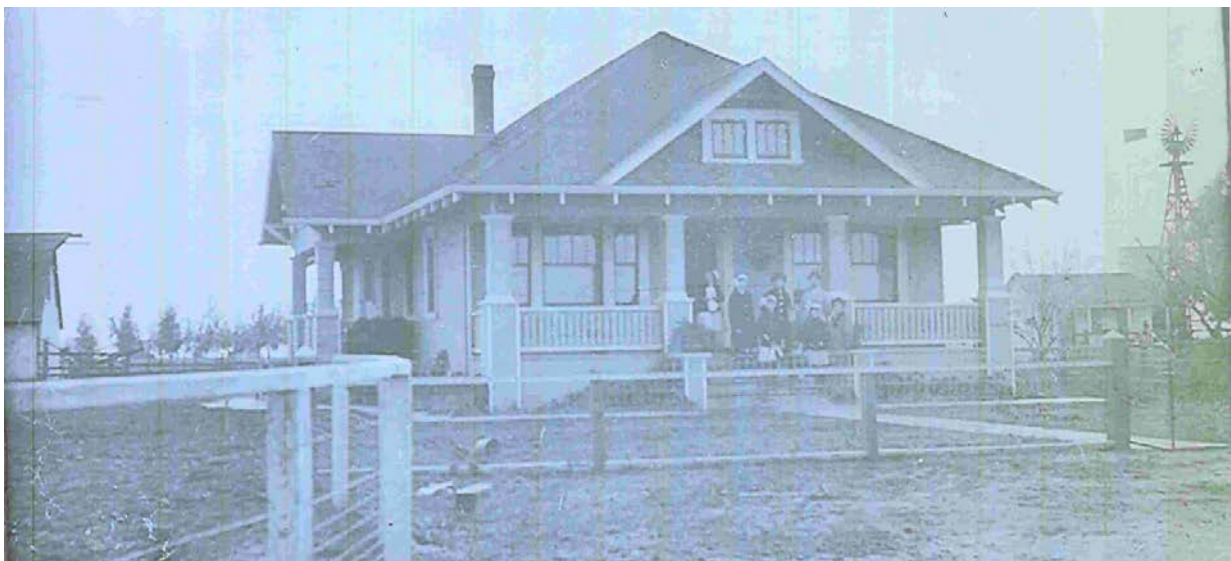
Figure 45: Undated photograph taken around the turn of the twentieth century, with the ranch house at center and additional buildings within Dillard Ranch in the background. Source: Courtesy Wilton History Group.

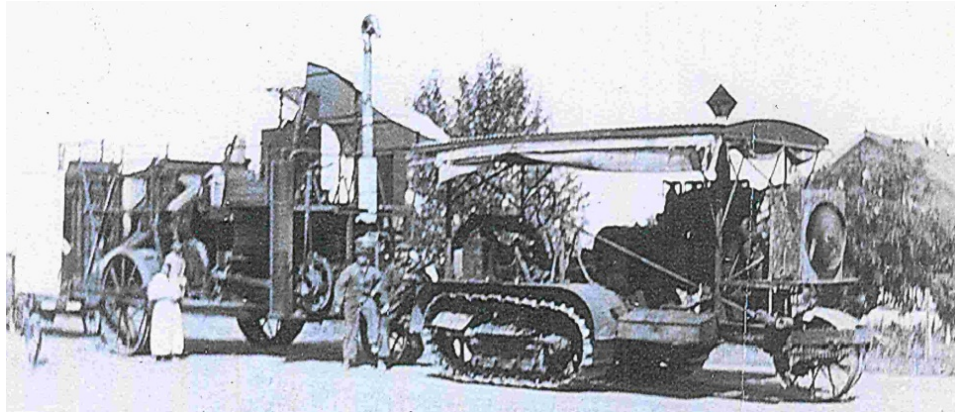
Figure 47: Undated photograph of Columbus "Lum" Dillard's harvest and tractor. Note: the building to the rear of the machine is unidentified. Source: Wilton History Group.

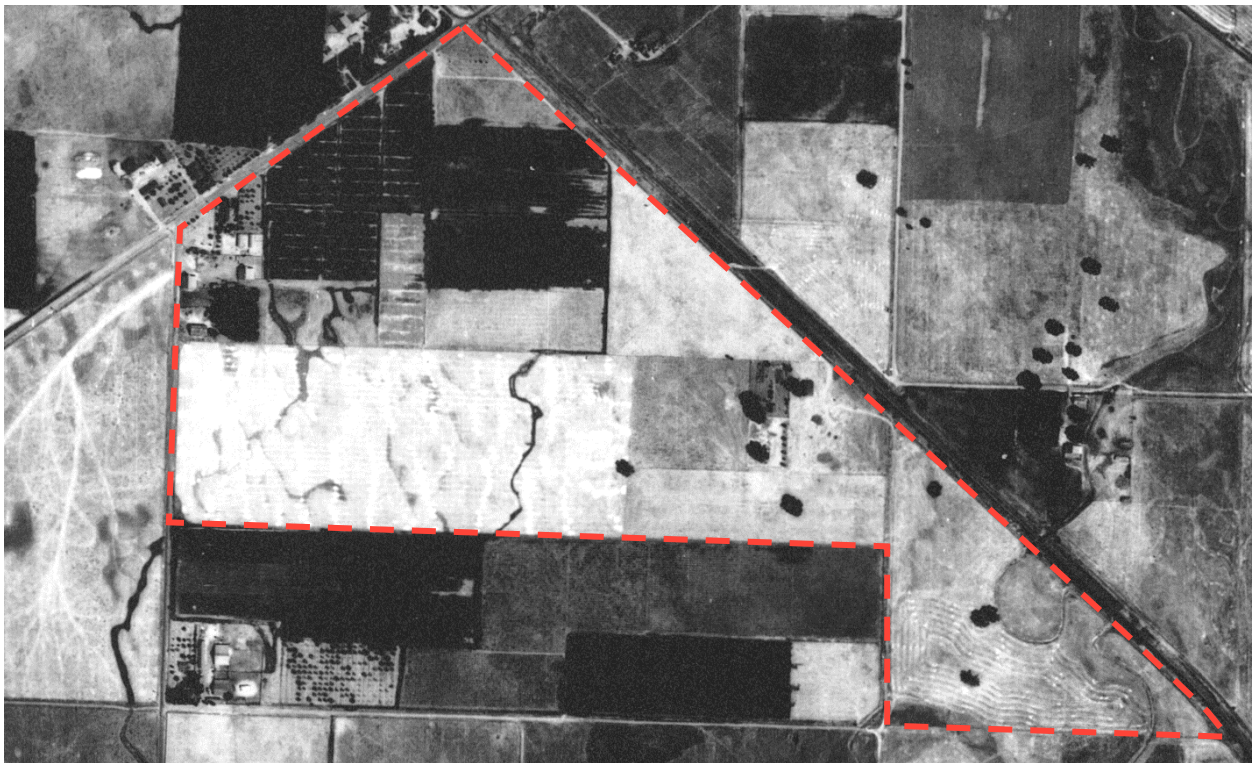
Figure 48: Aerial view of Dillard Ranch (approximate property boundaries outlined in red, 1937. Cluster of buildings within the ranch appear at upper left. Source: UC Santa Barbara Frame Finder, ABC-1937-45-79. Edited by Page & Turnbull.

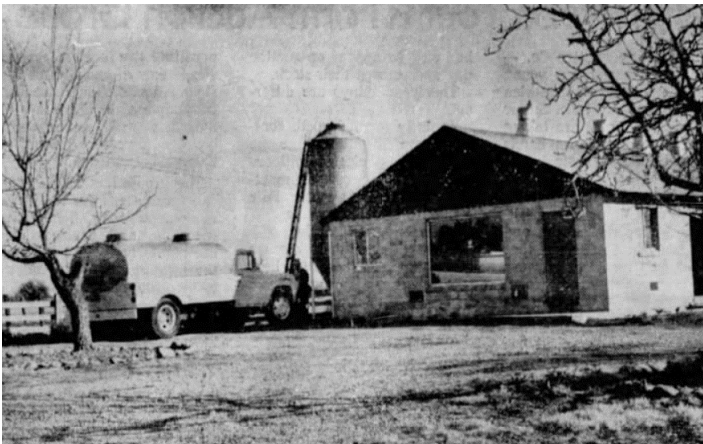
Figure 53: Parlor type milking barn, pictured shortly after construction in late May of 1964. Note original single-lite window, and taller silo to the rear of the building, which have since been replaced. Source: *Sacramento Bee*.

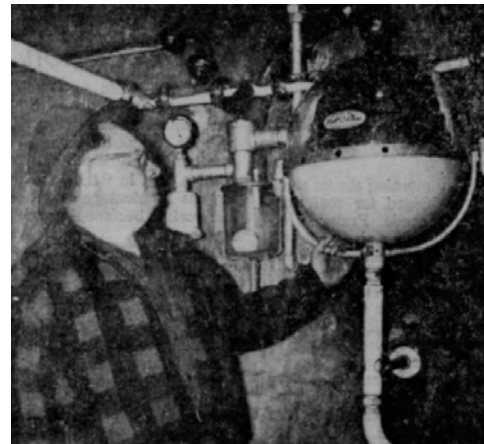
Figure 54: Walter Dillard inspects milk flowing through his dairy’s automatic pipeline system, 1964. Source: *Sacramento Bee*.

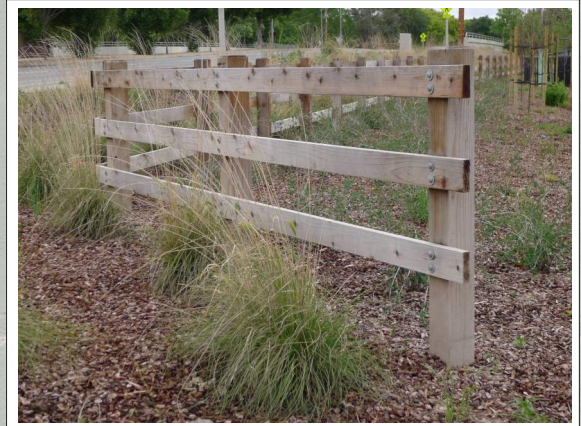
- A Ranch House Rehabilitation
 Approx area: 1,620 sf
 Proposed use: Wilton Historic Group Admin & Stor.
 Recommended upgrades include:
 - Exterior rehabilitation
 - Accessible ramp / access
 - Accessible restroom(s)
- B Hay Barn Adaptive Reuse:
 Approx area: 2,200 - 2,500 sf
 Proposed use: 4H/Community Meeting Space
 Recommended upgrades include:
 - Exterior rehabilitation
 - Seismic Stabilization & Upgrade
 - Interior construction of meeting space

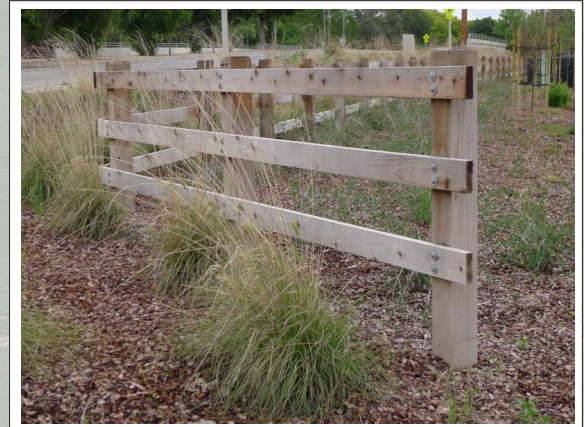
- A Ranch House Rehabilitation
 Approx area: 1,620 sf
 Proposed use: Wilton Historic Group Admin & Stor.
 Recommended upgrades include:
 - Exterior rehabilitation
 - Accessible ramp / access
 - Accessible restroom(s)
- B Hay Barn Adaptive Reuse:
 Approx area: 2,200 - 2,500 sf
 Proposed use: 4H/Community Meeting Space
 Recommended upgrades include:
 - Exterior rehabilitation
 - Seismic Stabilization & Upgrade
 - Interior construction of meeting space
