DILLARD RANCH CONCEPTUAL MASTER PLAN HISTORIC AND CULTURAL RESOURCES REPORT

WILTON, SACRAMENTO COUNTY, CALIFORNIA
[19374]

PREPARED FOR SACRAMENTO COUNTY PARKS
April 14, 2021

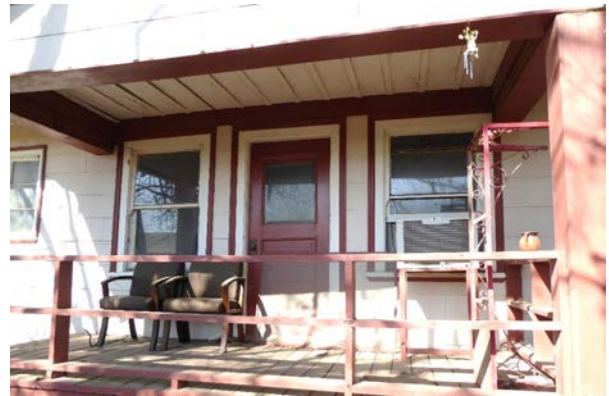
Figure 5: Side porch along east facade, looking west.

The east façade contains a side porch beneath an overhanging cross gable. Windows along this façade are a mix of one-over-one wood-sash within the porch area, a divided-lite fixed wood window to the south, and a replacement aluminum-sash window at the rear (**Figure 4 and Figure 5**). The house's original brick chimney stack with corbeled crown is visible above the east façade. The rear façade has been altered by the addition of a shed roof porch, set beneath the overhanging eave of the main roof. The porch is built on a slab foundation and is accessed by wood steps with a wood railing (**Figure 6**). The east façade has five replacement one-over-one vinyl-sash windows (**Figure 7**).

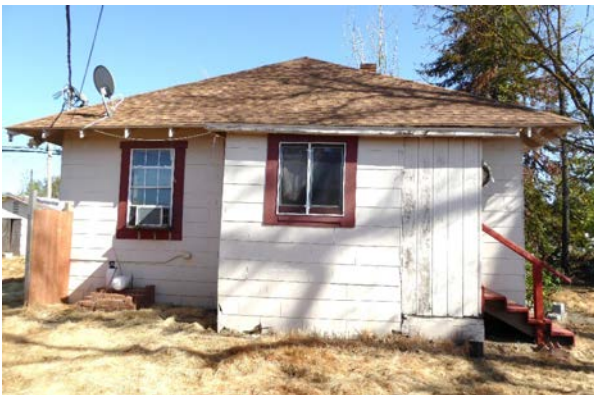
Figure 6: Rear façade of the ranch house, with shed porch addition.

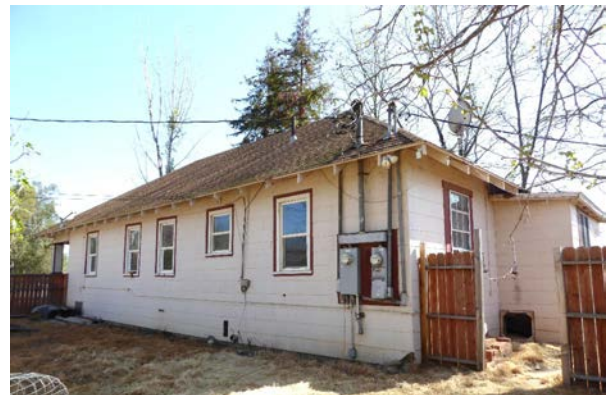
Figure 7: West façade, looking northeast.

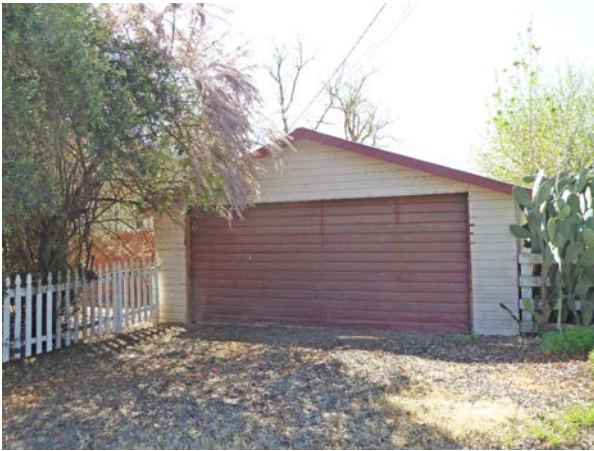
Figure 8: Front of garage, looking south.

The existing garage is situated alongside Dillard Road and immediately west of the ranch house. It appears to have been built by 1937, based upon historic aerial photography of the site (**Figure 8**). This date range appears plausible, as the garage appears to have been designed to house automobiles, which became increasingly more common between ca. 1900 and 1937. The garage is a wood-frame, one-story, gable-roofed building with an overhead door made of channeled wood siding that faces Dillard Road. The exterior is clad with channeled wood siding. The roof is covered with corrugated metal and has a moderate overhang with exposed rafter tails and simple wood fascia. Skylights are inserted into the metal roofing. A door made of contemporary wood paneling is set into a wood frame at the garage's east façade, and the rear façade has a plywood door at center (**Figure 9 and Figure 10**).

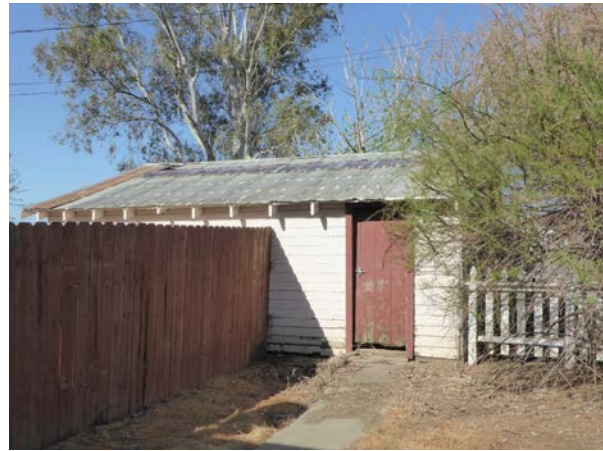
Figure 9: East façade, looking west.

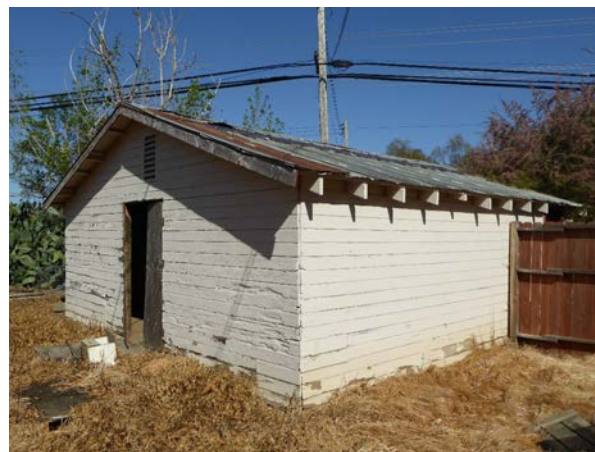
Figure 10: Rear of garage, looking northwest.

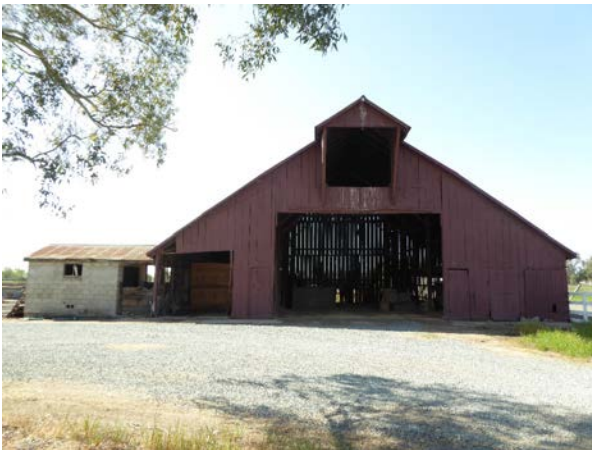
Figure 11: Looking south toward hay barn 1.

Hay barn 1, situated along the west perimeter of the site, features a small concrete block addition off of its northeast corner, which was built sometime between 1937 and 1953, based on aerial photography (**Figure 11 to Figure 14**). This building's total square footage is approximately 2,400 square feet. Hay barn 2 features a similar design, materials, hay hood, and footprint, but does without any apparent additions, resulting in its slightly smaller square footage of approximately 2,300 square feet (**Figure 15 and Figure 18**).

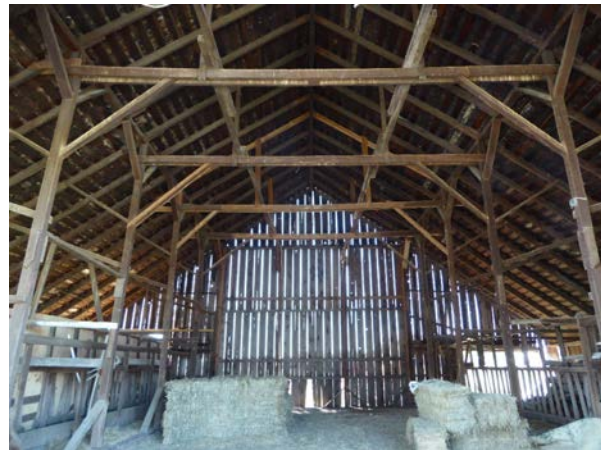
Figure 12: Wood truss structural system, looking south.

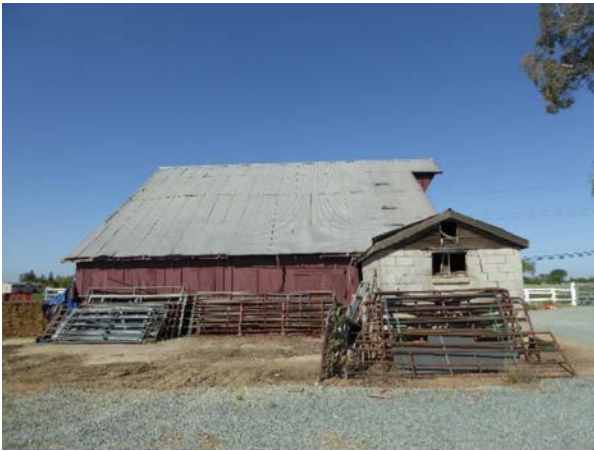
Figure 13: East façade of hay barn 1, looking west.

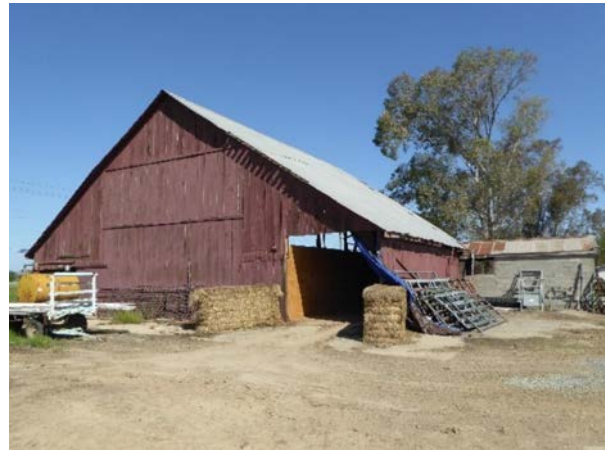
Figure 14: Rear façade of hay barn 1, looking northwest.

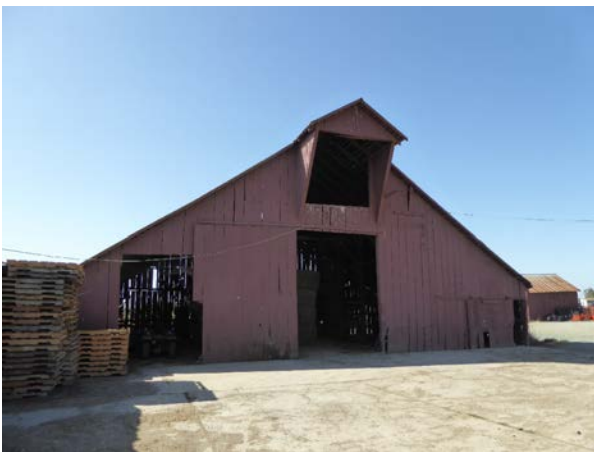
Figure 15: North façade of hay barn 2, looking south.

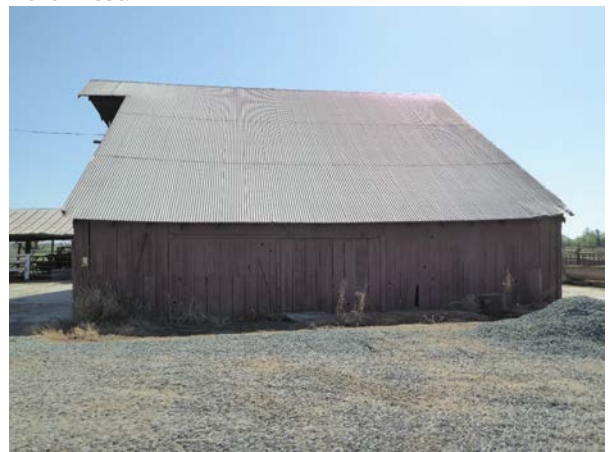
Figure 16: Looking east at west façade of hay barn 2.

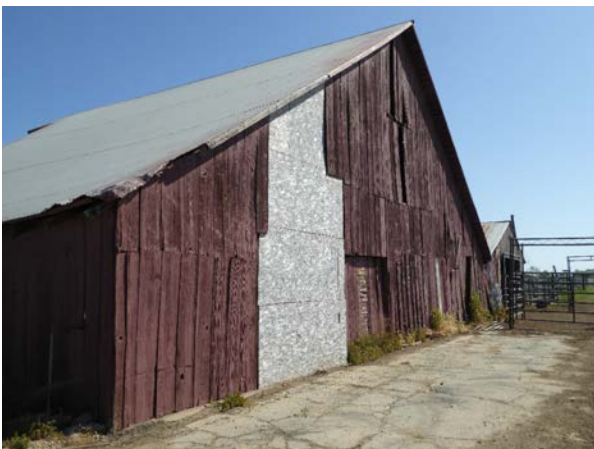
Figure 17: Rear façade of hay barn 2, looking east.

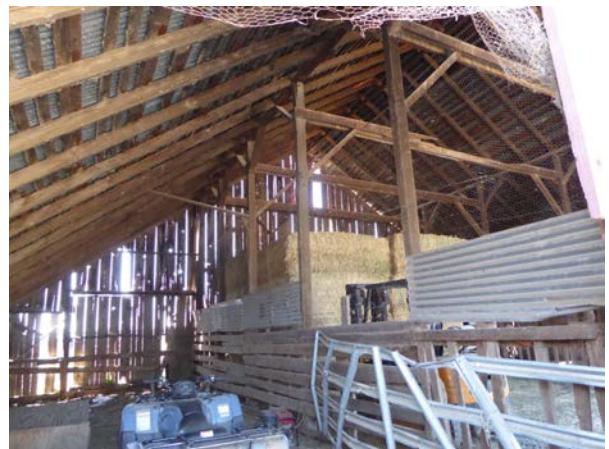
Figure 18: Interior truss system at hay barn 2.

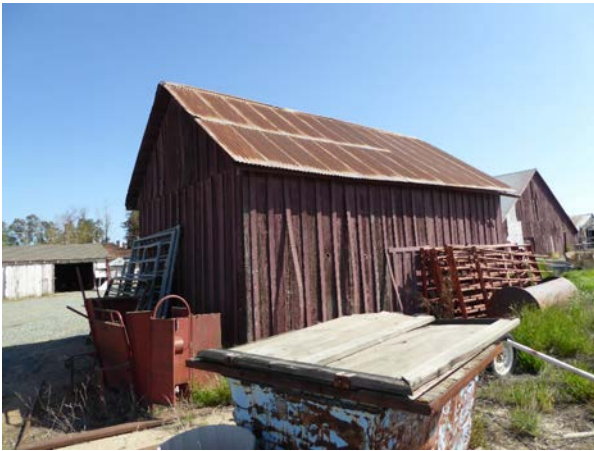
Figure 19: Oblique view of south facade of granary, looking northeast.

The granary was built prior to 1937 and potentially as early as ca. 1900 for storing grain harvested from the ranch during its early use for grain cultivation. The building is approximately 400 square feet. The exterior is board-and-batten wood siding. The building is capped by a gable roof with moderate overhang that is covered with corrugated metal. The building is not fenestrated in order to limit light penetration, which was a common feature of granaries to keep grains cool and out of sunlight (**Figure 19 to Figure 20**).

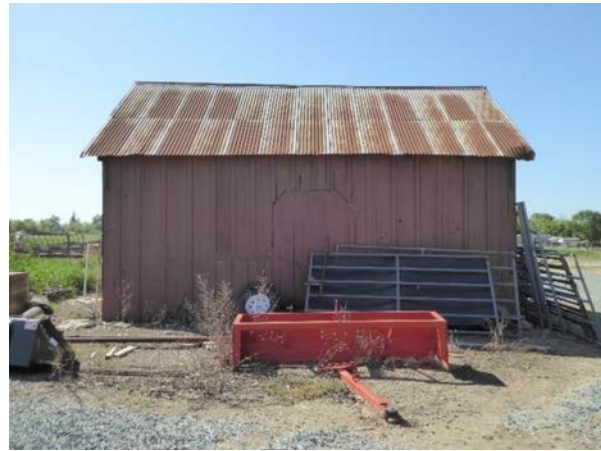
Figure 20: Looking south at north façade of granary with door cut into board-and-batten siding.

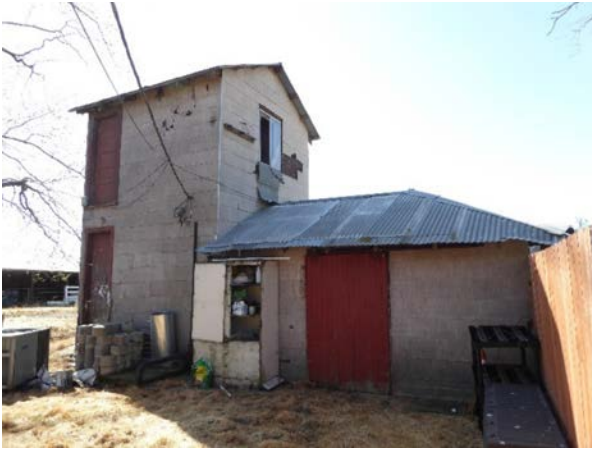
Figure 21: View of the tankhouse building, looking northwest.

The tankhouse was built sometime between 1899 and 1937 and is approximately 720 square feet. The tankhouse is comprised of a two-story gabled section and a lower one-story section with a hip roof (**Figure 21 and Figure 22**). Both sections have moderate roof overhangs, corrugated metal sheet roofing, and exposed rafter tails. Walls are wood-framed and clad with narrow lapped wood siding. Asbestos siding has been placed over most of the wood siding. The north façade of the two-story section features a door opening at each story, indicating a staircase was likely attached to the exterior but has since been removed prior to the installation of the non-original asbestos materials at the exterior.

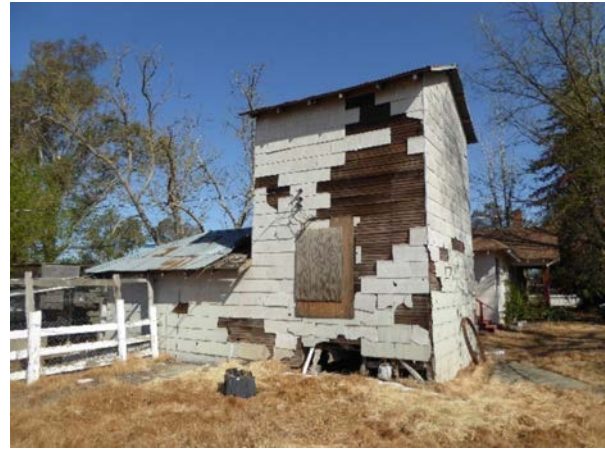
Figure 22: South façade of tankhouse, looking north.

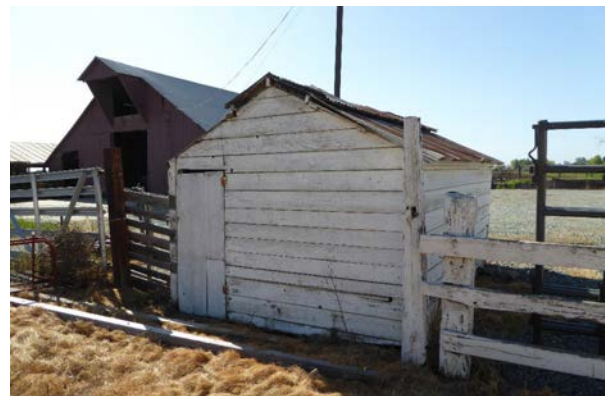
Figure 24: North façade of the small storage shed, looking southeast.

The small storage shed is an ancillary building of approximately 100 square feet. The building does not appear to have a foundation and has horizontal wood siding and a gable roof covered with metal sheets. Openings are cut into the front and rear walls, with the rear opening enclosed by a plywood door (**Figure 23 and Figure 24**).

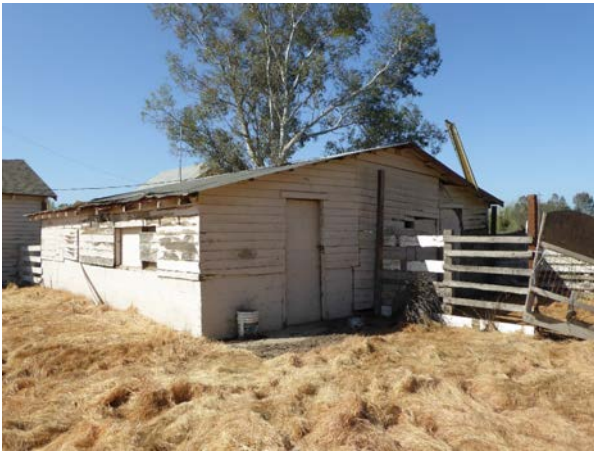
Figure 25: East (left) and north (right) façades of the storage shed, looking south.

The Storage Shed is a wood-frame ancillary building with a rectangular footprint and an area of approximately 650 square feet. The roof is gabled, overhangs the building footprint slightly, and has exposed rafter tails and metal covering. The base of the building's east and north walls are built of concrete block with wood framing above (**Figure 25 and Figure 26**). Two windows at the east façade have been infilled. The north façade has a single door opening with a vertical plank door and is covered with lapped siding that has several cut joints. The west façade is partially covered with wood siding and features a wide opening for access into the shed.

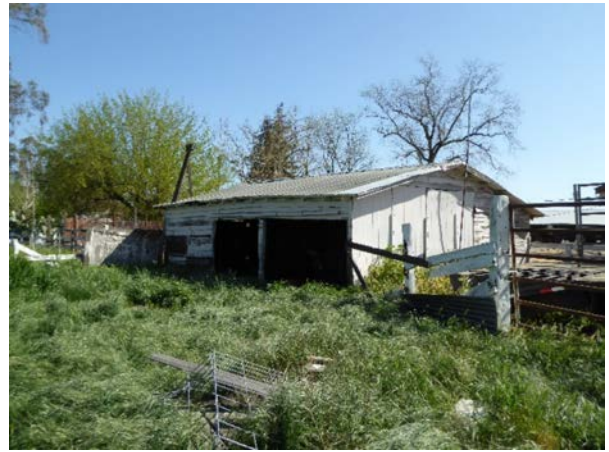
Figure 26: West (left) and south (right) façades, looking north.

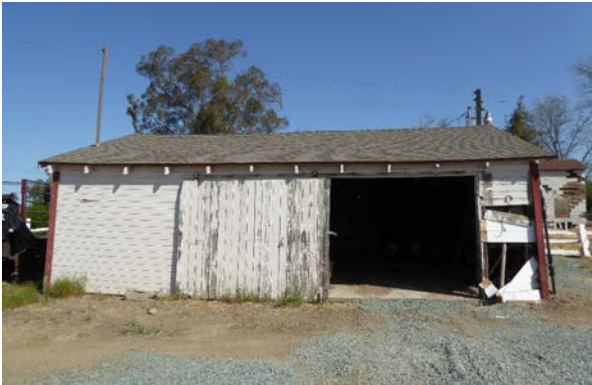
Figure 27: South façade of workshop, looking east.

The workshop is a wood-frame ancillary building that was built sometime between 1937-1952, based upon aerial photography, and is approximately 850 square feet (**Figure 23 and Figure 24**). It has horizontal wood siding; flat wood corner boards; and a gable roof with moderate overhangs, metal covering, wood fascia, and exposed rafter tails. A sliding door built of vertical wood siding provides access through a wide bay at the south façade.

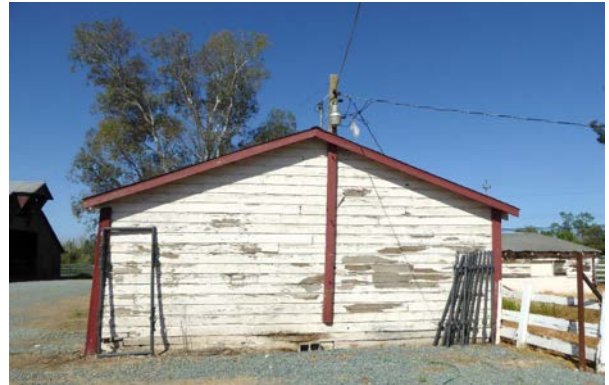
Figure 28: East façade of workshop, looking west.

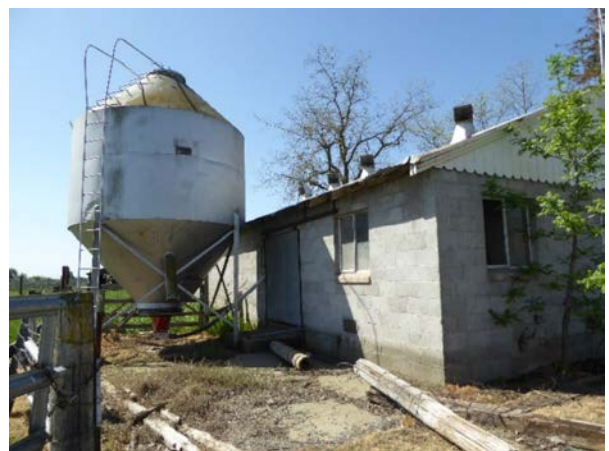
Figure 30: Feed hopper next to east façade, looking south.

The dairy barn is a two-part building combining a milking parlor and a covered corral, which were originally constructed by dairyman Walter C. Dillard in 1964. The building's primary façade is oriented north to Dillard Road, with a setback from the road of roughly 115 feet. The walls of the building are constructed of concrete block, and the building is capped by a gable roof covered with corrugated metal. The primary façade of the parlor features a large storefront window with replacement sash and a replacement single-entry door. A smaller aluminum sash window is located east of the central display window. The gable end of the primary façade is decorated with vertical wood siding that extends to the eave line (**Figure 29**). The west façade includes a sliding corrugated metal door that accesses the parlor. A steel grain hopper is situated to the immediate east of the milking parlor section of the dairy barn (**Figure 30**).

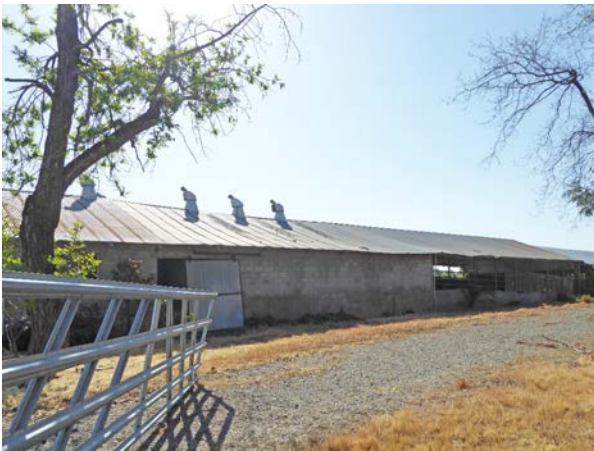
Figure 31: Concrete block section of the east façade, looking southeast.

The rear two-thirds of the building have a wood truss roof covered in corrugated metal (**Figure 31 and Figure 32**). The floors in these areas are concrete with linear grooves. The concrete floors enabled dirt and manure to be cleaned out after cows entered the barn prior to milking. The rear one-third of the building has concrete block half walls at the exterior, which provide air circulation. The interior retains a milker's pit near the north end of the building (**Figure 33**). Further south, the interior features concrete floors and walls that are enclosed by either metal siding or metal fencing. The roof is supported with wood trusses throughout (**Figure 34 and Figure 35**).

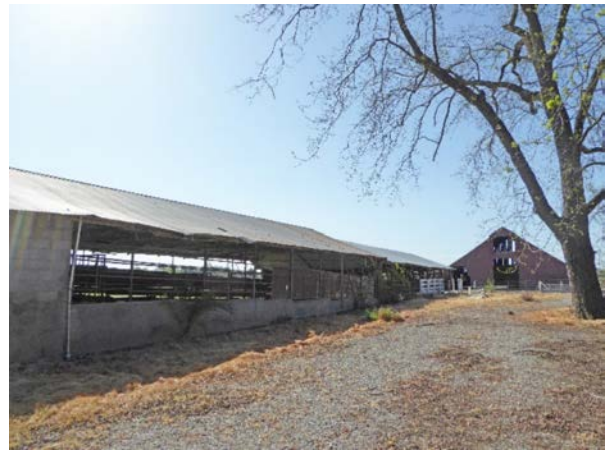
Figure 32: Covered corral section of dairy barn, looking south.

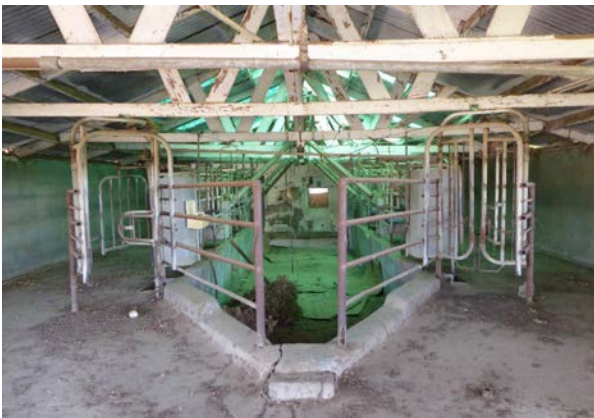
Figure 33: Milker's pit within parlor, looking south.

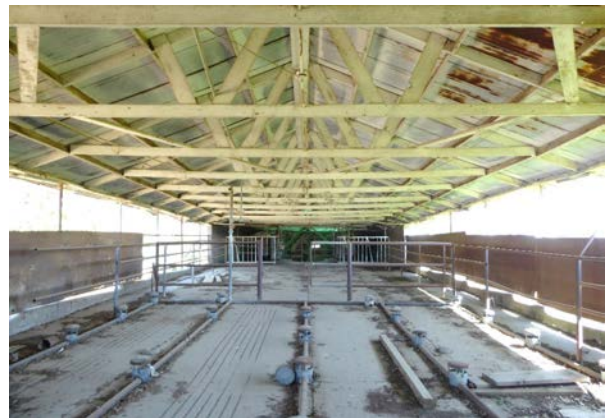
Figure 34: Dairy barn, to the south of the milker's pit, looking north.

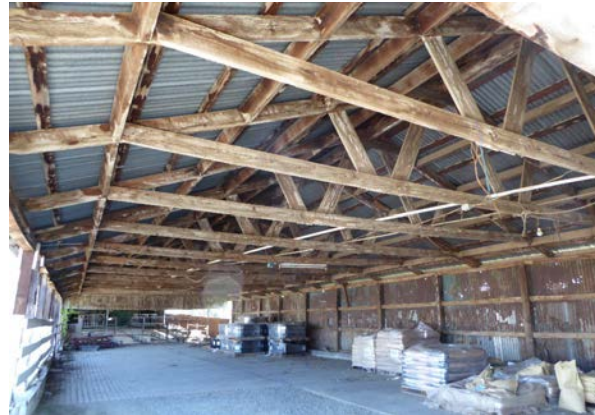
Figure 35: Southern end of the dairy barn, looking north.

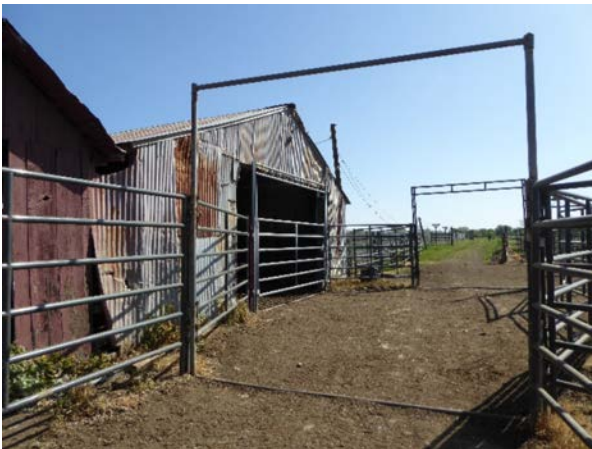
Figure 36: Entrance to loafing barn at south façade.

The loafing barn provides a place for cattle to take shade or dry off after inclement weather, prior to entering the dairy barn that is situated immediately north of the loafing barn. The loafing barn abuts the east façade of hay barn 2 and is roughly 2,600 square feet. The building has a gable roof that is supported by wood trusses and wood posts. The roof is covered with corrugated metal. The barn's walls are largely open with wood posts supporting the edge of the roof above and a combination of wood and metal fencing forming the walls. The interior is accessed from a large, gated opening at the south façade (**Figure 36 and Figure 37**).

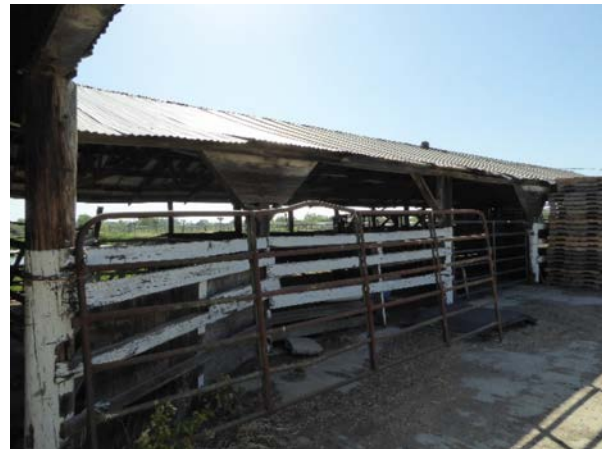
Figure 37: Looking southeast toward loafing barn.

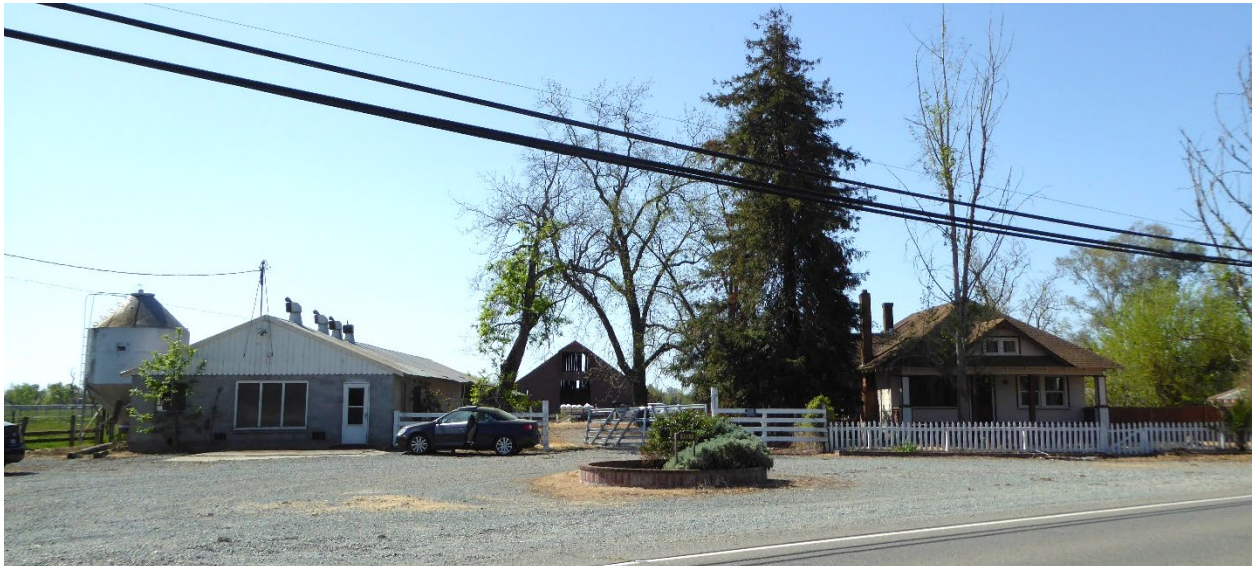
Figure 38: Dairy barn and ranch house viewed from Dillard Road, looking south.

Most of the site's 97 acres are dedicated to grazing land and pasture. Buildings are concentrated toward the site's northwest corner, just east of the intersection of Dillard and Davis roads (**Figure 38**). Entrances include the main residential entrance off of Dillard Road, directly north of the ranch house and Dairy Barn, a secondary driveway to the immediate west of the garage and ranch House, and a driveway off of Davis Road along the site's west perimeter. Each of these entry areas has gravel surfacing. Wood rail fencing stands along the northern perimeter of the site, west of the ranch house, and parallels a secondary driveway that appears to have accessed the non-extant Milker's House, immediately west of the garage (**Figure 39**).

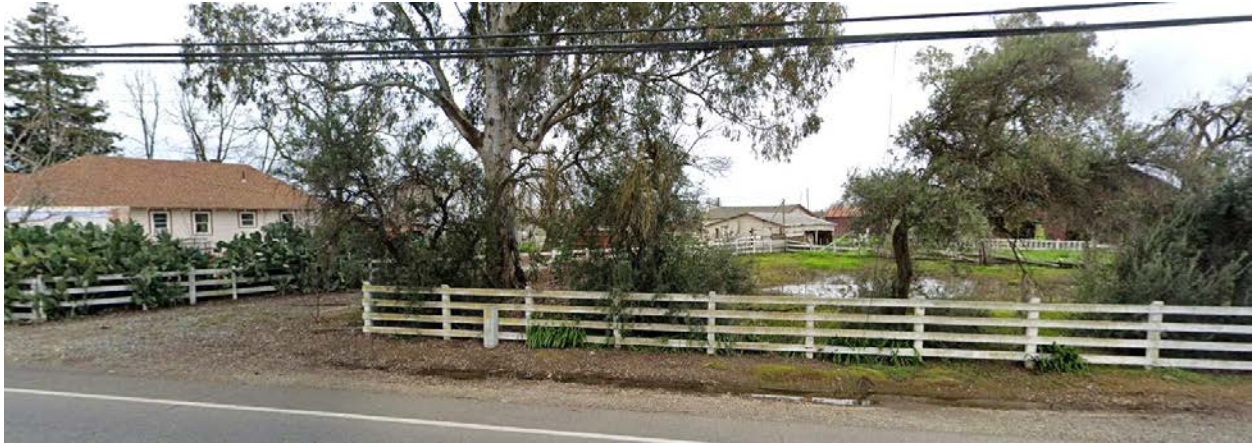
Figure 39: Former location of Milker's House at the northwest corner of the property, viewed from Dillard Road. Wood rail fencing remains in place at this location. Source: Google Street View, 2019.

Similar wood rail fencing is located between the ranch house and the dairy barn, to the rear of the ranch house and tankhouse, and in the area to the immediate west of the dairy barn (**Figure 39** and **Figure 40**). Modern wood picket fencing is located in front of the ranch house. Modern wire fencing encloses the remainder of the north perimeter of the site, west of the ranch house and dairy barn and the cattle corrals at the south end of the building cluster (**Figure 41**).

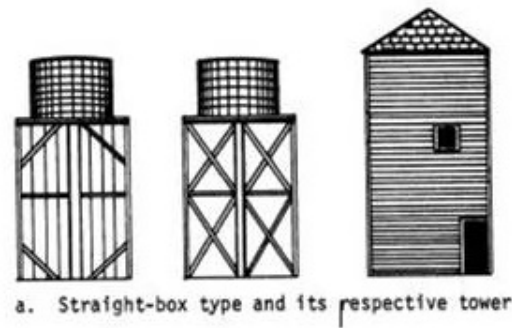
Figure 42: California tankhouse types identified by scholar Leon S. Pitman in "Domestic Tankhouses of California," 1976. Source: *Pioneer America*. Edited by Page & Turnbull.

Domestic tankhouses developed in California in about 1865. [...] Some of the first walled tower tankhouses were probably those found in towns in the 1860s, where owners of hotels, hospitals, boarding houses and other businesses needing their own water supplies built some of the largest elevated water tanks. Enclosing the towers with walling material made them more attractive to the public and functionally more useful, for the rooms beneath the tank platform could be used for storage space. For some businesses a walled tankhouse closely attached to a building could be incorporated in the floor space of that building. [...]

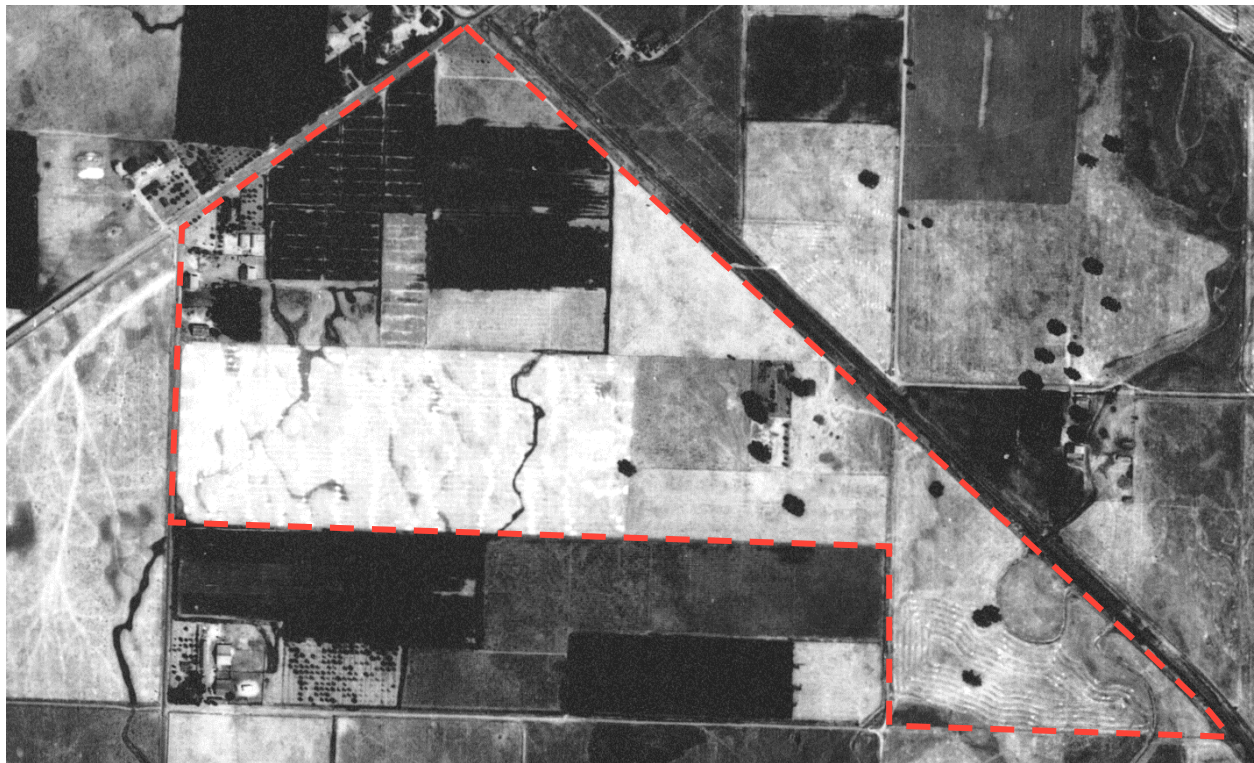
Figure 48: Aerial view of Dillard Ranch (approximate property boundaries outlined in red, 1937. Cluster of buildings within the ranch appear at upper left. Source: UC Santa Barbara Frame Finder, ABC-1937-45-79. Edited by Page & Turnbull.

A small orchard was located to the east of the ranch house, immediately south of Dillard Road. The detached garage to the immediate west of the ranch house also stood at its existing location by 1937. Land immediately west of the residence, facing the intersection of Dillard and Davis Roads was vacant. Two sheds or barns were located to the southeast of the ranch house, however, the use of these non-extant buildings as of 1937 is unknown. Further south, two similar hay barns stood, one closer to Davis Road and the other closer to the open land. It is unknown whether either of these barns were that which appeared in the ca. 1900 photograph shown above. Both barns pictured in 1937 are extant and in the same location as of 2021.

By the late 1920s, Walter Columbus Dillard took over operation of the ranch from his father and began to transition the ranch's operations to dairy production. Over the next three decades, Walter expanded from milk production and a small herd of stock to raising replacement stock for other dairies, and eventually pursued retail sales. An aerial photograph from 1937 provides the earliest available aerial documentation of the property (**Figure 48**).

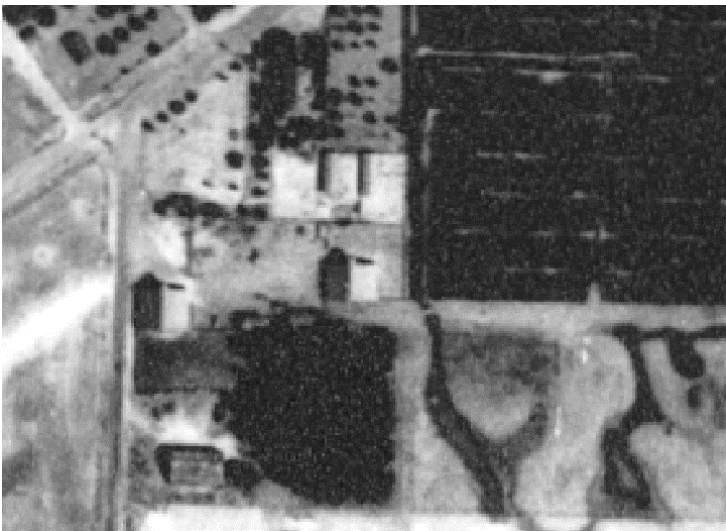
Figure 49: Detail view of buildings present at Dillard Ranch as of 1937.

A group of two to three ancillary buildings were placed between the barns and appear to be the sheds that are present in that location as of 2021 (**Figure 49**). Finally, a non-extant barn with a smaller rectangular footprint than the existing hay barns stood immediate east of Davis Road, at the southwest corner of the grouping. It appears that another potential building or structure stood further eastward, just west of the railroad tracks that run along the northeastern boundary of the property. The 1937 aerial photograph does not provide for a clear indication of what stood at this location, but the area does appear to have featured a series of trees or shrubs aligned in rows (**Figure 50**).

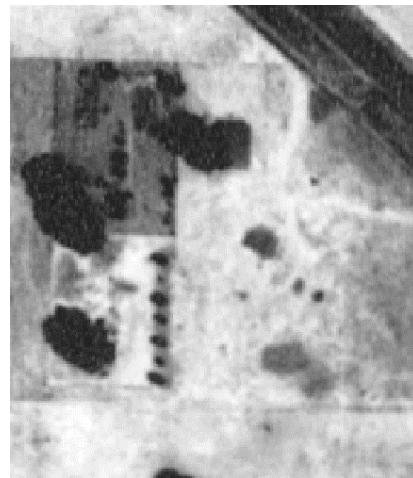
Figure 50: Detail view of secondary area to the east of the main grouping of buildings at the southeastern section of the ranch as of 1937.

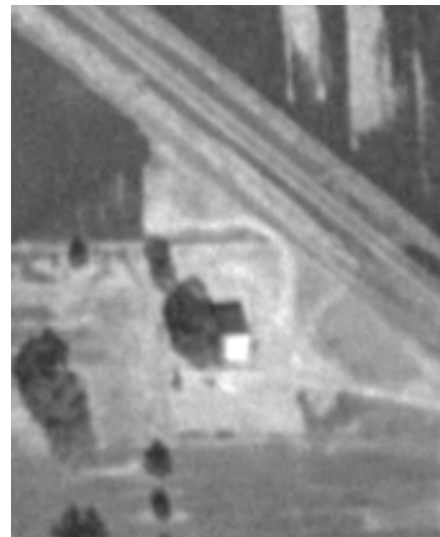
Figure 52: Since-demolished building near railroad tracks, 1952. Source: UC Santa Barbara Frame Finder, pai-abc_3k-53-1952.

Walter was very community-oriented and in the 1930s, he constructed Wilton's first fire engine with donated parts and funds from local residents. Walter also served as a trustee of the Wilton Town Hall Association in the 1940s and as the Fire Commissioner for the Wilton Volunteer Fire Department for nine years. Daughters Shirley (1932-2018) and Jeannie (1933-2010) grew up on the family dairy and contributed to the dairy's operations during school lunch times. By the mid-1940s and into the 1950s, Walter Dillard's stock raising operations and related auctions of stock were advertised in regional newspapers. In 1946, Dillard and fellow dairy operator Joe T. Lopes auctioned several heifers, guernsey, and spring stock. In 1954, Dillard, Lopes, and fellow Elk Grove area dairymen DeLore Lawrence, John Mensh, and Jack Hansen were appointed to a committee to study the possible formation of a milk pool or dairy producer cooperative for the Western Dairymen's Association.⁵⁰ A 1952 aerial photograph shows several changes to the complex of buildings at Dillard Ranch that occurred after 1937 (**Figure 51**). A milker's house with a rectangular footprint was constructed at the northwest corner of the site to the west of the ranch house. This area was vacant land in the 1937 aerial photograph. One of the smaller ancillary buildings that stood between the residence and the hay barn at the southeast corner of the cluster was removed. A building with a gable roof was photographed to the immediate west of the railroad tracks near the northeast boundary of the property (**Figure 52**).

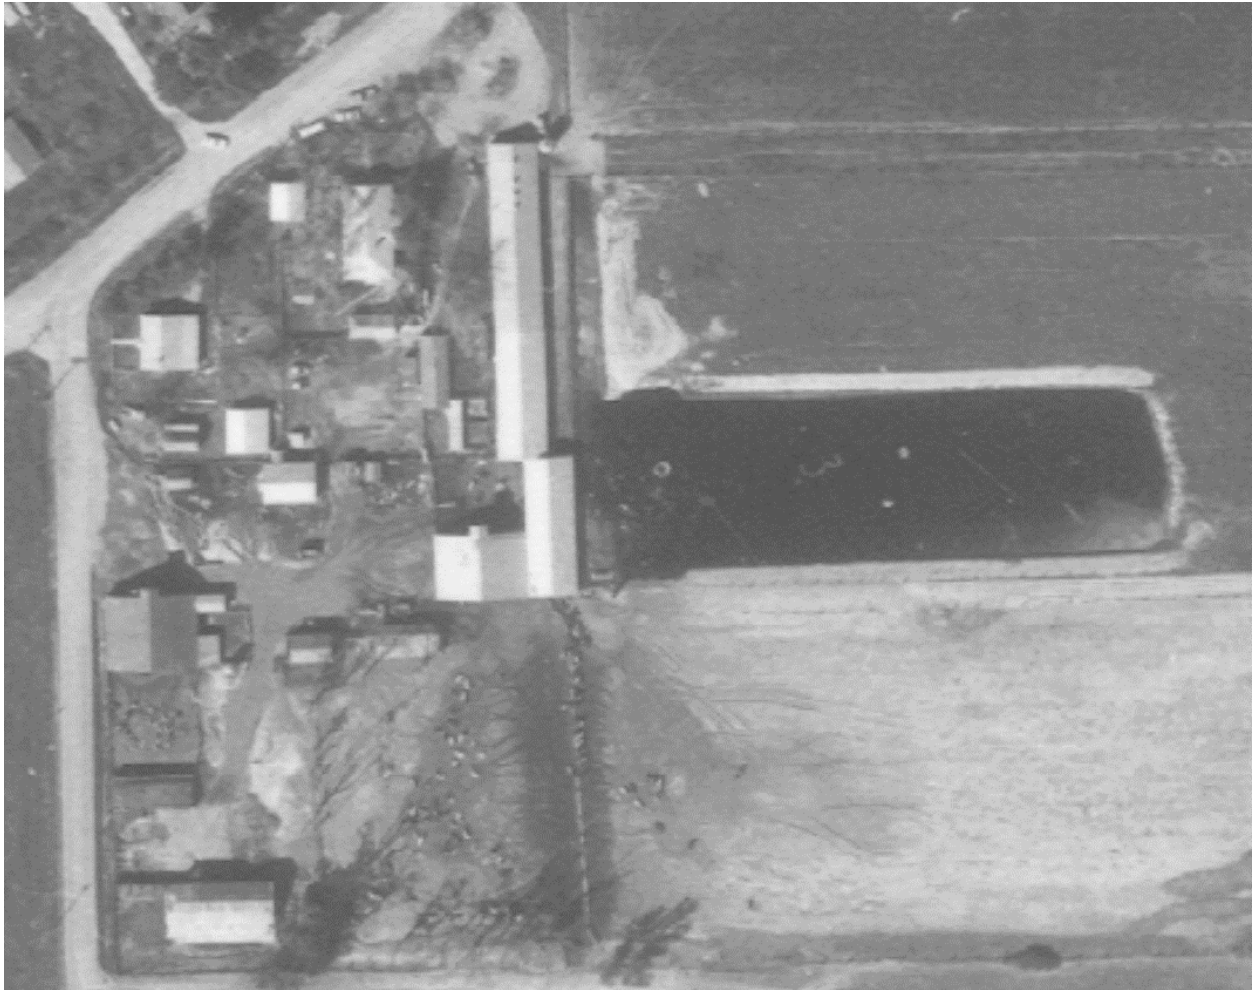
A 1971 aerial photograph provides a detailed view of the property following the construction of the dairy barn in 1964 (**Figure 55**). By 1971, a section of pasture was repurposed as a retention pond, located immediately east of the dairy barn and loafing barn. This aerial also shows that between the 1950s and early 1970s, several ancillary buildings that are no longer standing at the property were located immediately west of the dairy barn (southeast of the tankhouse), and west of the workshop, near the site’s west perimeter. Livestock, likely cattle, can be seen in the corral to the immediate south-southeast of the granary and haybarns. The 1971 aerial also captured a gabled shed building at the east perimeter of the site near the railroad tracks; this building appears to have been larger than the buildings photographed at that location on prior aerials, and is no longer present at the site. By 1971, the small, rectangular, concrete block addition on the east façade of the west hay barn was built.

Figure 55: Aerial view of the buildings at Dillard Ranch, 1971. Source: UC Santa Barbara Frame Finder, Cartwright Aerial Surveys Flight CAS 3069, Frame 5-207.

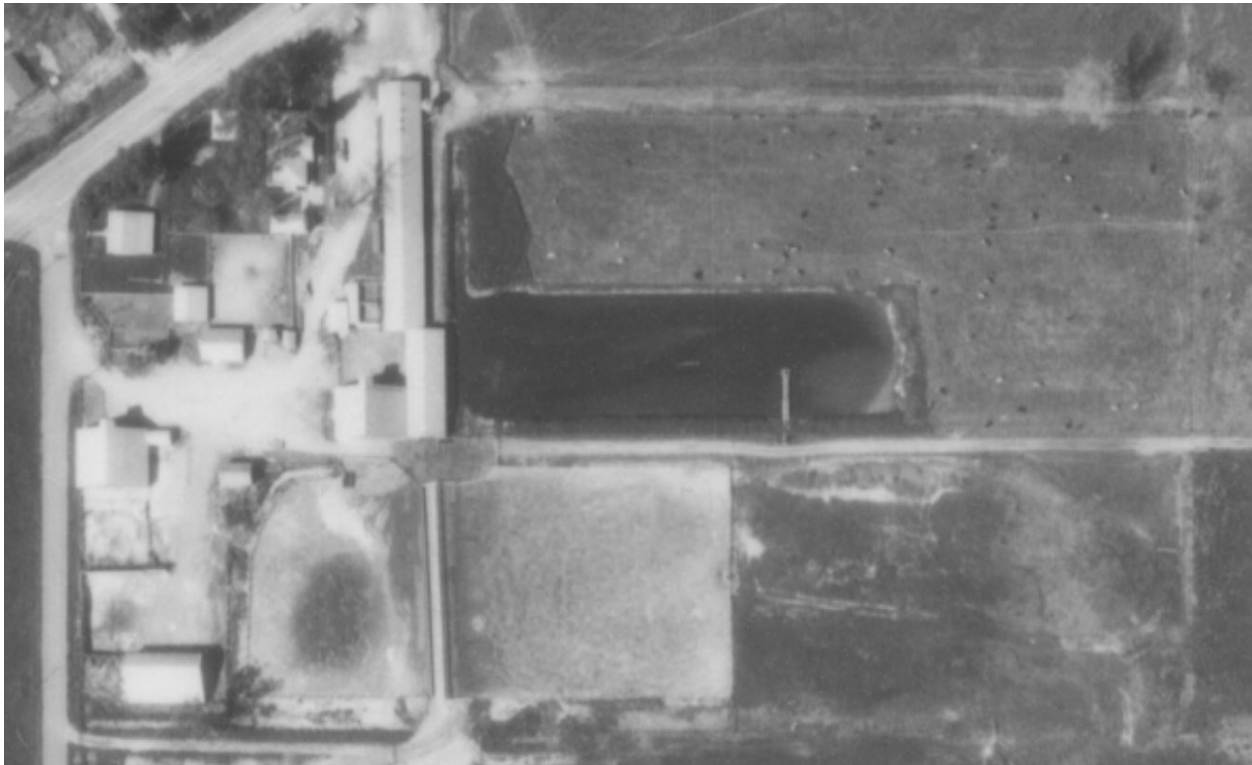
By 1981, the horse barn situated immediately east of David Road at the south end of the cluster of buildings remained extant, but was demolished ca. 1999-2006, based upon available historic satellite imagery (**Figure 56**). The corral to the east of the Horse Barn and south of the Granary appears to have been upgraded with a linear path that directed cattle toward the entrance to the loafing barn between 1971 and 1981. The milker's house that was situated near the intersection of Dillard and Davis roads was demolished ca. 2007-2008, based upon available historic satellite imagery.

Figure 56: Aerial photograph of buildings at Dillard Ranch, 1981. Source: UC Santa Barbara Frame Finder, Cartwright Aerial Surveys, Flight CAS-81081, Frame 6-40.

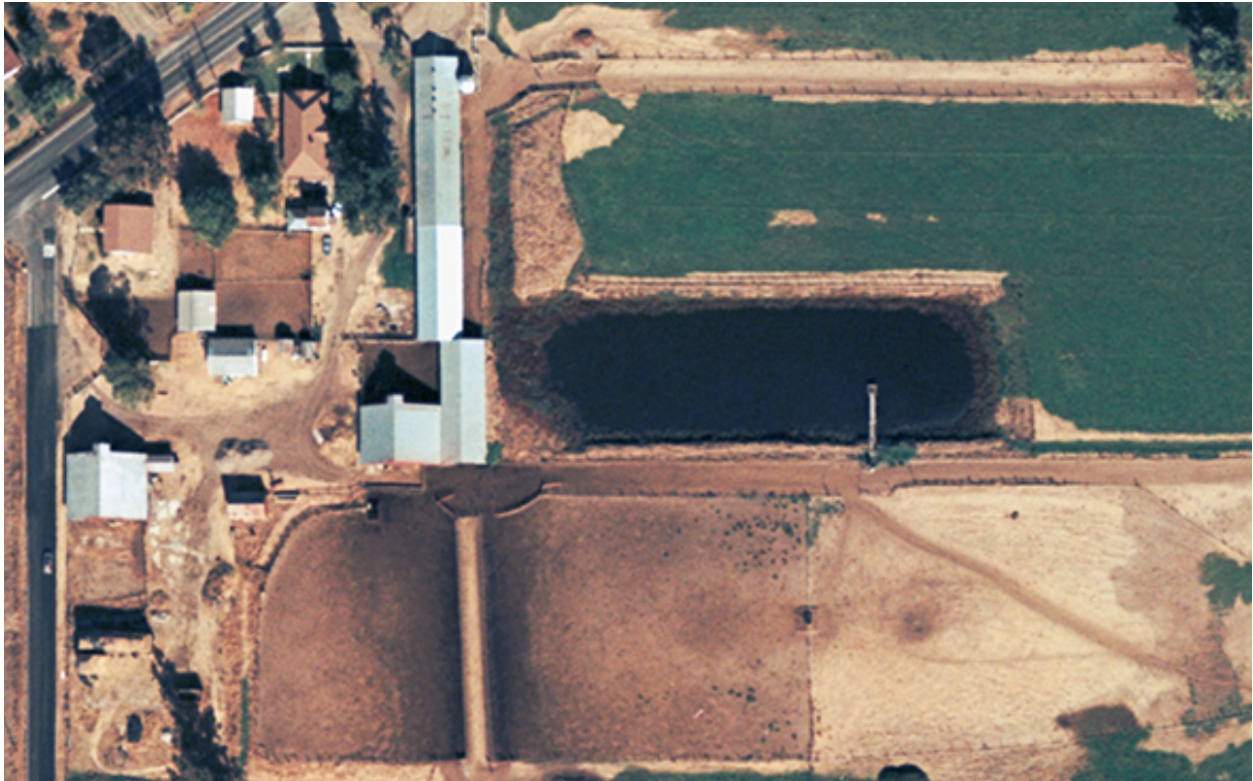
Figure 57: Aerial photograph of buildings at Dillard Ranch, 1999. Source: UC Santa Barbara Frame Finder, HM-1999-usa_1002-174. Edited by Page & Turnbull.

By 1999, the smaller unidentified ancillary buildings documented on prior aerial photographs were no longer present at the site. The location of the former Horse Barn was repurposed with a concrete slab for hay bale storage. The retention pond and corrals retained their general size and relationship to the building cluster as documented on the 1981 aerial (**Figure 57**).

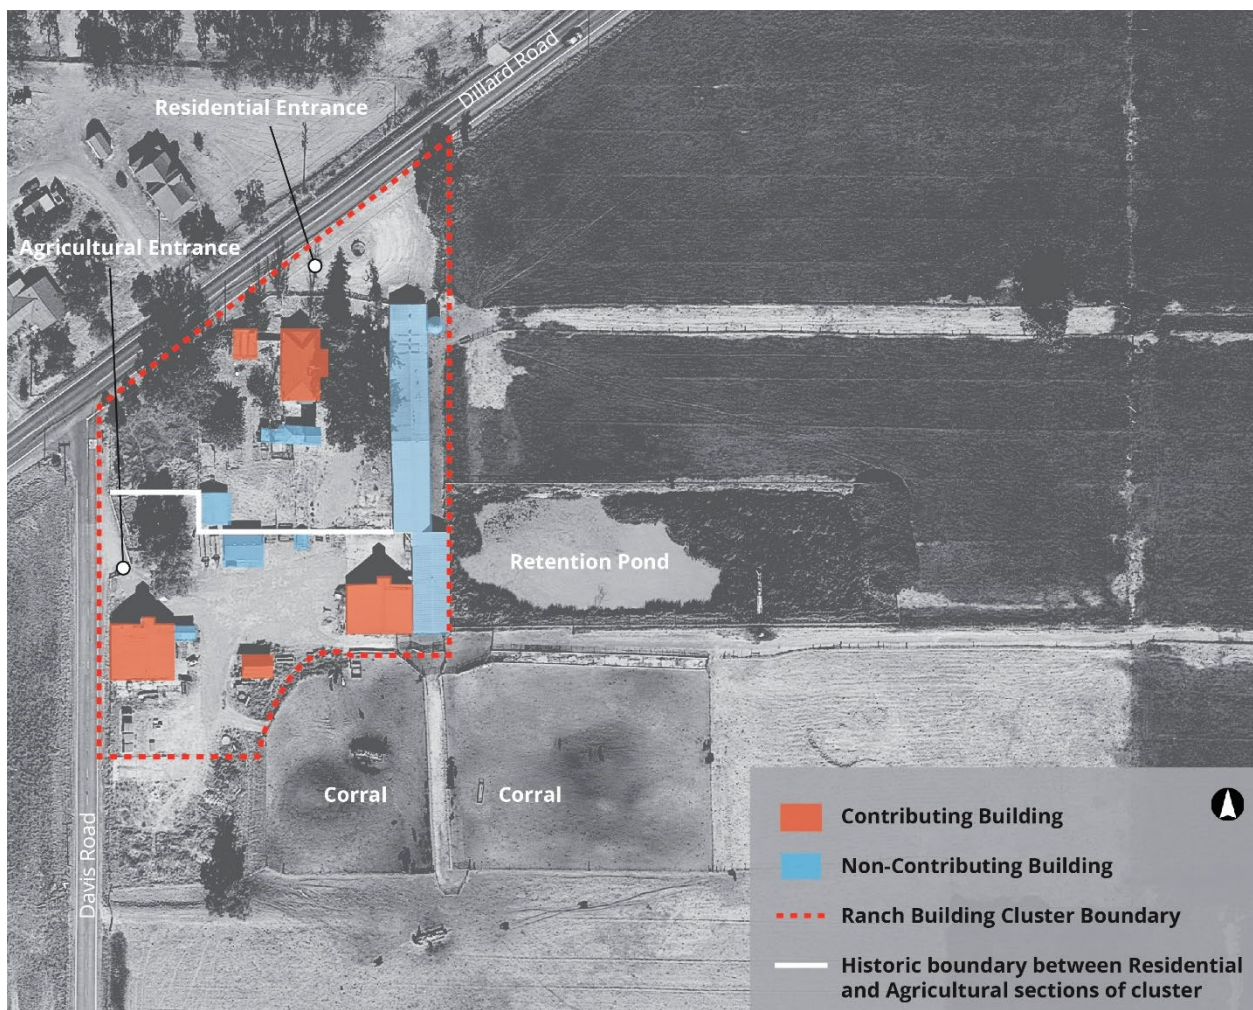
Appendix B – Contributing Features Diagram

The diagram below illustrates locations of each of the contributing and non-contributing buildings within the ranches building cluster. The ranch features two entry areas that served the residential and agricultural sections of the property's building cluster. The intact portion of the historic cluster area is outlined with an orange dashed line. Remnants of wood rail fencing running east-west from the west side of the dairy barn towards the three non-contributing ancillary buildings at the center of the cluster provide evidence of the division of residential and agricultural areas within the historic building cluster area. The existing retention pond and corrals at the property are not contributing features as they were built outside of the identified periods of significance.

Figure 58: Diagram prepared by Page & Turnbull, 2021.
Aerial imagery date, October 2020. Source: Google Earth Pro.
