PHYSICAL RESOURCES

CHAPTER 5

INTRODUCTION AND OVERVIEW

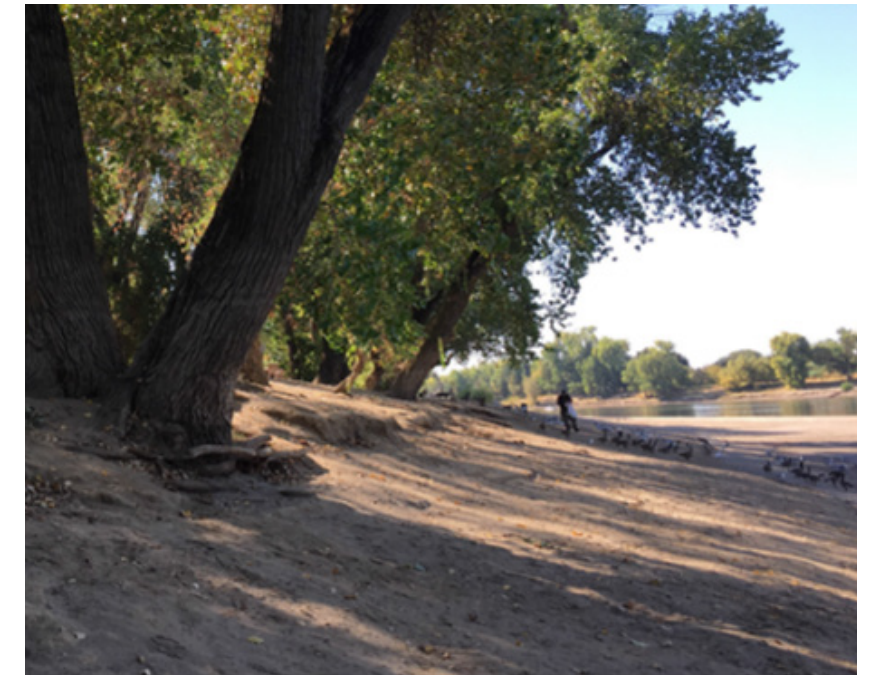
FIGURE 5-10 MATURE OAKS LINE UPPER PORTION OF MOSTLY BARE EARTHEN LEFT BANK NEAR CONFLUENCE (~RM0.2)

BED AND BANK TYPES: In the lower LAR reaches (Parkway Segment 1), the most common banks are earthen side slope banks with varying amounts of native and non-native vegetation. Adjacent to a sediment-laden stream with slow moving water, these banks are stable and relatively homogenous, with little to no floodplain variability (Figure 5-10). In the high use Parkway areas, banks are often heavily compacted or crisscrossed with social trails. A few scattered locations vulnerable to erosion within Parkway Segment 1 are armored with cobble/gravel toe protection, primarily for levee protection. At Paradise Beach, a well-vegetated bar along the left bank was reportedly cleared during the 1997 flood flows of 115,000 cfs. As seen in Figure 5-11, the vegetation grew back in essentially the same footprint, exhibiting a “scour and sprout” phenomenon as opposed to a meandering floodplain channel with point bars and downed woody debris (Watson 2019). Further upstream along Parkway Segment 1 there is a shift to more intermittent vertical banks.

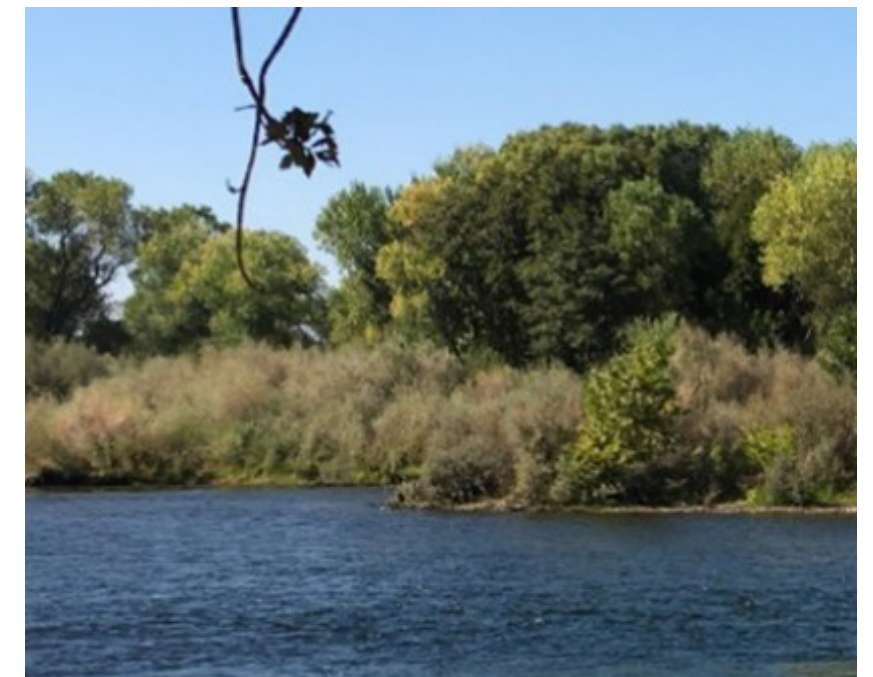
FIGURE 5-11 LEFT BANK VEGETATED BAR AT PARADISE BEACH (~RM 5.6)

environment of Sacramento River backwater, and rising sea level. In response to net aggradation, channel adjustments are expected to result in local bank erosion and/or channel shifts. At Paradise Beach the channel could shift due to the interplay between aggradation in the main channel along the outside bend and degradation/incision of the overflow channel that flows around the left side of the left bar. This

could result in a “cut off” of the meander and head cut up the deepening overflow channel, causing the overflow channel to become the main channel and slope through the area to increase. This possible channel cut off at Paradise Beach could increase local bed slope and bed erosion. Projected channel dynamics in this segment could increase the risk of erosion to levees.

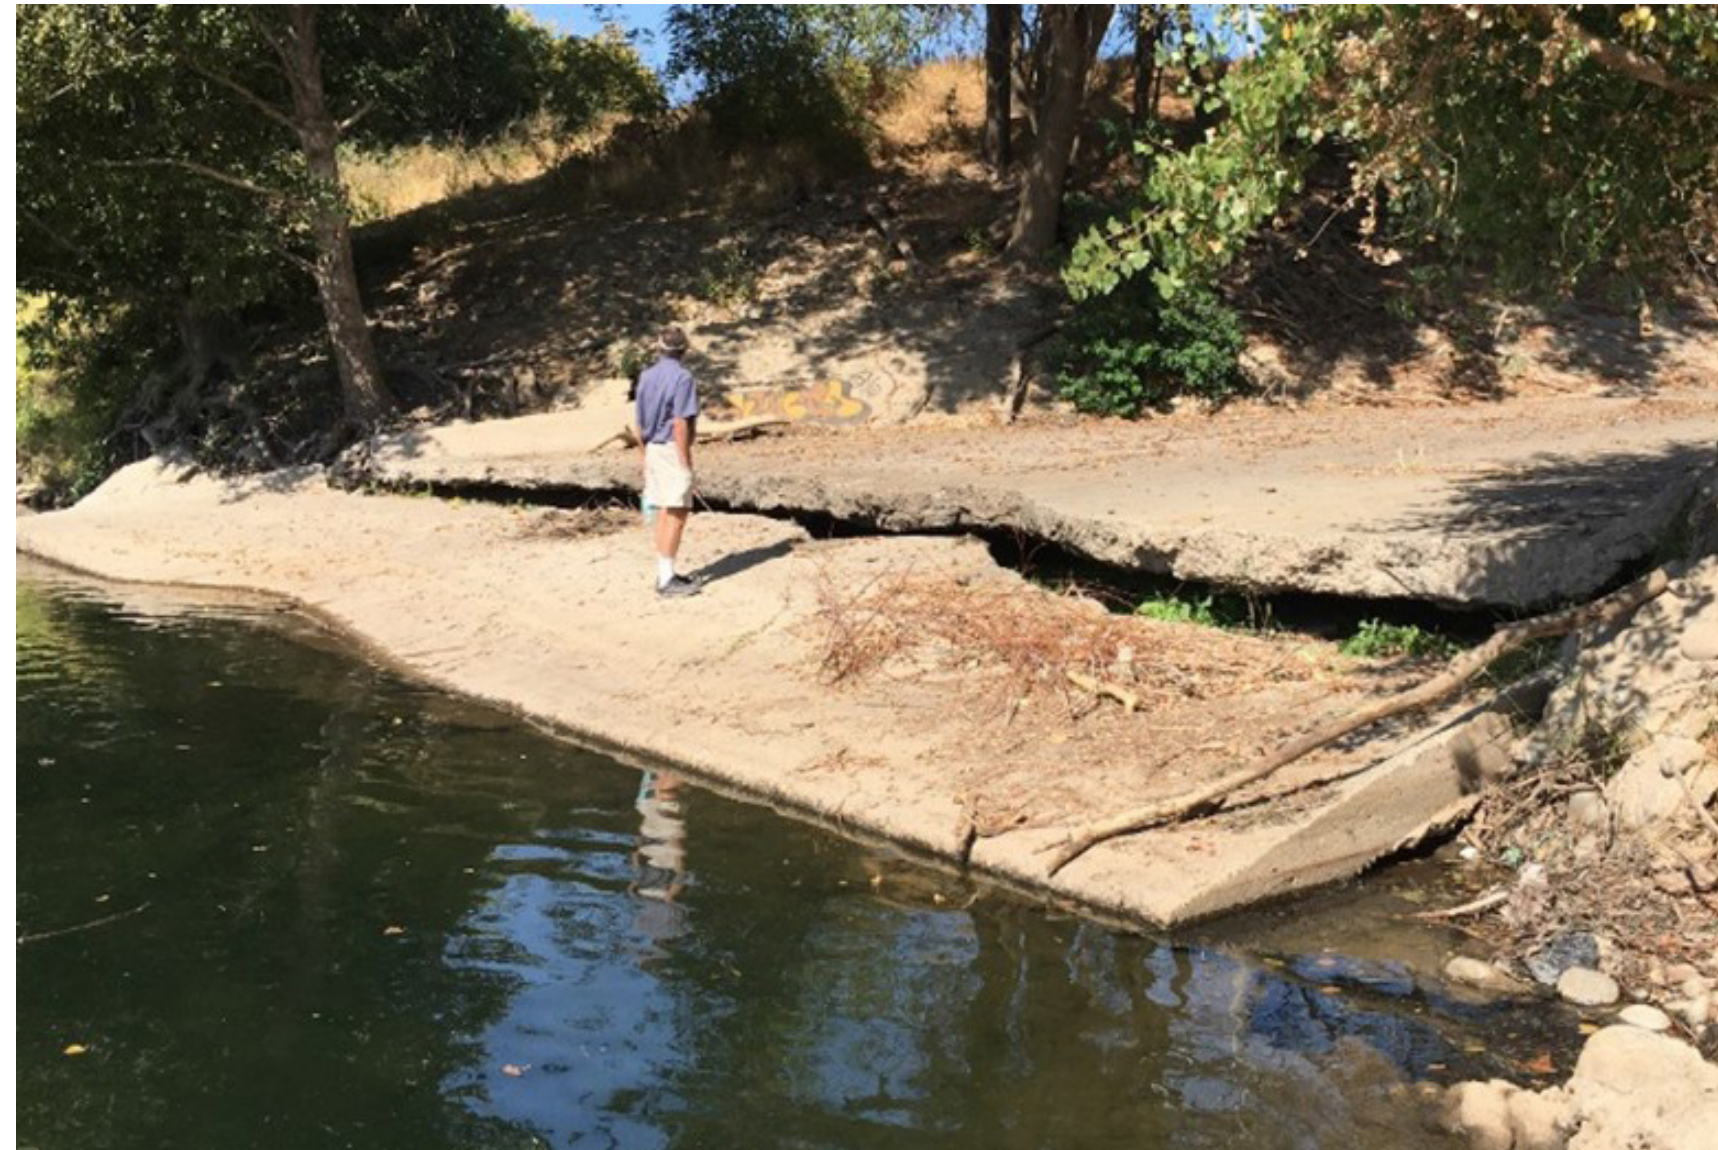
FIGURE 5-12 LARGE URBAN STORMWATER OUTFALL WITH BROKEN APRON (~RM 5.3)

OUTFALLS: Many of the outfalls along Parkway Segment 1 are associated with large stormwater drainages from the urban areas and often pose point sources for pollutants and infrastructure needs and erosion risks along the bank edge (Figure 5-12).

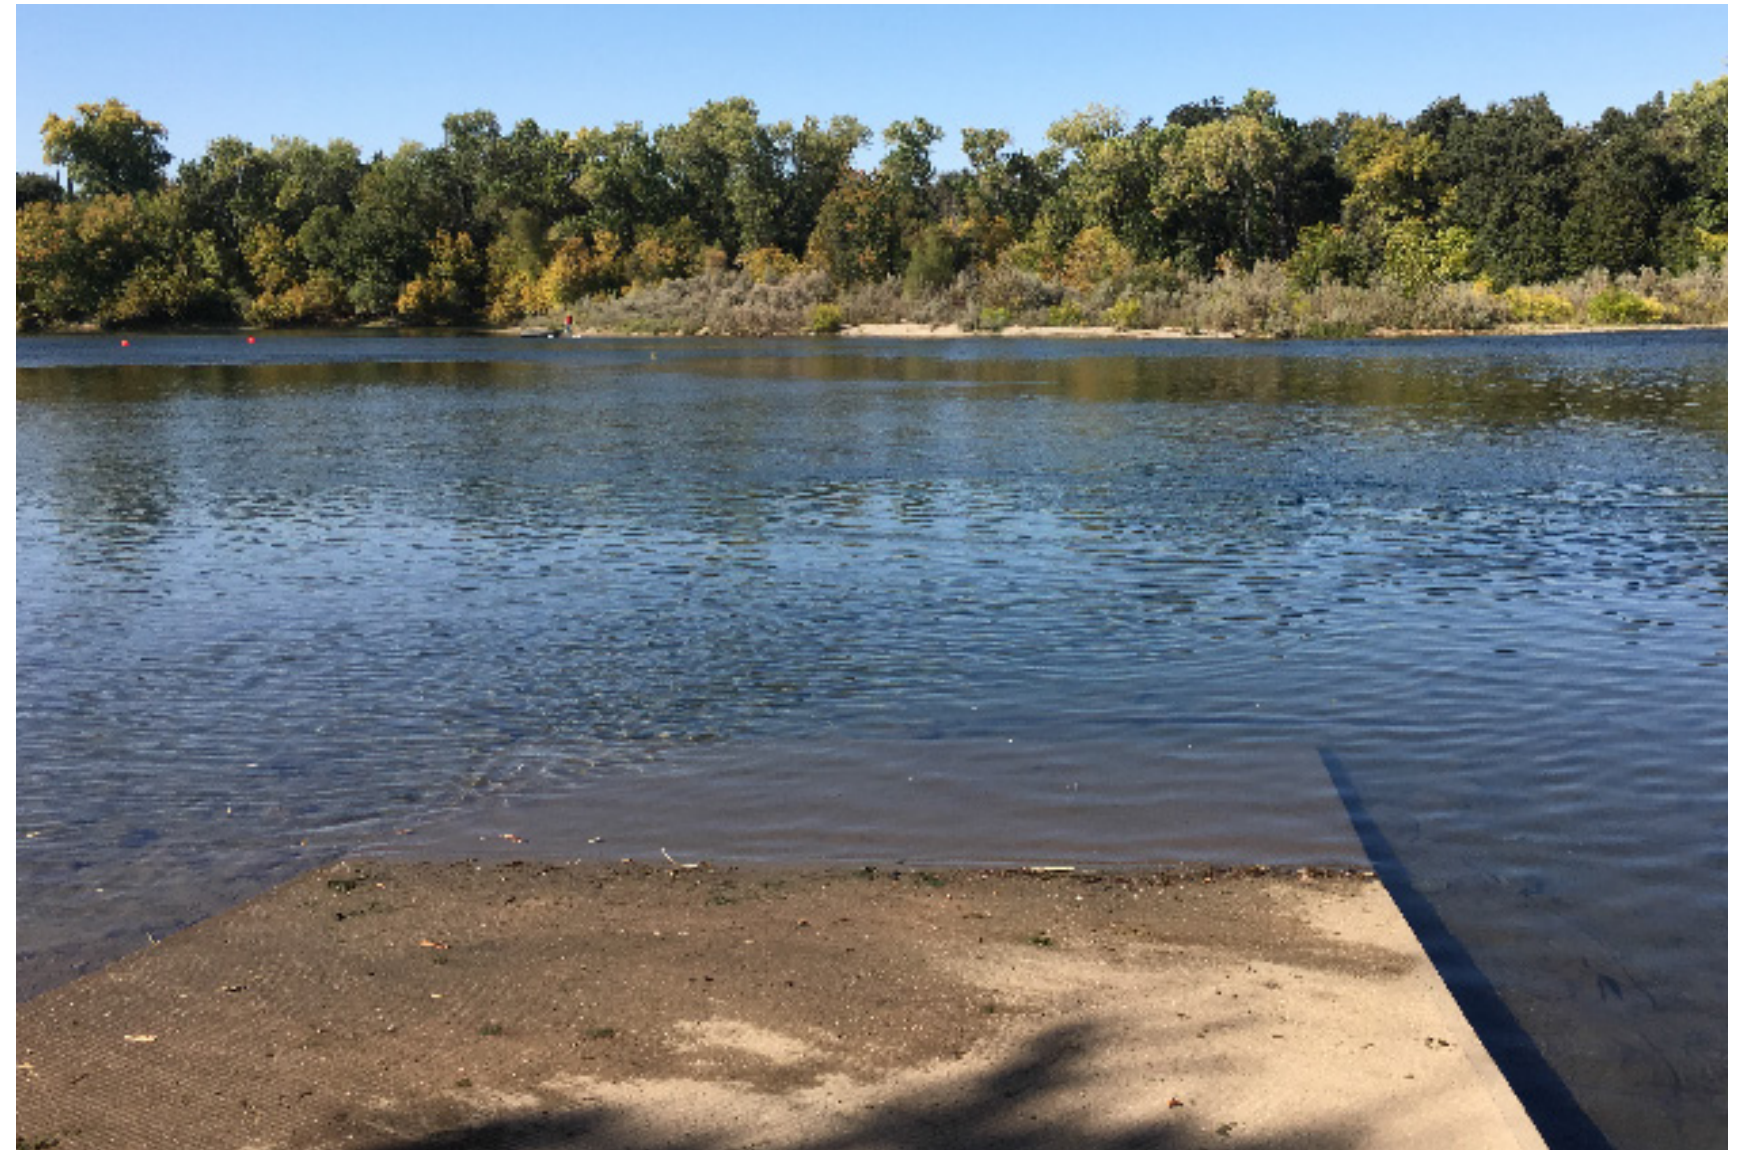
FIGURE 5-13 MINED LEFT BANK WIDENED RIVER, FORMED IN CHANNEL BAR SEEN FROM BOAT RAMP (~RM 9).

TERRACE GRAVEL MINING: Past hydraulic mining practices caused channel instability and sediment displacement on the LAR, particularly in the upper reaches. Along the upstream portion of Parkway Segment 2, hydraulic mining activities prior to 1970 widened the river from approximate RM 10 to RM 11.5 with the left bank bar first lowered to roughly the main channel bed elevation at the erosion resistant layer, followed by lowering of the right bank floodplain (nhc 2018). Channel areas that have been over-widened experience reduced velocities and sediment transport and are likely to continue to aggrade and become shallower (Figure 5-13).

accessibility to the river, such as the boat ramp southwest of Watt Avenue Bridge (Figure 5-13).

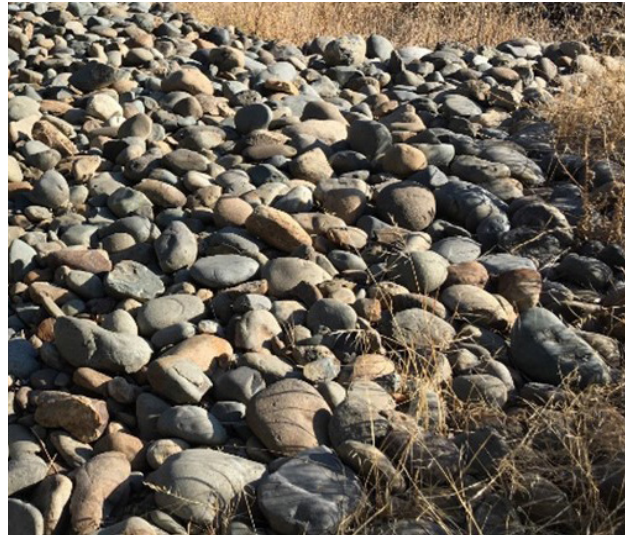
FIGURE 5-14 COBBLE SPOILS ALONG ARDEN BAR, EVIDENCE OF PAST GRAVEL MINING

TERRACE GRAVEL MINING: As introduced earlier, the majority of hydraulic mining that ended in the 1970s took place upstream of RM 8. Cobble spoil piles left behind are scattered throughout the terraces of Arden Bar from roughly RM 12 to 13 at William B. Pond Recreation Area (Figure 5-14) and could provide some local source material for future restoration efforts.

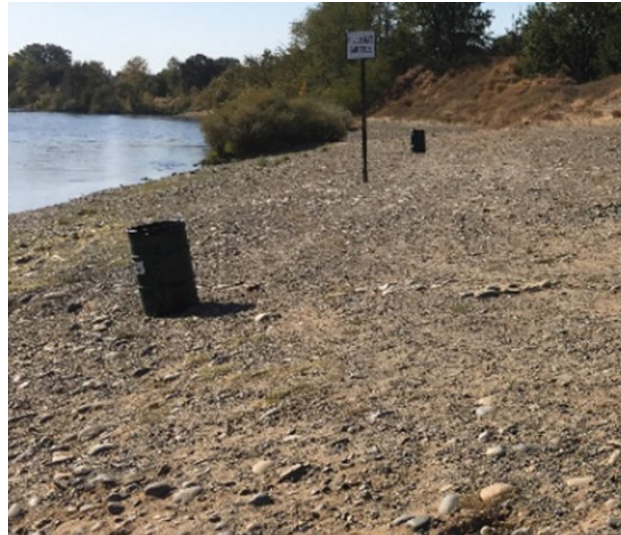
FIGURE 5-15 HEAVILY USED RIGHT BANK AT CAR TOP BOAT LAUNCH (~RM 11.6)

banks. Some of these areas are heavily compacted in high use areas such as boat launches (Figure 5-15). Other banks appear to be increasing in height due to overbank deposition (Figure 5-16). Locally, the more resistant Fair Oaks formation is exposed along some bank margins (Figure 5-17). Cobble spoil piles, remnants from hydraulic mining, are scattered throughout the terraces of Arden Bar from roughly RM 12 to 13 at William B. Pond Recreation Area.

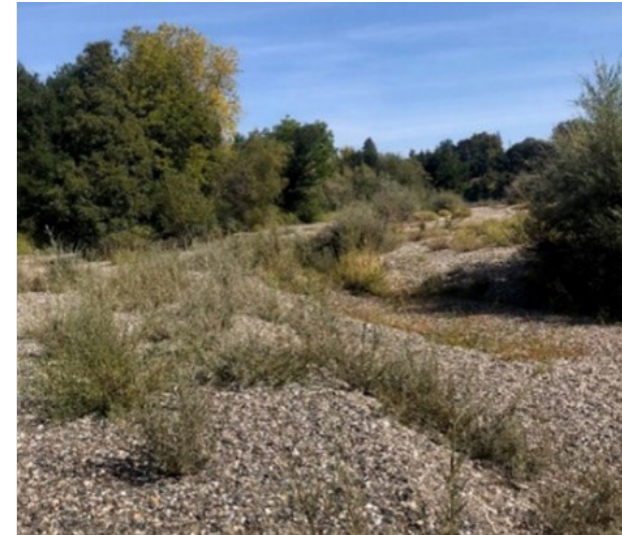
FIGURE 5-16 RIVER RIGHT BANK GRAVEL SIDE BAR (~ RM 12.1)

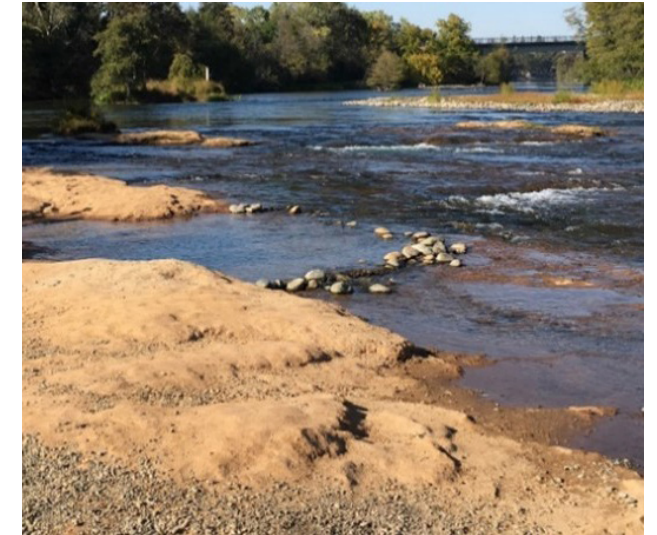
FIGURE 5-17 EXPOSED FAIR OAKS FORMATION ALONG RIVER RIGHT BANK.

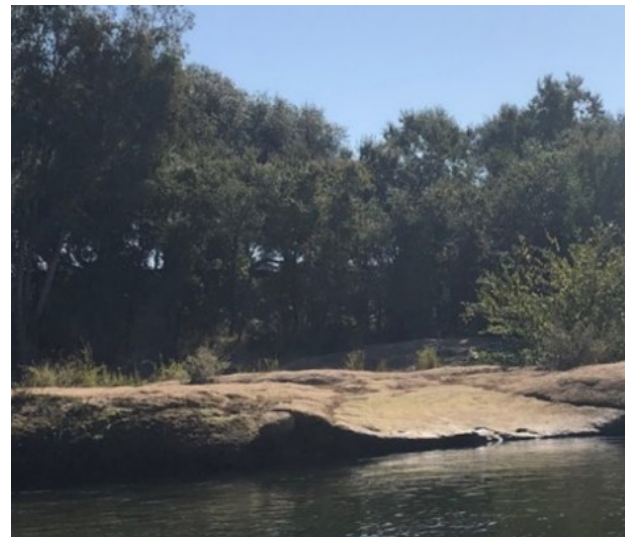
FIGURE 5-18 EXPOSED EROSION RESISTANT BANK TOE (~RM 15.3)

BED AND BANK TYPES: The channel bed in Parkway Segment 4 is holding grade due to the underlying Fair Oaks formation (Figure 5-18) and cobble size armoring, particularly in the upper portions. The hardened bed through this area applies increased pressure on the earthen banks during higher flow events, often causing accelerated erosion on sparsely vegetated or unprotected outer banks (Figure 5-19). While some well-vegetated banks with a small amount of woody debris at the toe were observed in Parkway Segment 4, there is limited evidence of downed wood along the river margins, giving further evidence to a limited active floodplain and little to no natural channel migration (Figure 5-20).

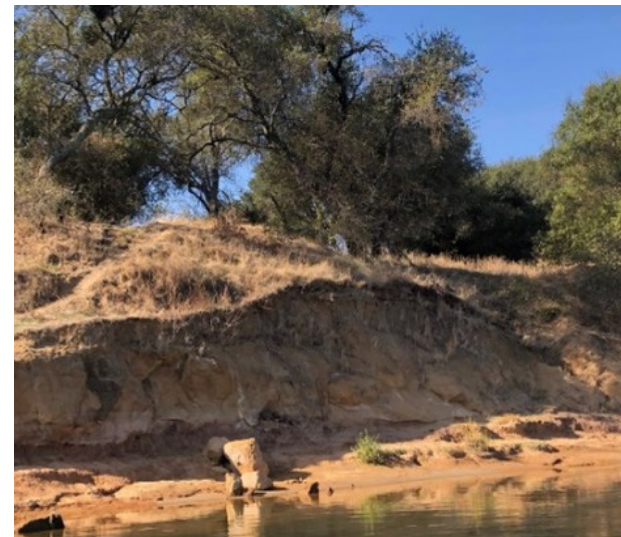
FIGURE 5-19 EROSION ALONG CLAY SHELF (~RM 16.7)

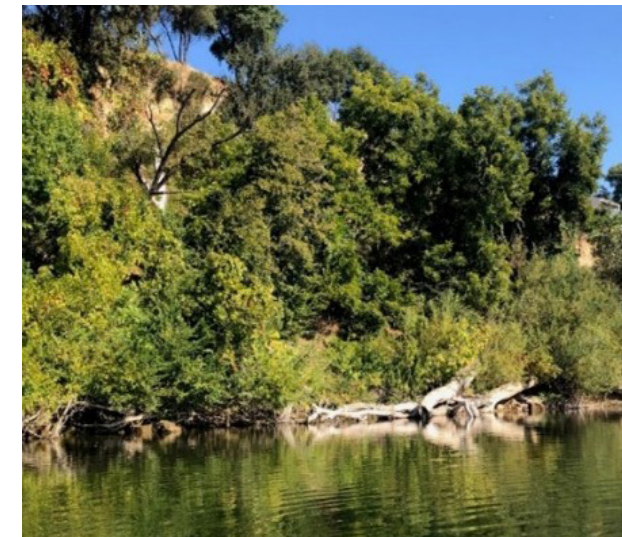
FIGURE 5-20 ACTIVELY ERODING BANK ALONG CLAY SHELF (~RM 17.8)

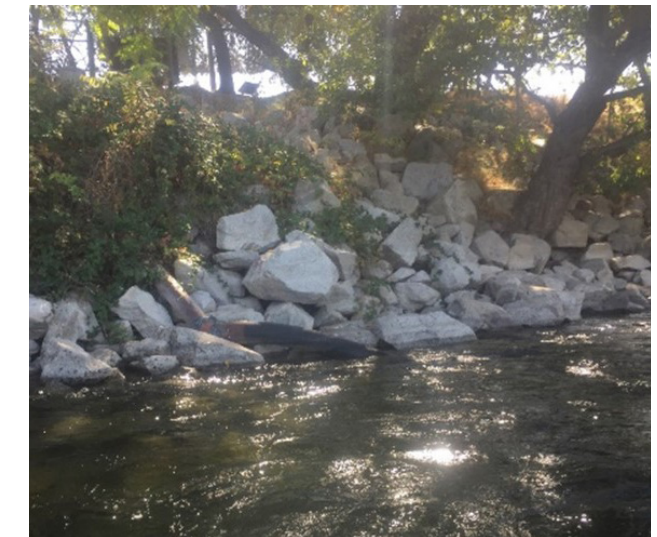
FIGURE 5-21 ROCK RIP-RAP PLACED AT CORDOVA CREEK OUTFALL (~RM 14.5)

OUTFALLS: Stormwater and creek armored outfalls are interspersed throughout the Parkway segments, two of the larger tributaries between Nimbus Dam and the confluence with the Sacramento River, Cordova Creek (Figure 5-21) and Carmichael Creek outlet near the downstream end of Parkway Segment 4.

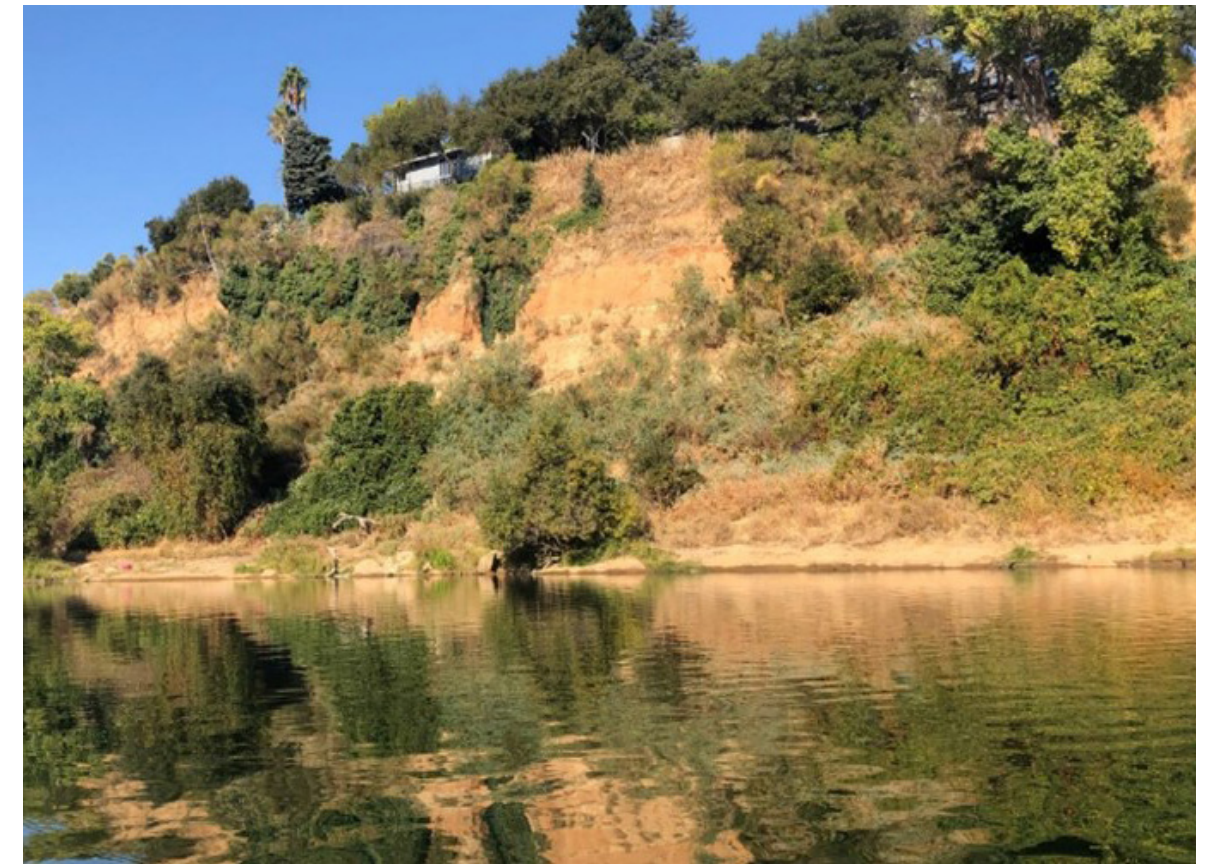
FIGURE 5-23 STEEP BLUFFS ALONG RIGHT BANK (~RM 19.4)

BLUFFS: In the upper reach of Parkway Segment 4 and into Parkway Segment 5, the resistant Fair Oaks formation has been more fully exposed and there are a number of nearly vertical, but relatively stable bluffs often with a clay shelf forming along the toe (Figure 5-23). The cliff banks can however be destabilized by activities from above, including loading the upper surface via irrigation or stormwater runoff, and below from trail encroachment, road maintenance, or channel overflow events impinging on the face of the bank. These events could produce mass wasting via slumps, slides or surface erosion that could threaten private property and cause a large sediment influx to the river impacting water quality, fish spawning grounds or other sensitive resources.

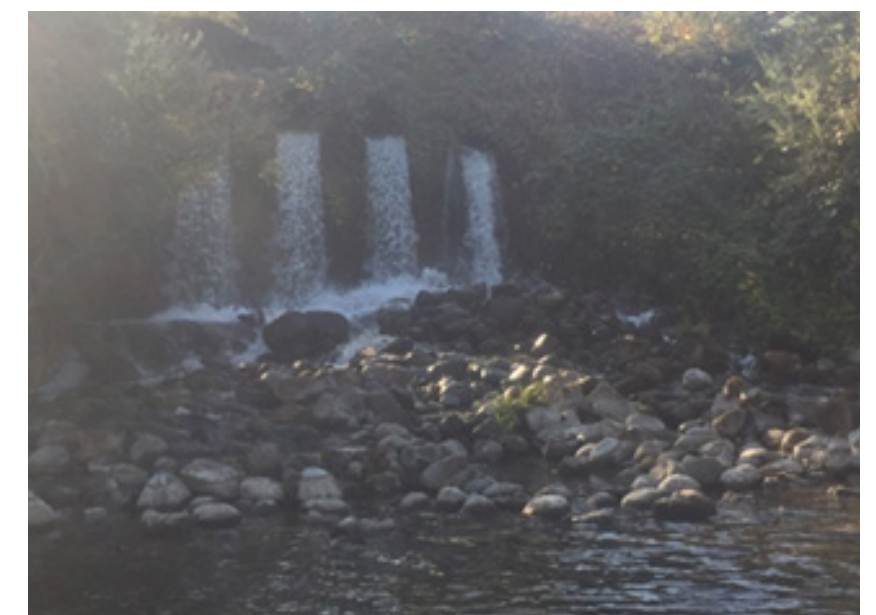
FIGURE 5-24 BUFFALO CREEK OUTFALL (~RM 19.5)

OUTFALLS: Along with stormwater outfalls, one of the larger tributaries to LAR, Buffalo Creek outfalls in Parkway Segment 5 (Figure 5-24).
