# PHYSICAL RESOURCES

## CHAPTER 5

# INTRODUCTION AND OVERVIEW

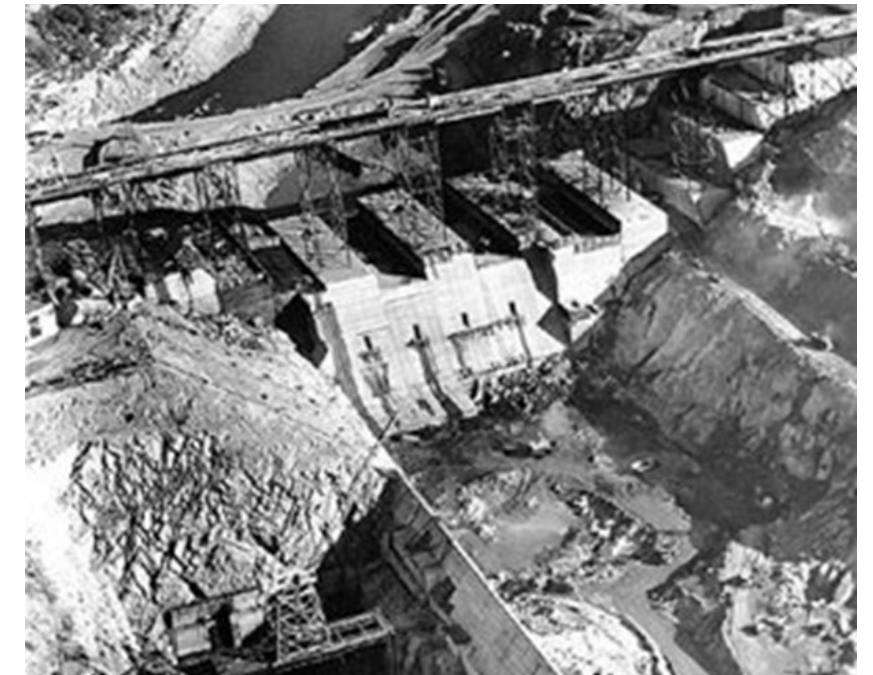
**FIGURE 5-6 FOLSOM DAM CONSTRUCTION, 1953**  
(SOURCE: MY FOLSOM.COM 2019)

In 1940, the U.S. Congress approved the American River Basin Development Project. Its scope included constructing the Folsom and Nimbus Dams for flood control, hydroelectric power generation, and water storage/diversion. Construction of the Folsom and Nimbus Dams by the US Army Corps of Engineers started in 1948 and was completed in 1955 (Figure 5-6). At the end of 1955, the dams were functionally storing full capacity and producing electricity. The dams have been continuously operated and maintained by the US Bureau of Reclamation (USBR). The dams essentially cut off the spawning and rearing habitat along the American River, so as part of the Folsom-Nimbus Dam construction, USBR also constructed the Nimbus Hatchery (overseen by CDFW) to replace the salmon and steelhead runs (CDFW 2019).

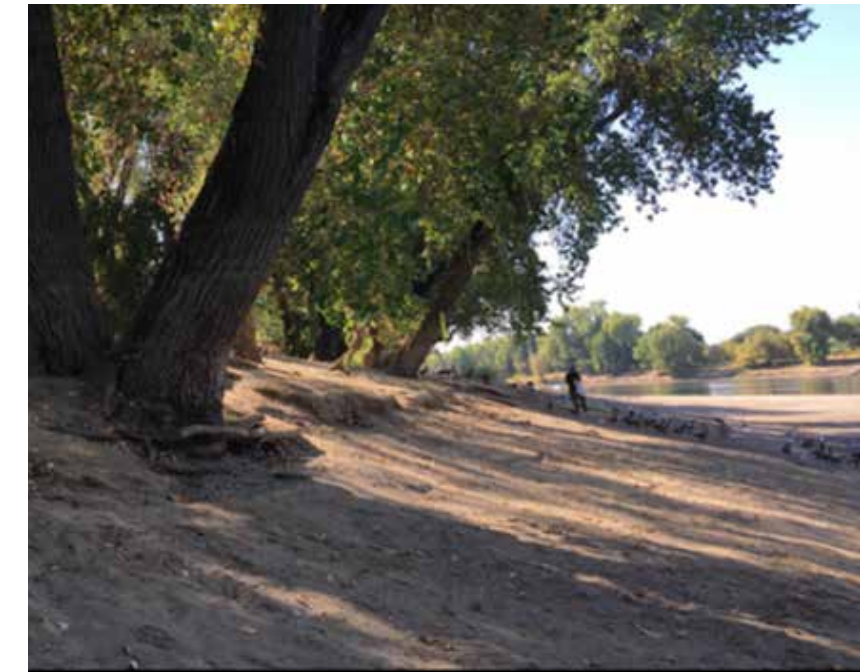
**FIGURE 5-11 MATURE OAKS LINE UPPER PORTION OF MOSTLY BARE EARTHEN LEFT BANK NEAR CONFLUENCE (~RM0.2)**

**BED AND BANK TYPES:** In the lower LAR reaches (Parkway Segment 1), the most common banks are earthen side slope banks with varying amounts of native and non-native vegetation. Adjacent to a sediment-laden stream with slow moving water, these banks are stable and relatively homogenous, with little to no floodplain variability (Figure 5-11). In the high use Parkway areas, banks are often heavily compacted or crisscrossed with social trails. A few scattered locations vulnerable to erosion within Parkway Segment 1 are armored with cobble/gravel toe protection, primarily for levee protection. At Paradise Beach, a well-vegetated bar along the left bank was reportedly cleared during the 1997 flood flows of 115,000 cfs. As seen in Figure 5-12, the vegetation grew back in essentially the same footprint, exhibiting a “scour and sprout” phenomenon as opposed to a meandering floodplain channel with point bars and downed woody debris (Watson 2019). Further downstream along Parkway Segment 1 there is a shift to more intermittent vertical banks.

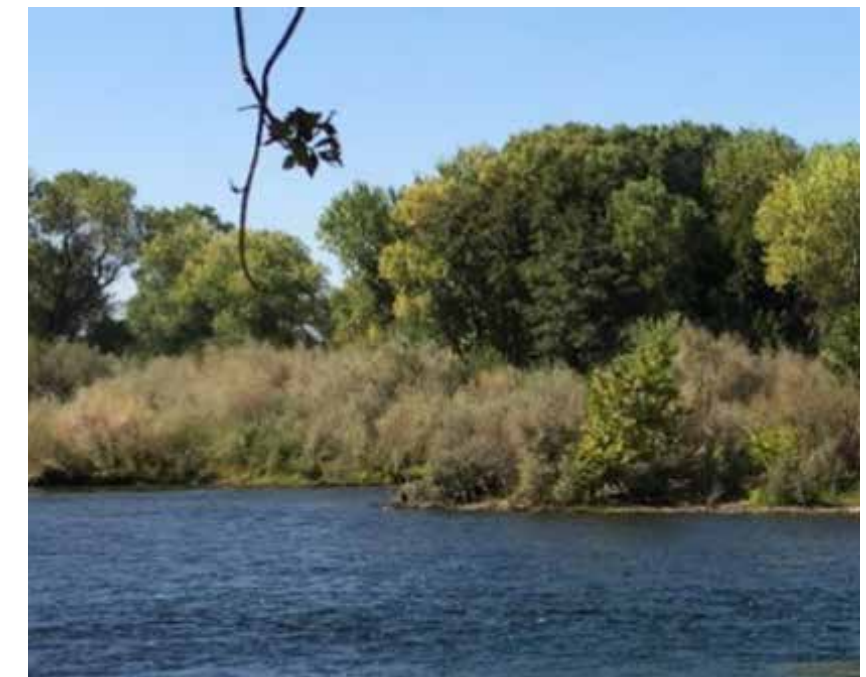
**FIGURE 5-12 LEFT BANK VEGETATED BAR AT PARADISE BEACH (~RM 5.6)**

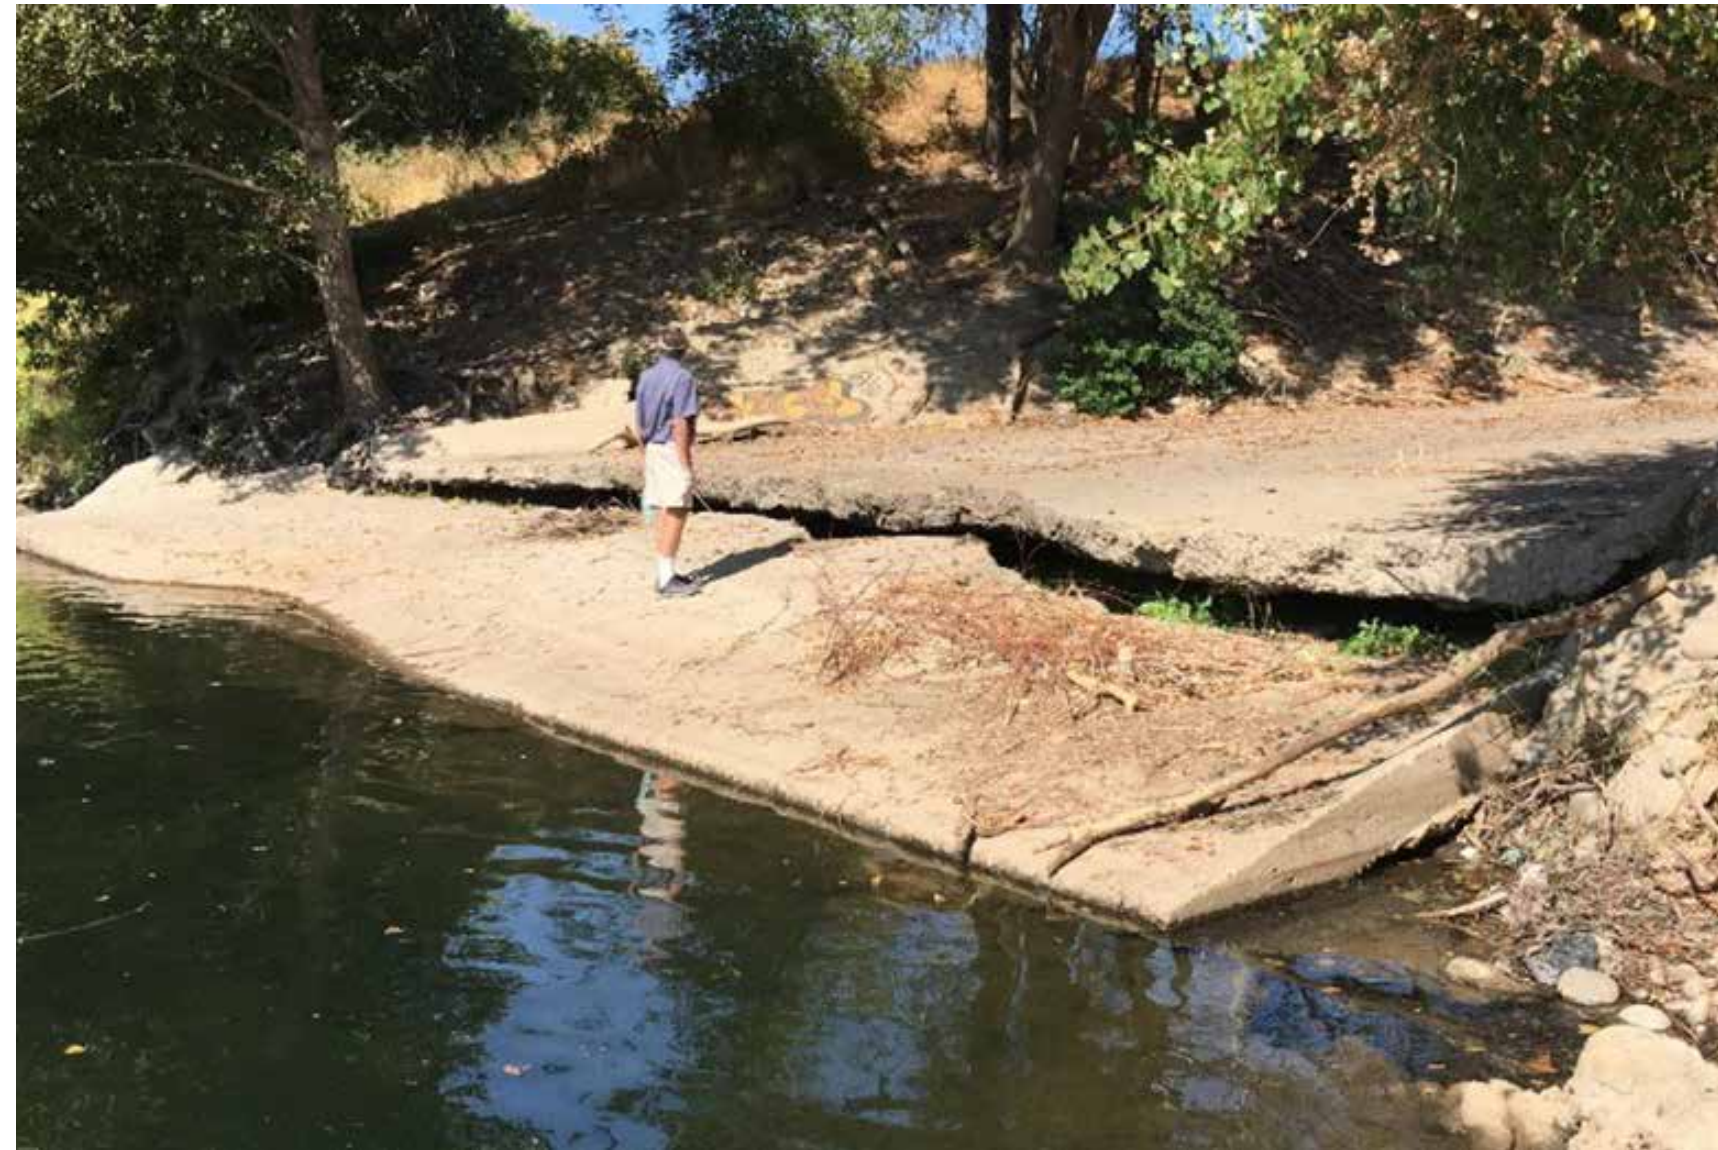
**FIGURE 5-13 LARGE URBAN STORMWATER OUTFALL WITH BROKEN APRON (~RM 5.3)**

**OUTFALLS:** Many of the outfalls along Parkway Segment 1 are associated with large stormwater drainages from the urban areas and often pose point sources for pollutants and infrastructure needs and erosion risks along the bank edge (Figure 5-13).

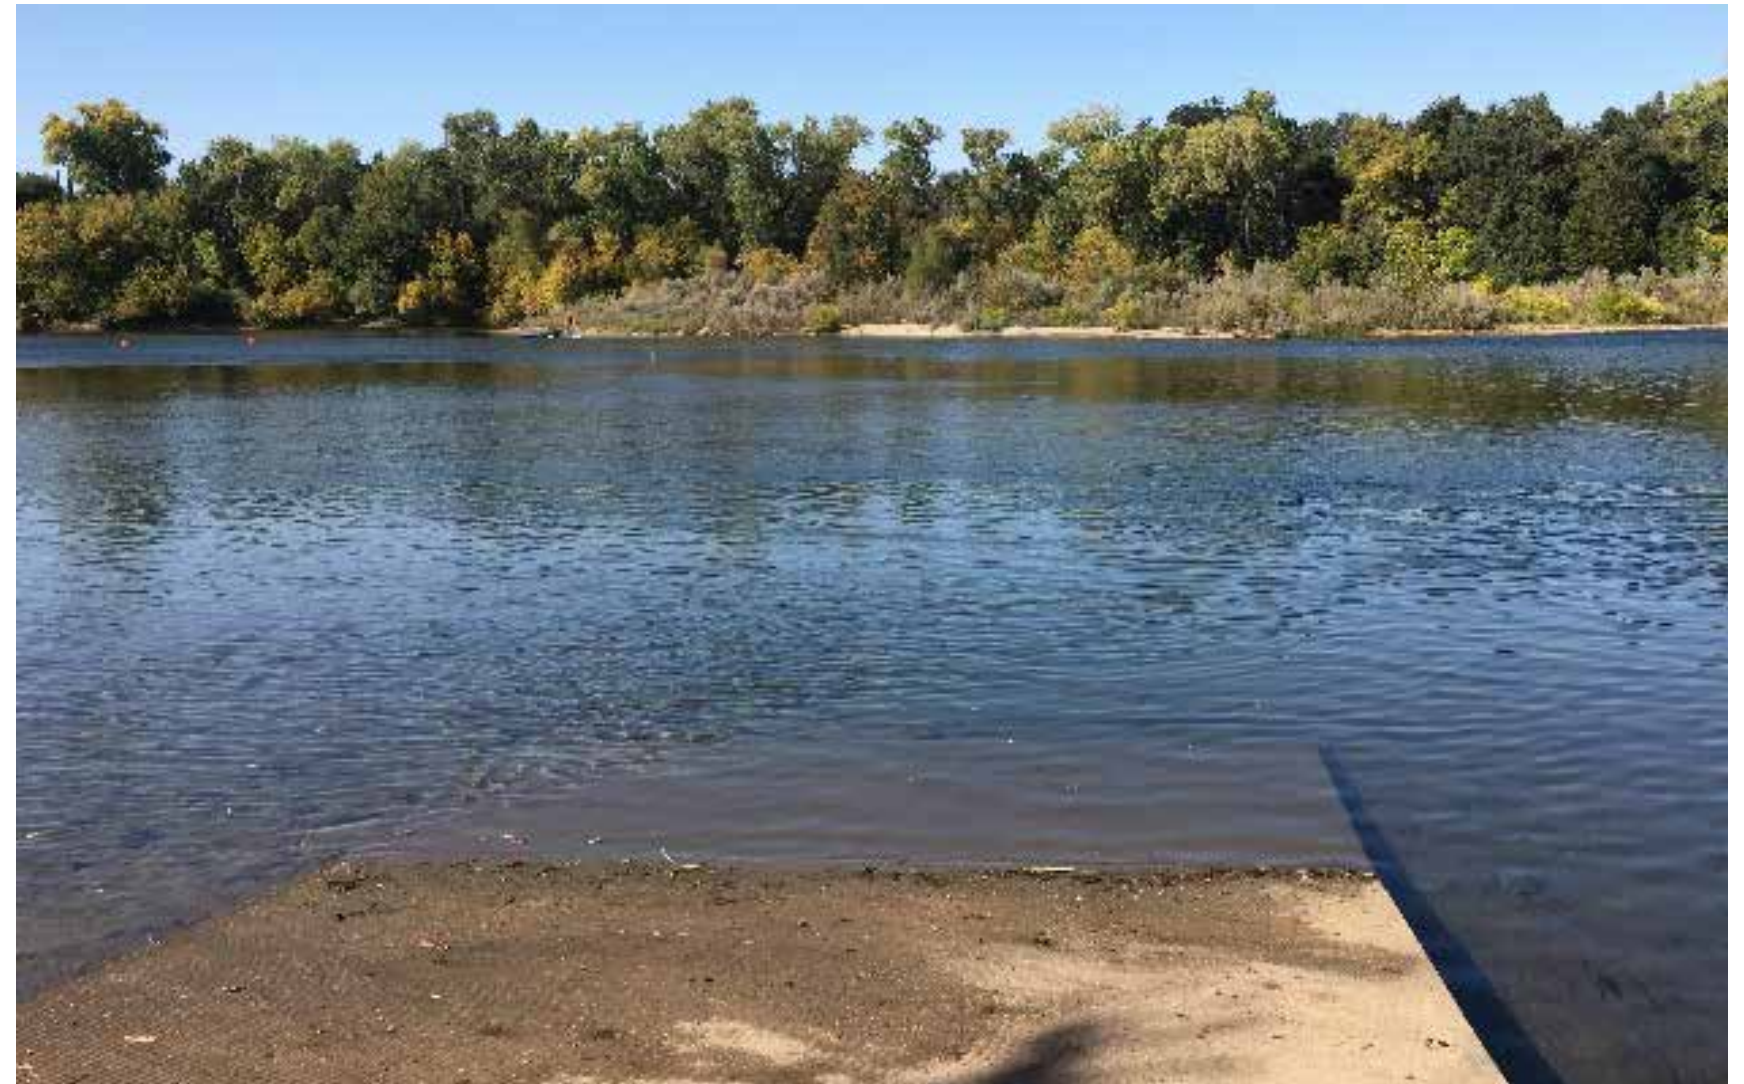
**FIGURE 5-15 MINED LEFT BANK WIDENED RIVER, FORMED IN CHANNEL BAR SEEN FROM BOAT RAMP (~RM 9).**

over-widened experience reduced velocities and sediment transport and are likely to continue to aggrade and become shallower (Figure 5-15).

has been directly manipulated by human activity. On the upstream side of Howe Avenue Bridge and the downstream side of Watt Avenue Bridge, old mining excavations lowered the left banks of the river, widening the channel and forming in-channel islands with alluvium surfaces. Parkway facilities and recreational access often coincide with these artificially lowered banks due to their accessibility to the river, such as the boat ramp southwest of Watt Avenue Bridge (Figure 5-15).

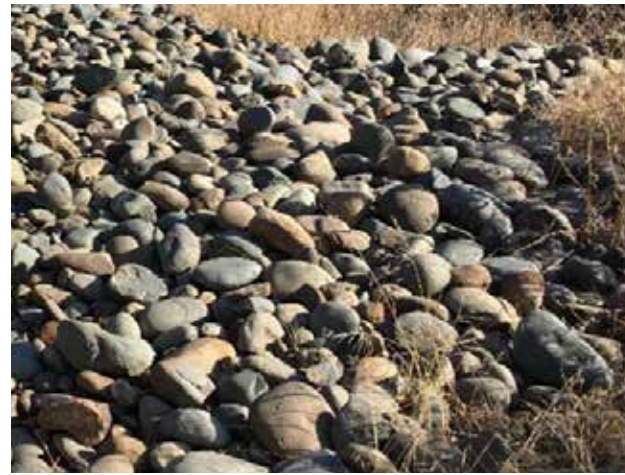
**FIGURE 5-17 COBBLE SPOILS ALONG ARDEN BAR, EVIDENCE OF PAST GRAVEL MINING**

**TERRACE GRAVEL MINING:** As introduced earlier, the majority of hydraulic mining that ended in the 1970s took place upstream of RM 8. Cobble spoil piles left behind are scattered throughout the terraces of Arden Bar from roughly RM 12 to 13 at William B. Pond Recreation Area (Figure 5-17)

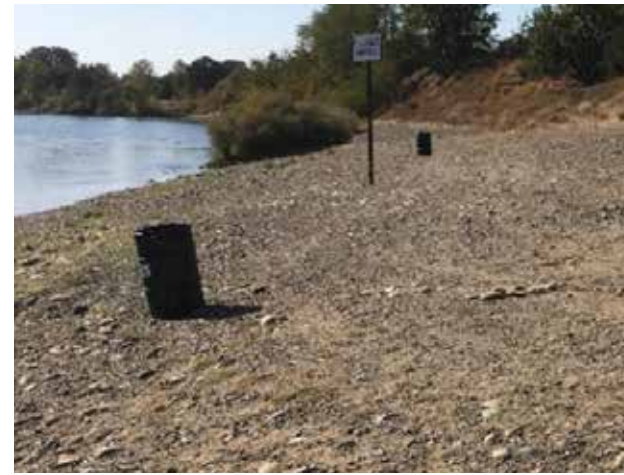
**FIGURE 5-18 HEAVILY USED RIGHT BANK AT CAR TOP BOAT LAUNCH (~RM 11.6)**

**BED AND BANK TYPES:** In Parkway Segment 3, the frequency of bare ground and exposed alluvial material increases in contrast to relatively undisturbed vegetated banks. Some of these areas are heavily compacted in high use areas such as boat launches (Figure 5-18). Other banks appear to be increasing in height due to overbank deposition (Figure 5-19). Locally, the more resistant Fair Oaks formation is exposed along some bank margins (Figure 5-20). Cobble spoil piles, remnants from hydraulic mining, are scattered throughout the terraces of Arden Bar from roughly RM 12 to 13 at William B. Pond Recreation Area.

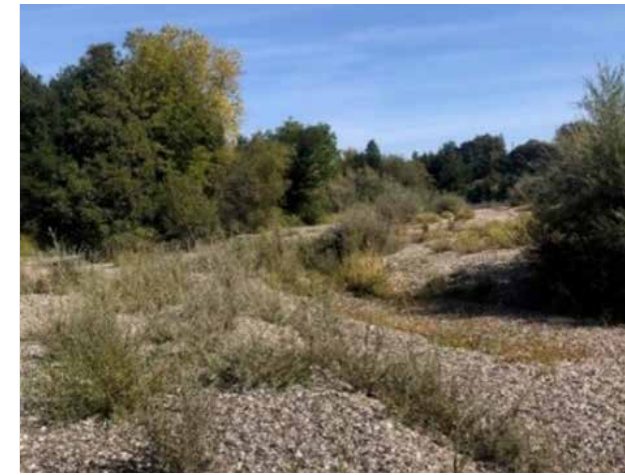
**FIGURE 5-19 RIVER RIGHT BANK GRAVEL SIDE BAR (~ RM 12.1)**

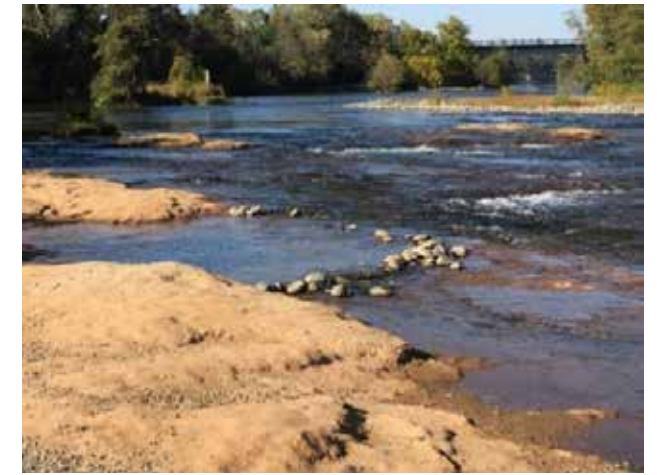
**FIGURE 5-20 EXPOSED FAIR OAKS FORMATION ALONG RIVER RIGHT BANK.**

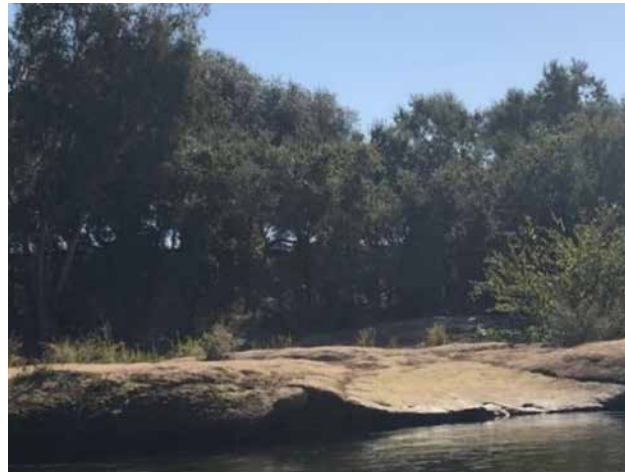
**FIGURE 5-22 EXPOSED EROSION RESISTANT BANK TOE (~RM 15.3)**

**BED AND BANK TYPES:** The channel bed in Parkway Segment 4 is holding grade due to the underlying Fair Oaks formation (Figure 5-22) and cobble size armoring, particularly in the upper portions. The hardened bed through this area applies increased pressure on the earthen banks during higher flow events, often causing accelerated erosion on

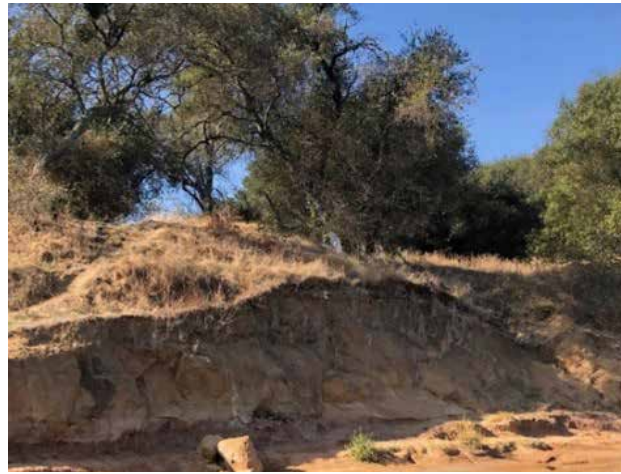
**FIGURE 5-23 EROSION ALONG CLAY SHELF (~RM 16.7)**

sparsely vegetated or unprotected outer banks (Figure 5-23). While some well-vegetated banks with a small amount of woody material at the toe were observed in Parkway Segment 4, there is limited evidence of downed wood along the river margins, giving further evidence to a limited active floodplain and little to no natural channel migration (Figure 5-24).

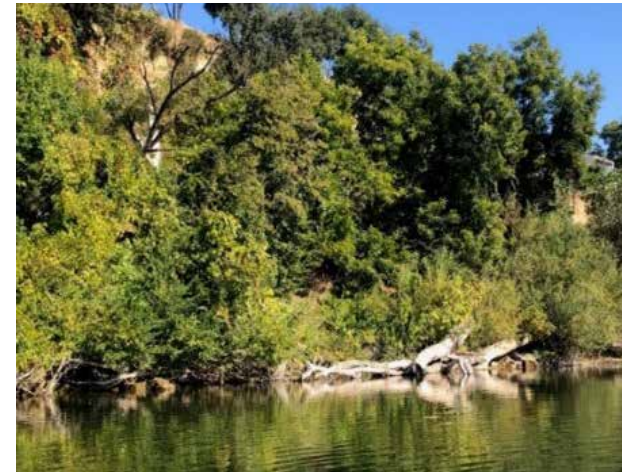
**FIGURE 5-24 ACTIVELY ERODING BANK ALONG CLAY SHELF (~RM 17.8)**

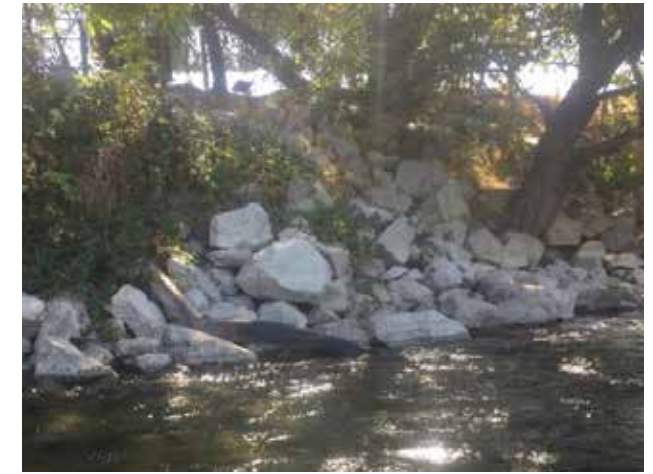
**FIGURE 5-25 ROCK RIP-RAP PLACED AT CORDOVA CREEK OUTFALL (~RM 14.5)**

**OUTFALLS:** Stormwater and creek armored outfalls are interspersed throughout the Parkway segments, two of the larger tributaries between Nimbus Dam and the confluence with the Sacramento River, Cordova Creek (Figure 5-25) and Carmichael Creek outlet near the downstream end of Parkway Segment 4.

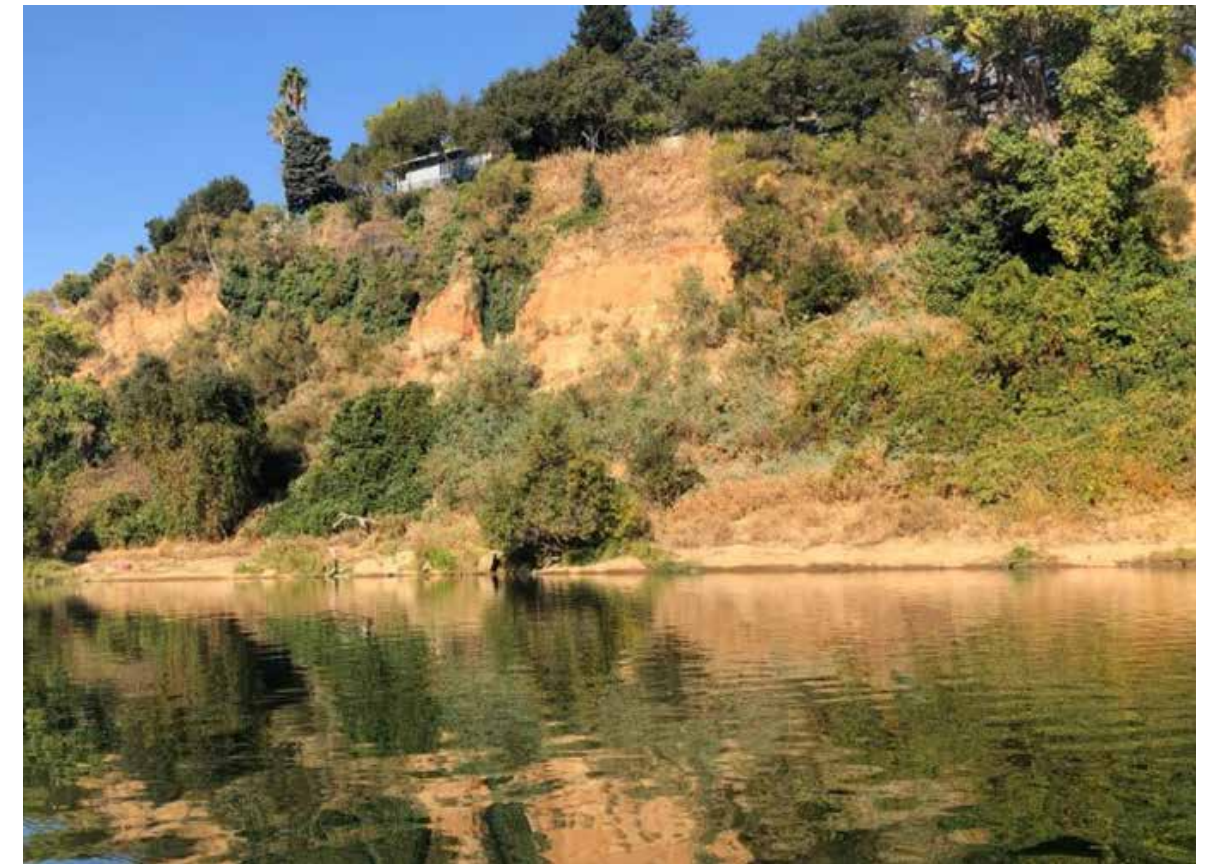
**FIGURE 5-28 STEEP BLUFFS ALONG RIGHT BANK (~RM 19.4)**

**BLUFFS:** In the upper reach of Parkway Segment 4 and into Parkway Segment 5, the resistant Fair Oaks formation has been more fully exposed and there are a number of nearly vertical, but relatively stable bluffs often with a clay shelf forming along the toe (Figure 5-28). The cliff banks can however be destabilized by activities from above, including

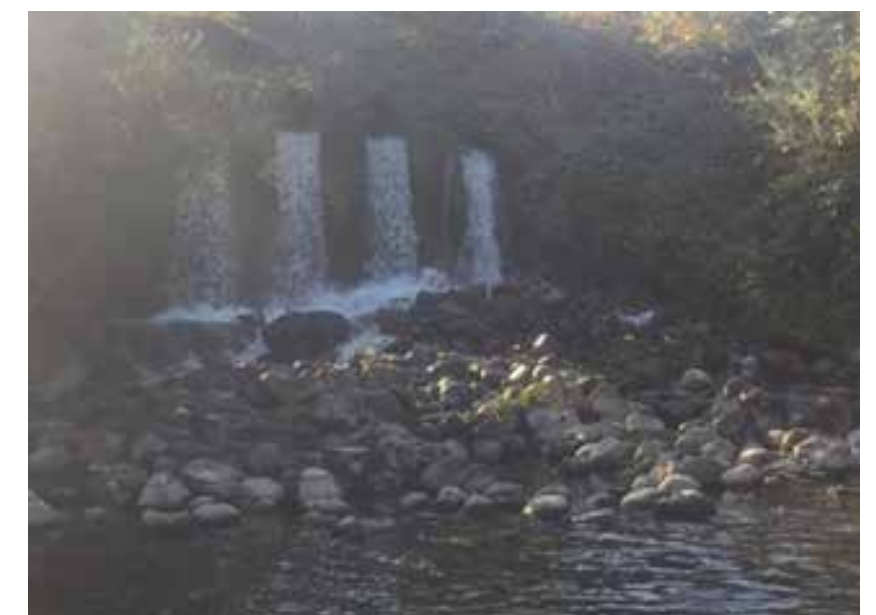
**FIGURE 5-29 BUFFALO CREEK OUTFALL (~RM 19.5)**

**OUTFALLS:** Along with stormwater outfalls, one of the larger tributaries to LAR, Buffalo Creek outfalls in Parkway Segment 5 (Figure 5-29).

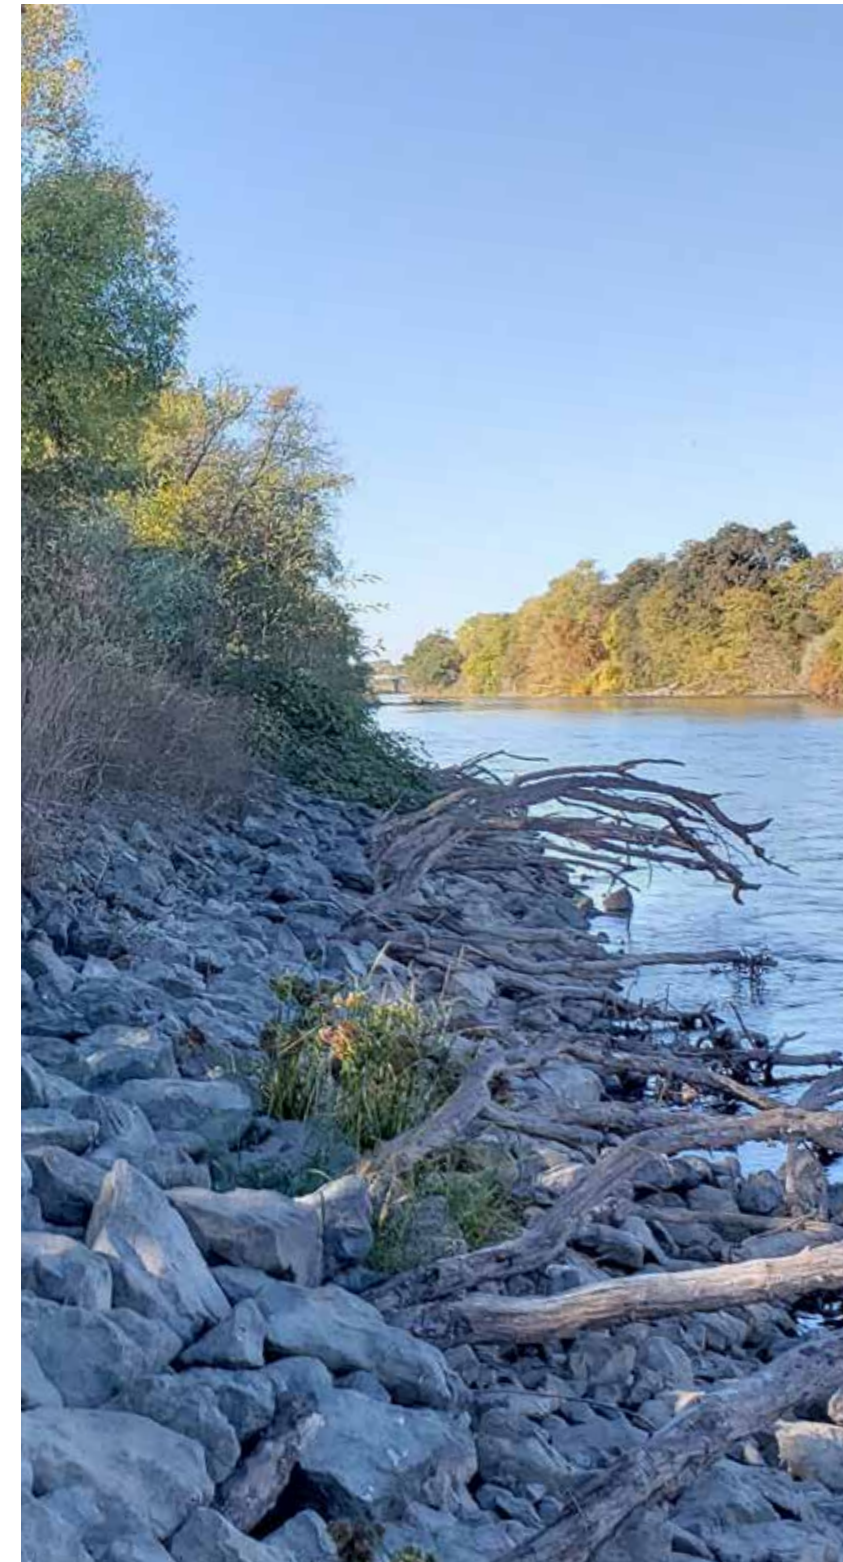
*Revetment and riparian plantings along riverbank.  
Photo Credit: KC Sorgen*

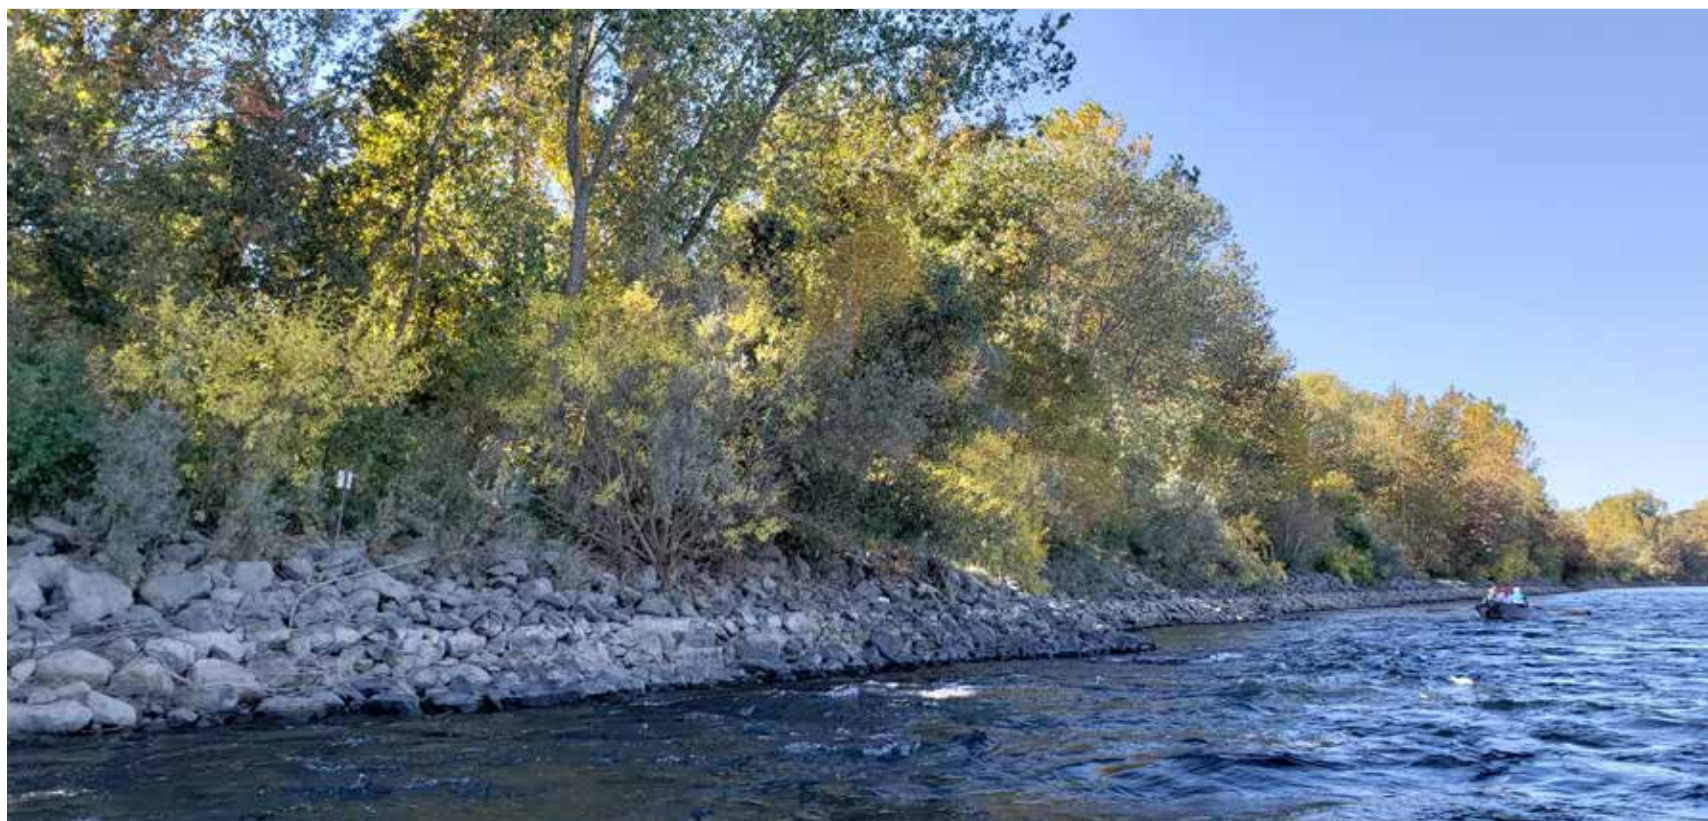
*Revetment and riparian plantings along riverbank. Photo Credit: KC Sorgen*
