American River Parkway

NATURAL RESOURCES MANAGEMENT PLAN

SACRAMENTO
COUNTY

FINAL | JANUARY 2023

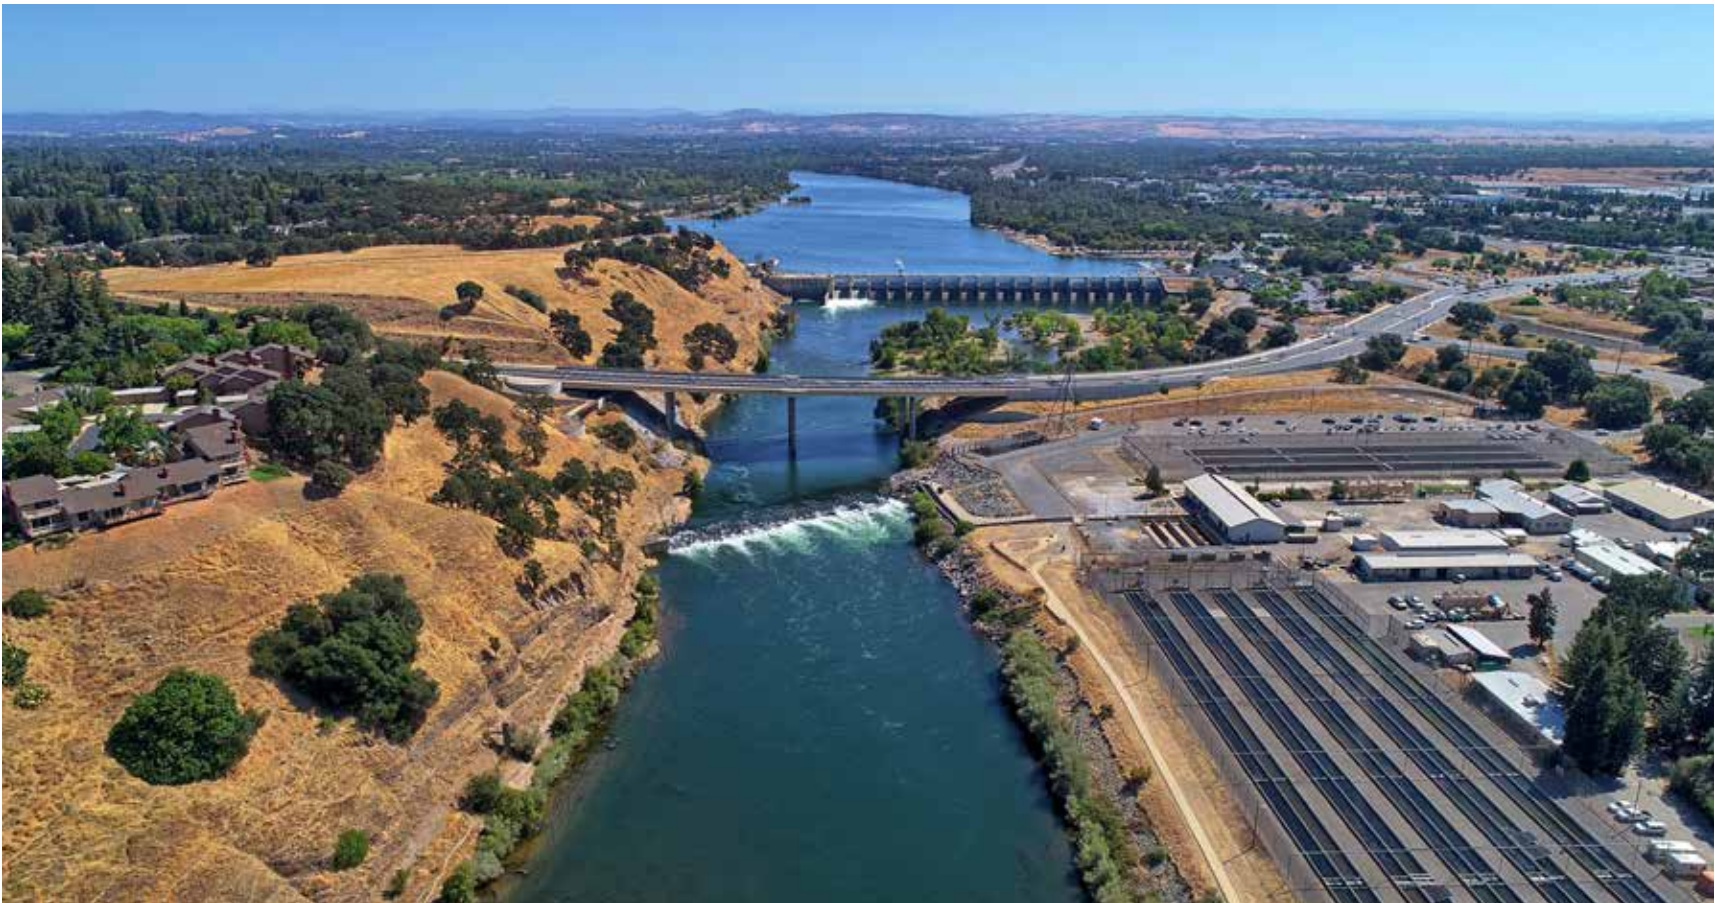
Aerial view of the Nimbus Fish Hatchery and American River Trout Hatchery (photo foreground, right) in the Upper Sunrise Area and the Nimbus Dam (photo background). Photo Credit: John Hannon

species, which removed access to the majority of salmonid spawning habitat and some areas of salmonid rearing habitat (Sacramento County 2008a). Construction of the dams involved moving aggregate from the LAR, which lowered the riverbed elevation that was previously raised by mining activities. In addition, the dams blocked the natural downstream transportation of sediments.

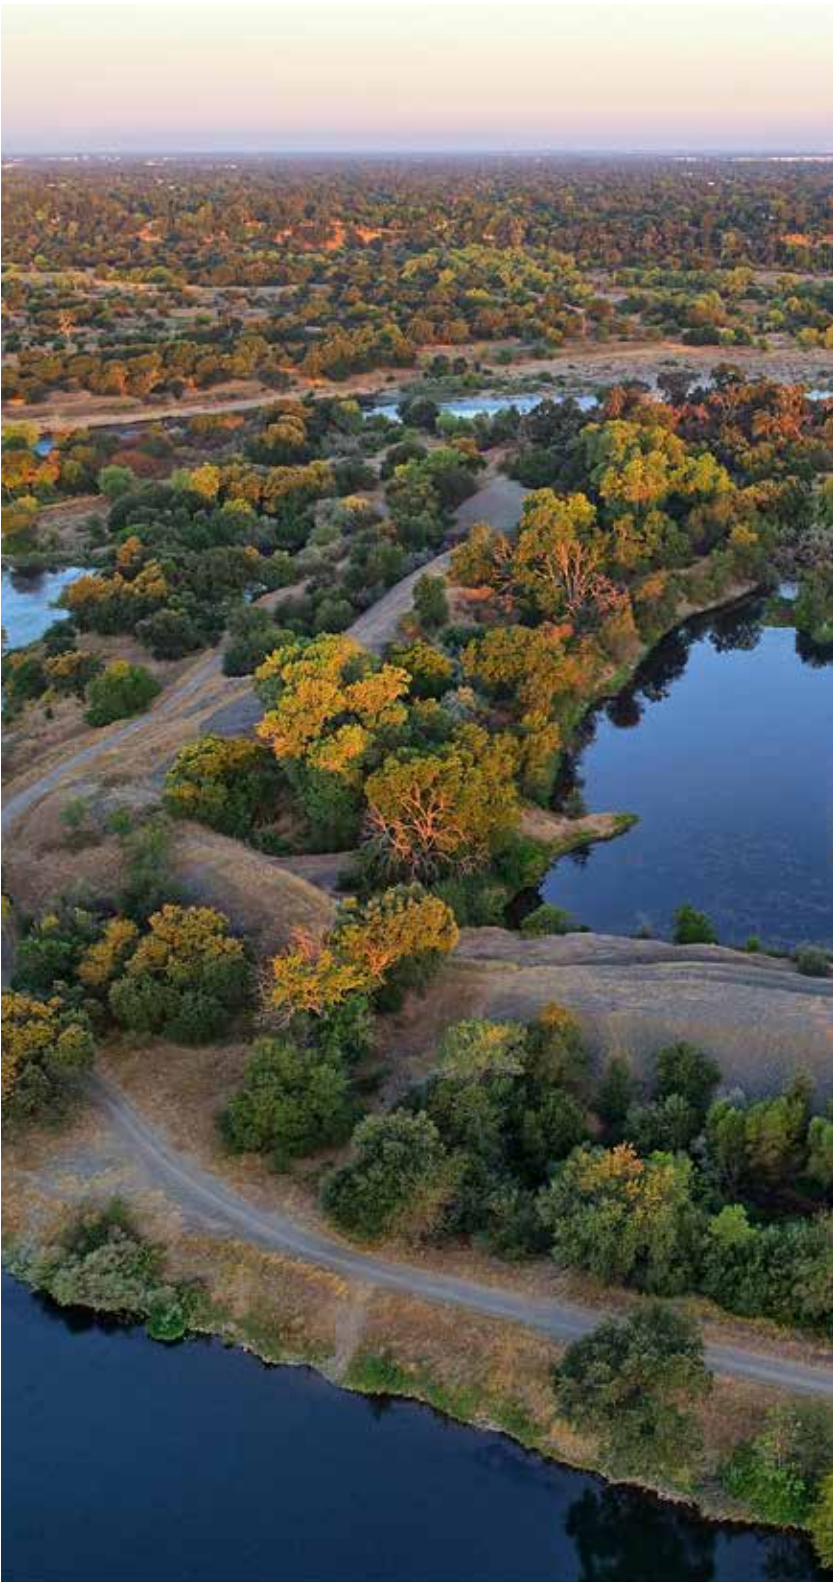
View of ponds remnant of historical mining activities in the Sacramento Bar Area. Photo Credit: John Hannon

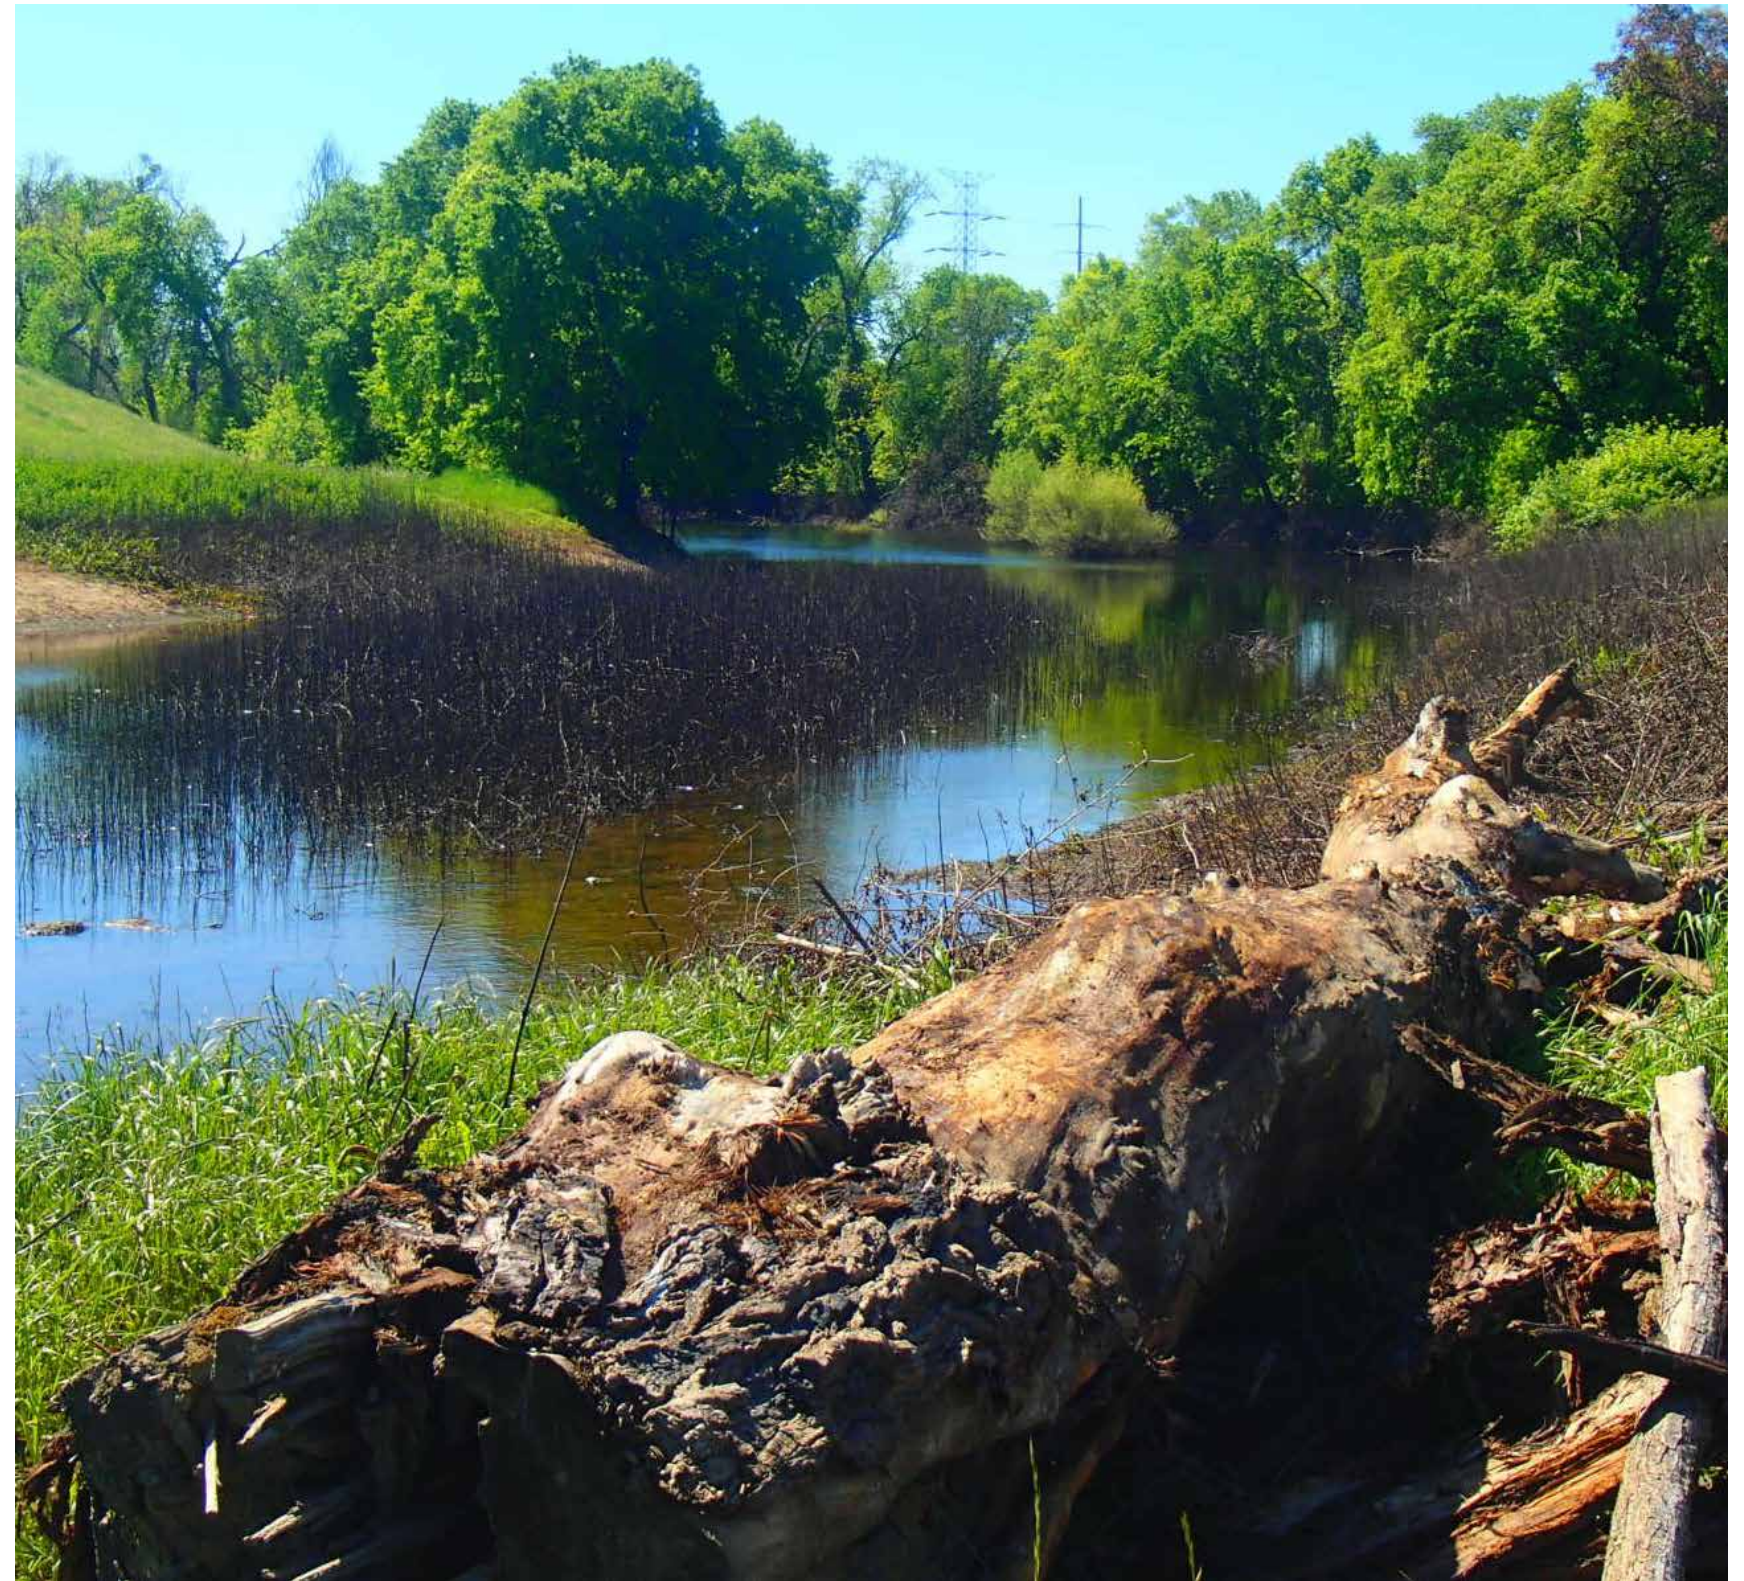
Levee borrow pit in the Discovery Park Area between River Mile 12 and the Sacramento Northern Bike Trail. Photo Credit: Wildlife Conservation Board

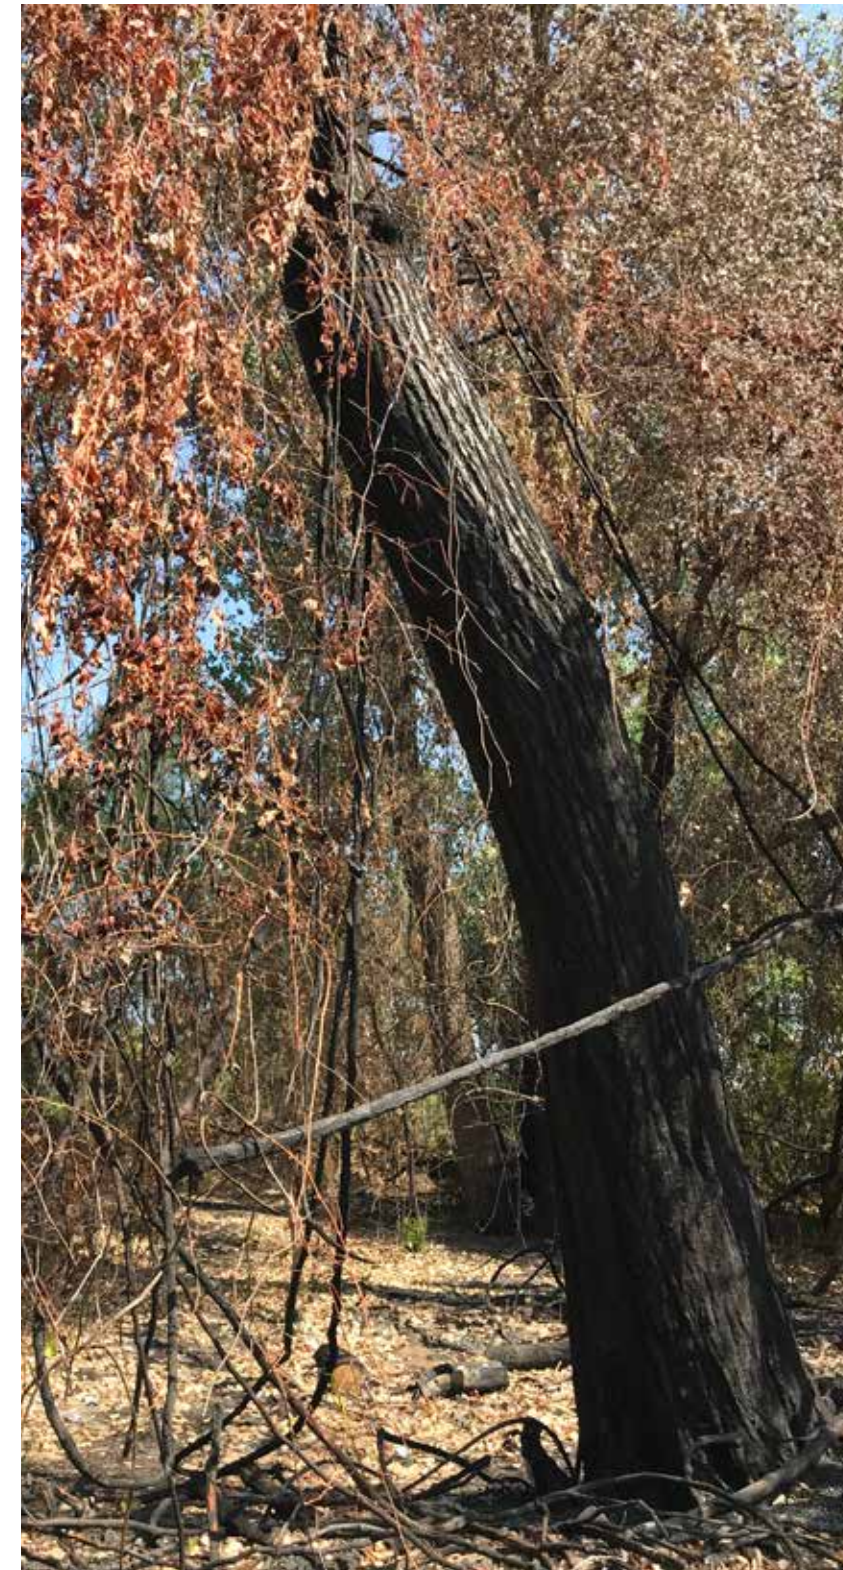
*Burned cottonwood tree in the Howe Avenue Area.
Photo Credit: Regional Parks*

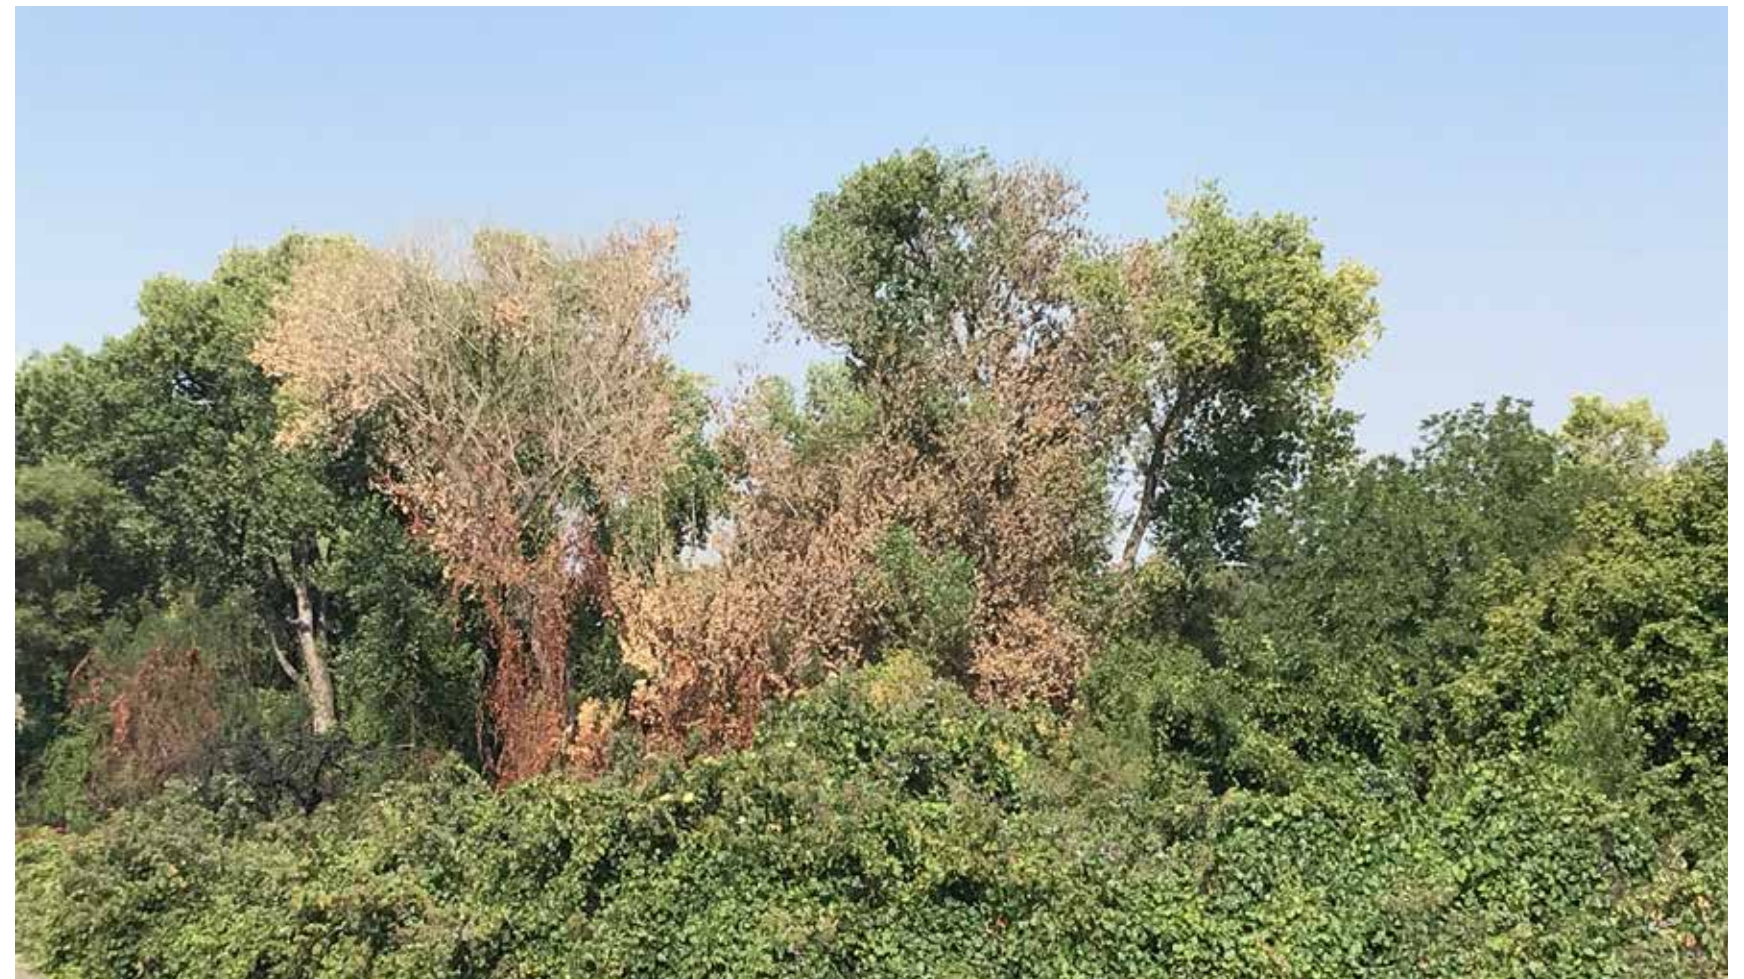
Burned trees in the Howe Avenue Area. Photo Credit: Regional Parks

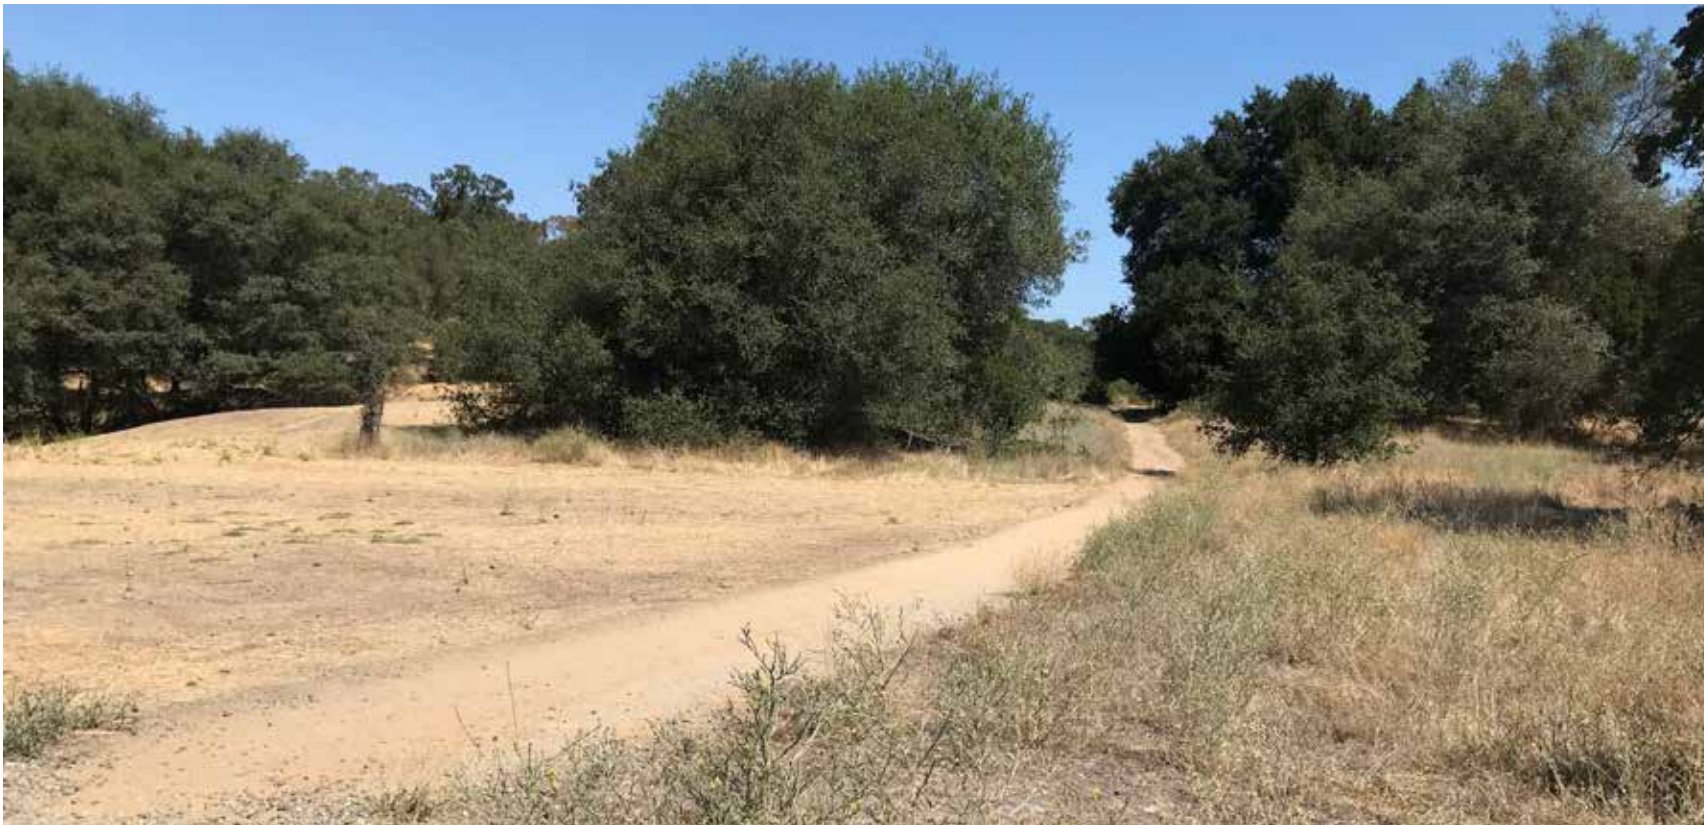
Grazed (photo left) versus ungrazed (photo right) vegetation. Photo Credit: Regional Parks

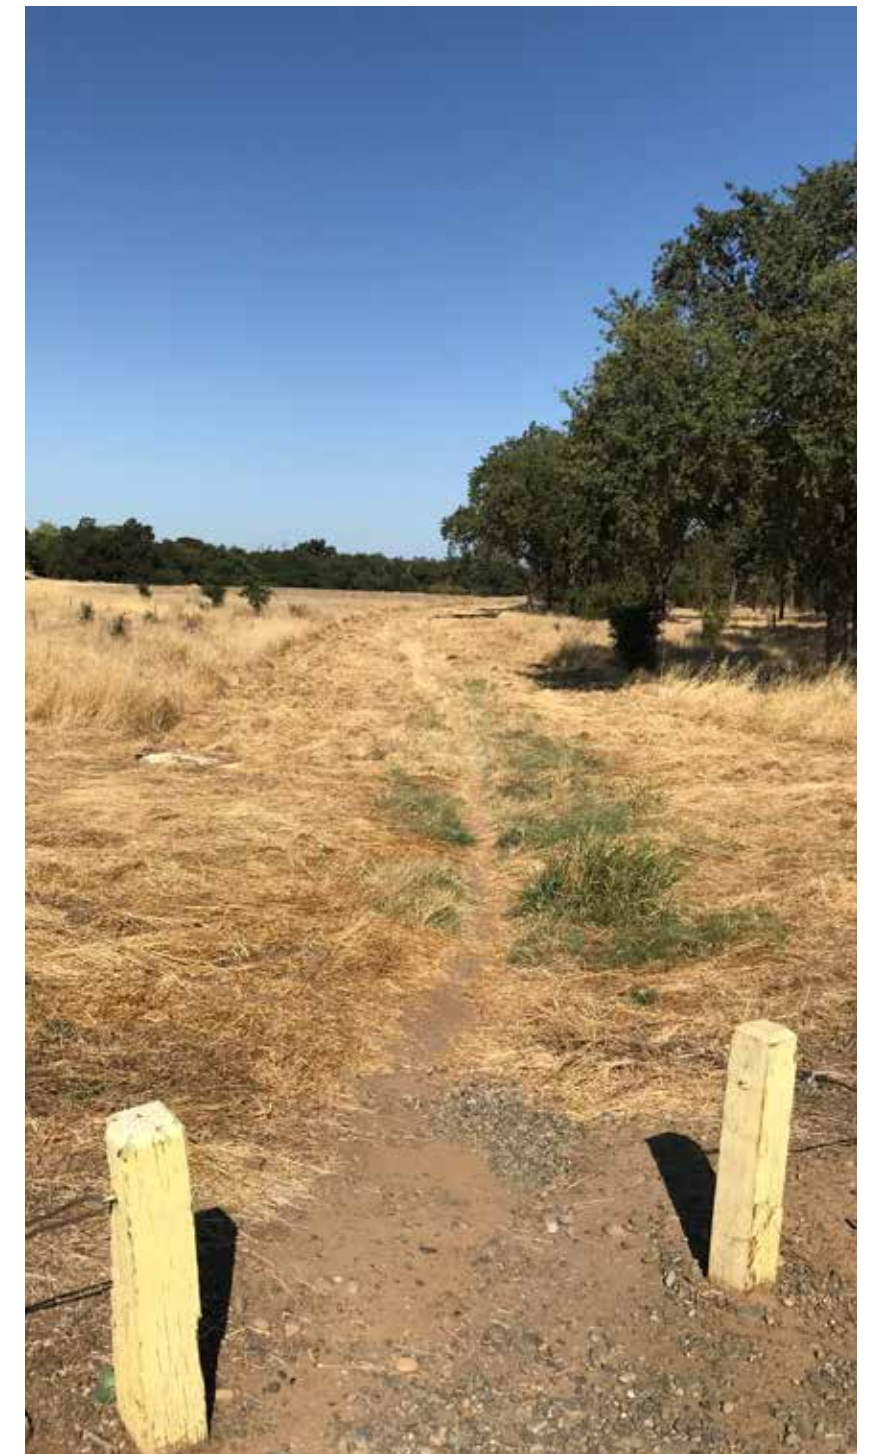
*Mowed firebreak between planted oak trees.
Photo Credit: Regional Parks*

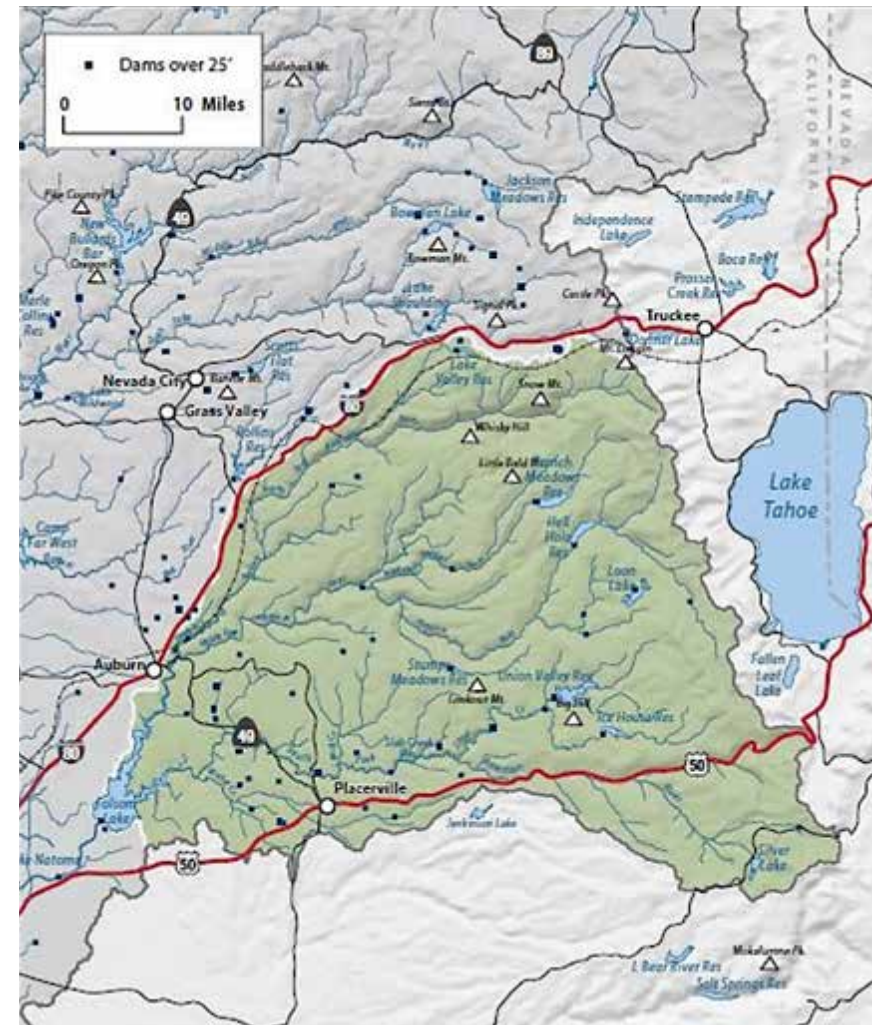
FIGURE 5-3A UPPER AMERICAN RIVER WATERSHED (ADAPTED FROM SRWP 2010)

The current LAR is part of a highly regulated river system fed by the American River basin that originates on the west side of the Sierra Nevada (Figure 5-3a and 5-3b) and encompasses portions of the Sierra high country, foothills, and central valley of California (Streamstats 2019). Several upper watershed reservoirs and tributaries collect, store, and convey water from the west slopes of the Sierra Nevada down to Folsom Lake, a reservoir created by Folsom Dam. From there the water continues down to Lake Natoma regulated by Nimbus Dam, the upstream end of the LAR Parkway. While tributaries exist along the LAR, their flow is negligible; however, their outfalls pose an erosion risk.

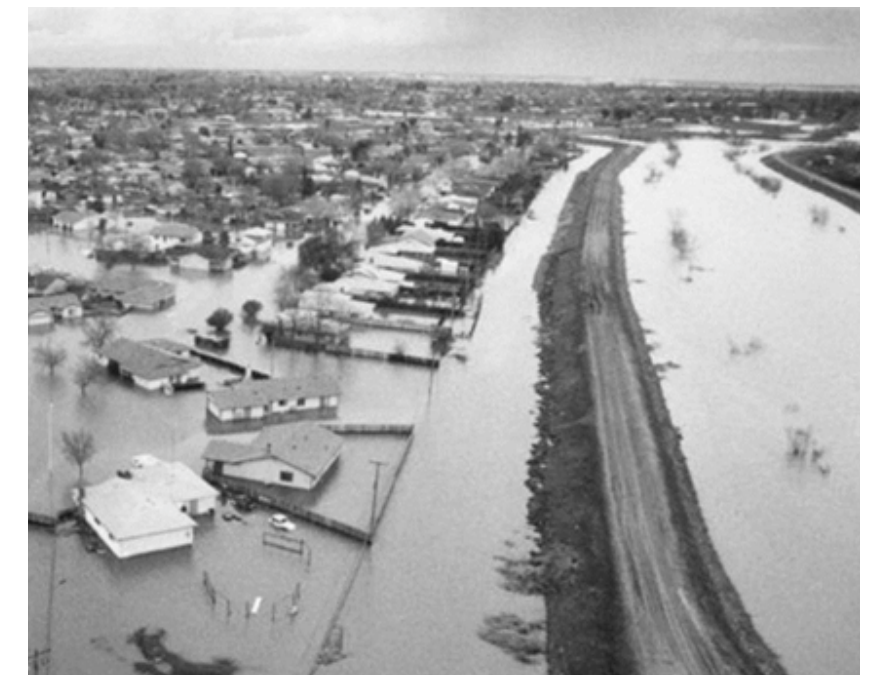
FIGURE 5-7 1986 FLOOD PHOTO (SOURCE: SAC BEE 2012)

An extensive system of federal levees protects the Sacramento Valley from flood risk. In response to the 1986 flood event (Figure 5-7), several levee assessment and upgrade efforts were put into motion in the 1990s and continue today to mitigate potential damage to the existing levee system, particularly if the allowable 200-year Folsom Dam release discharge of 160,000 cfs were to occur. (USACE 2017). The ongoing bank protection projects are implemented through USACE, Central Valley Flood Protection Board (CVFPB), and Sacramento Area Flood Control Agency (SAFCA). The primary projects driving levee improvements are the Sacramento River Bank Protection Project originally authorized under the Flood Control Act of 1960 (USACE 2020) to provide long term flood risk management, and the American River Common Features Project (ARCF) approved by Congress to provide levee and dam improvements following the 1986 flood.

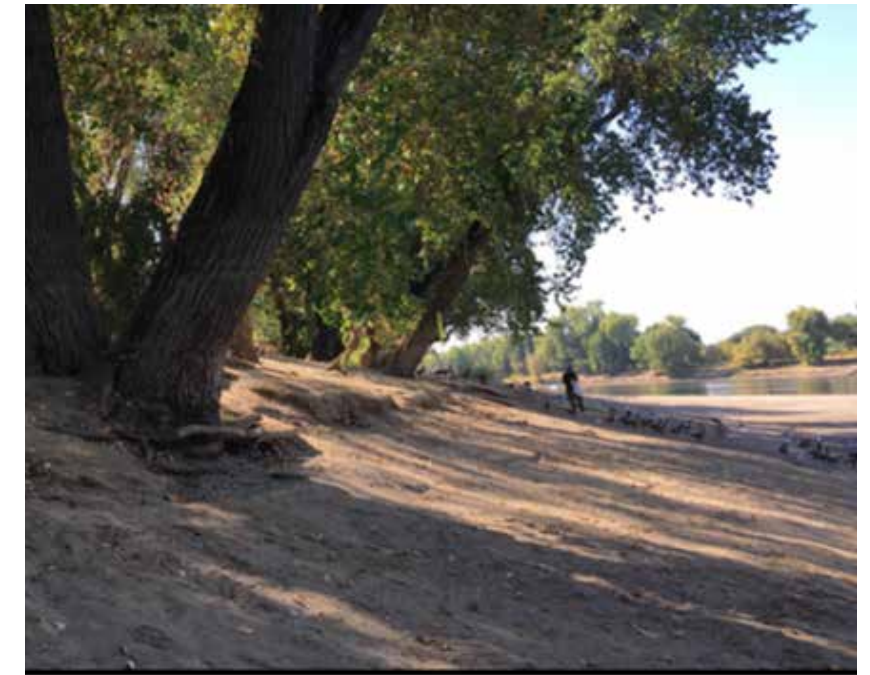
FIGURE 5-11 MATURE OAKS LINE UPPER PORTION OF MOSTLY BARE EARTHEN LEFT BANK NEAR CONFLUENCE (~RM0.2)

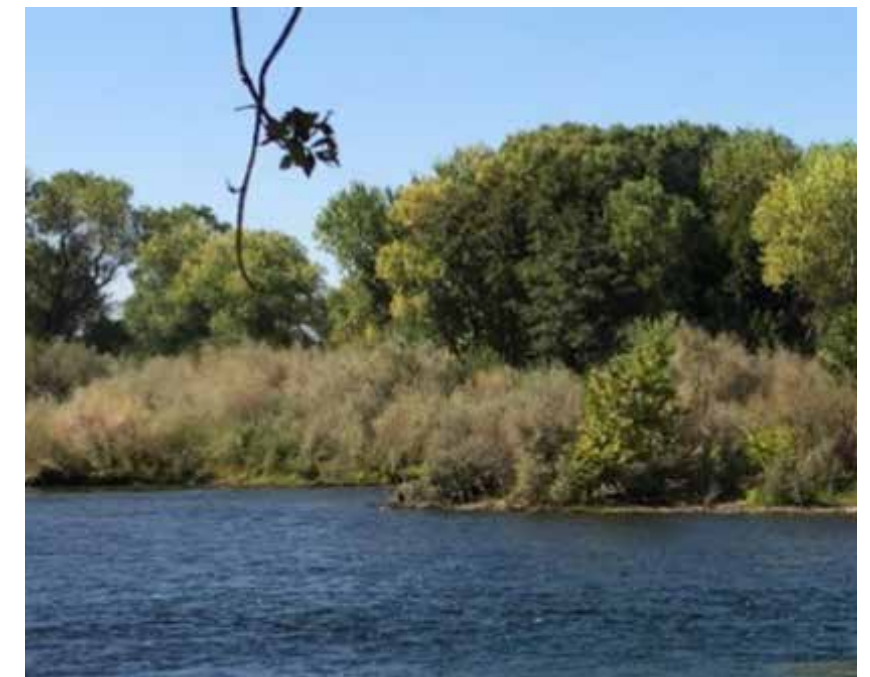
FIGURE 5-12 LEFT BANK VEGETATED BAR AT PARADISE BEACH (~RM 5.6)

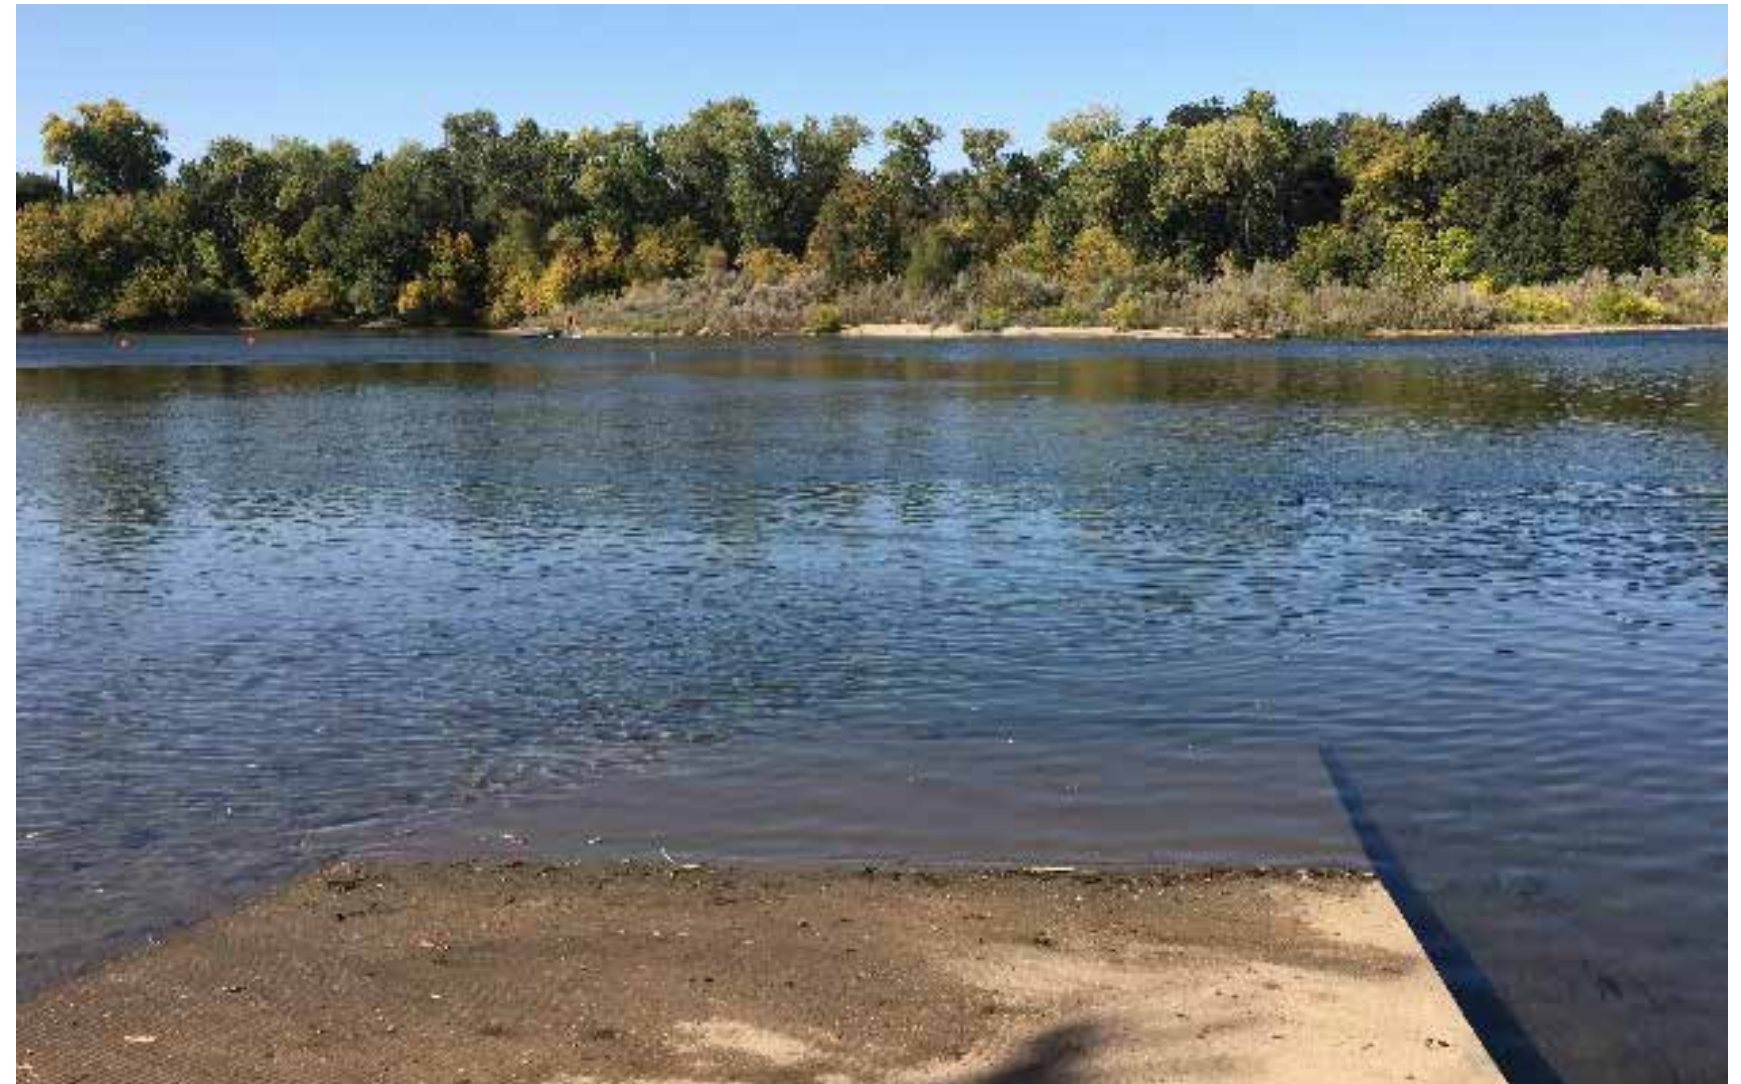
FIGURE 5-15 MINED LEFT BANK WIDENED RIVER, FORMED IN CHANNEL BAR SEEN FROM BOAT RAMP (~RM 9).

over-widened experience reduced velocities and sediment transport and are likely to continue to aggrade and become shallower (Figure 5-15).

has been directly manipulated by human activity. On the upstream side of Howe Avenue Bridge and the downstream side of Watt Avenue Bridge, old mining excavations lowered the left banks of the river, widening the channel and forming in-channel islands with alluvium surfaces. Parkway facilities and recreational access often coincide with these artificially lowered banks due to their accessibility to the river, such as the boat ramp southwest of Watt Avenue Bridge (Figure 5-15).

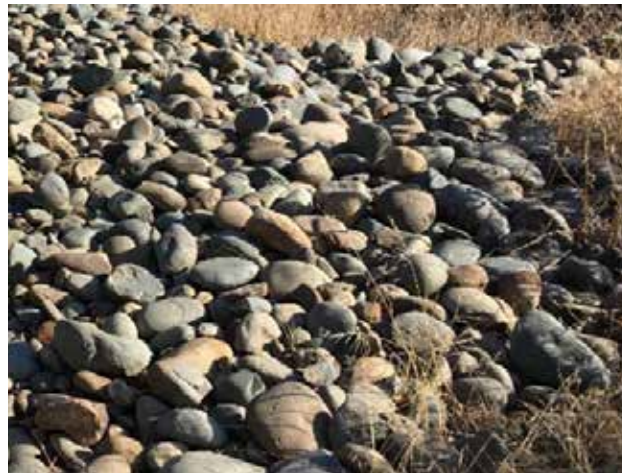
FIGURE 5-17 COBBLE SPOILS ALONG ARDEN BAR, EVIDENCE OF PAST GRAVEL MINING

TERRACE GRAVEL MINING: As introduced earlier, the majority of hydraulic mining that ended in the 1970s took place upstream of RM 8. Cobble spoil piles left behind are scattered throughout the terraces of Arden Bar from roughly RM 12 to 13 at William B. Pond Recreation Area (Figure 5-17)

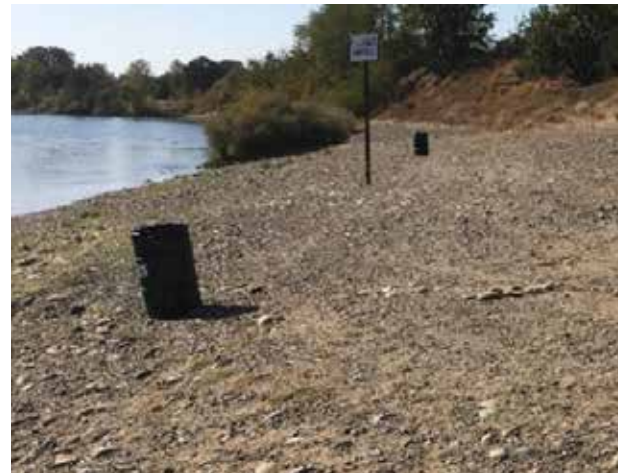
FIGURE 5-18 HEAVILY USED RIGHT BANK AT CAR TOP BOAT LAUNCH (~RM 11.6)

BED AND BANK TYPES: In Parkway Segment 3, the frequency of bare ground and exposed alluvial material increases in contrast to relatively undisturbed vegetated banks. Some of these areas are heavily compacted in high use areas such as boat launches (Figure 5-18). Other banks appear to be increasing in height due to overbank deposition (Figure 5-19). Locally, the more resistant Fair Oaks formation is exposed along some bank margins (Figure 5-20). Cobble spoil piles, remnants from hydraulic mining, are scattered throughout the terraces of Arden Bar from roughly RM 12 to 13 at William B. Pond Recreation Area.

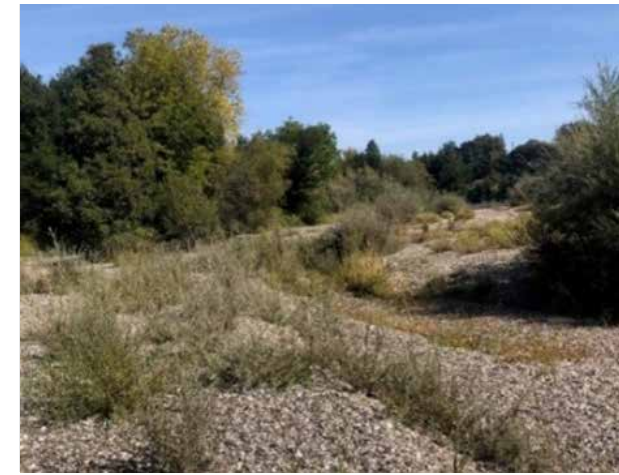
FIGURE 5-19 RIVER RIGHT BANK GRAVEL SIDE BAR (~ RM 12.1)

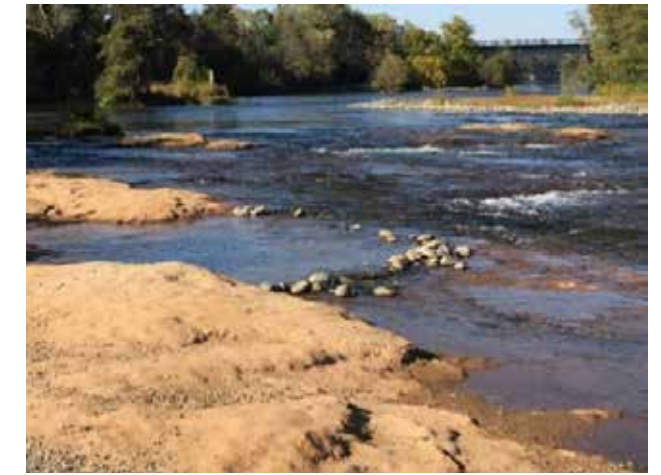
FIGURE 5-20 EXPOSED FAIR OAKS FORMATION ALONG RIVER RIGHT BANK.

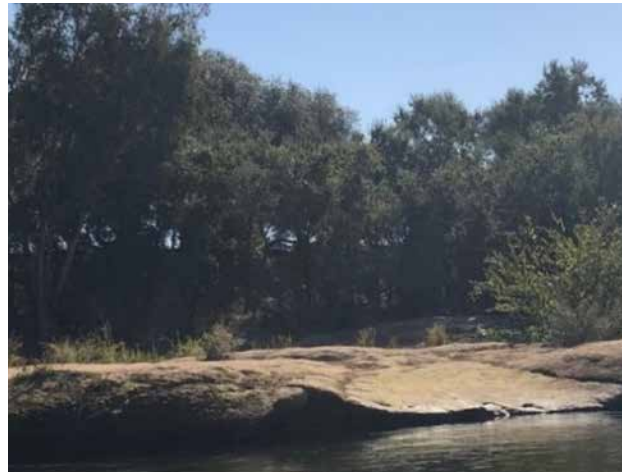
FIGURE 5-22 EXPOSED EROSION RESISTANT BANK TOE (~RM 15.3)

BED AND BANK TYPES: The channel bed in Parkway Segment 4 is holding grade due to the underlying Fair Oaks formation (Figure 5-22) and cobble size armoring, particularly in the upper portions. The hardened bed through this area applies increased pressure on the earthen banks during higher flow events, often causing accelerated erosion on

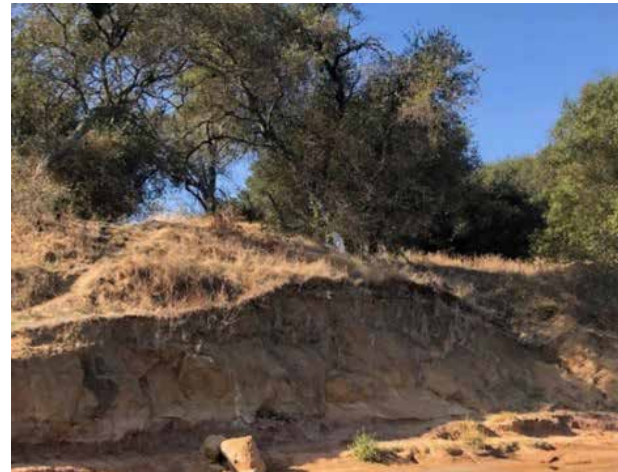
FIGURE 5-23 EROSION ALONG CLAY SHELF (~RM 16.7)

sparsely vegetated or unprotected outer banks (Figure 5-23). While some well-vegetated banks with a small amount of woody material at the toe were observed in Parkway Segment 4, there is limited evidence of downed wood along the river margins, giving further evidence to a limited active floodplain and little to no natural channel migration (Figure 5-24).

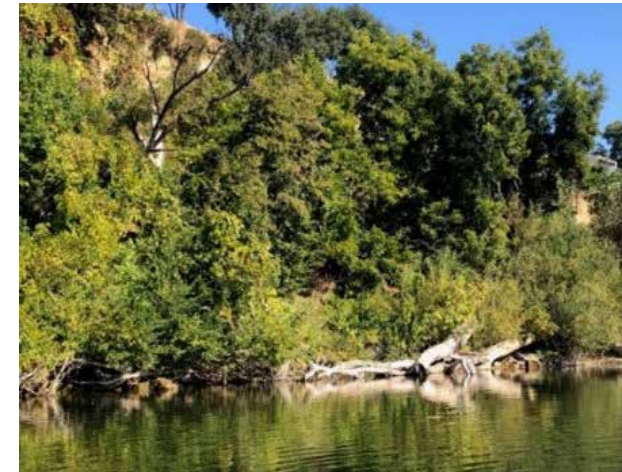
FIGURE 5-24 ACTIVELY ERODING BANK ALONG CLAY SHELF (~RM 17.8)

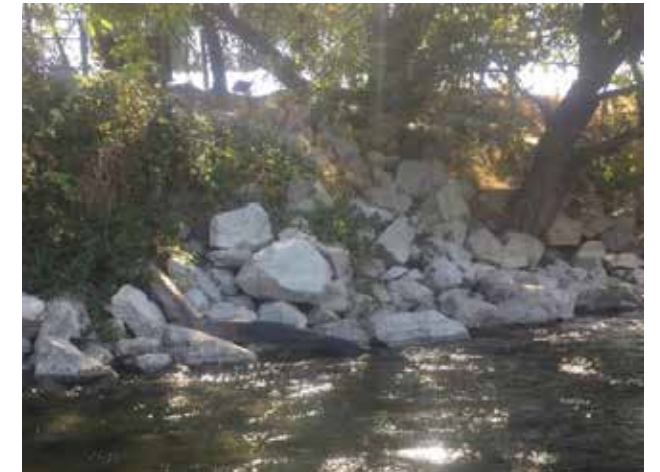
FIGURE 5-25 ROCK RIP-RAP PLACED AT CORDOVA CREEK OUTFALL (~RM 14.5)

OUTFALLS: Stormwater and creek armored outfalls are interspersed throughout the Parkway segments, two of the larger tributaries between Nimbus Dam and the confluence with the Sacramento River, Cordova Creek (Figure 5-25) and Carmichael Creek outlet near the downstream end of Parkway Segment 4.

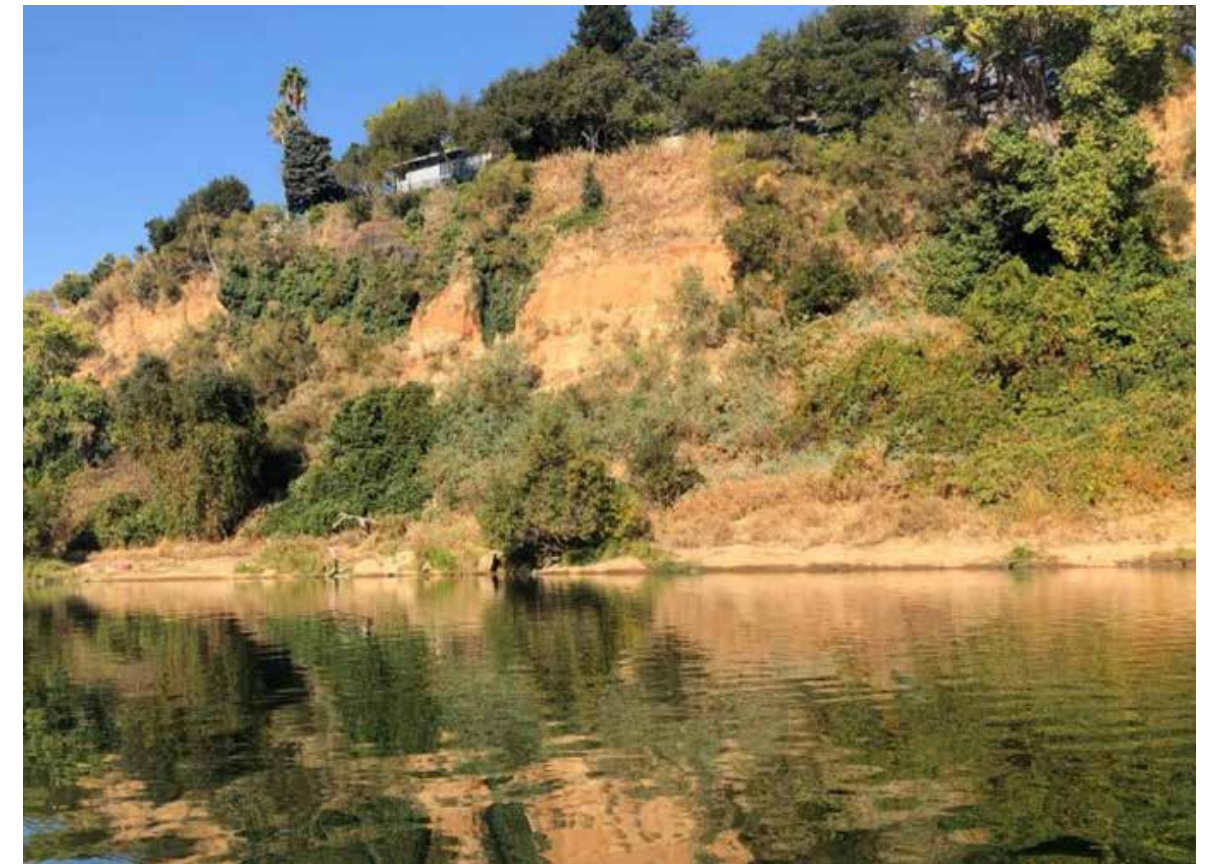
FIGURE 5-28 STEEP BLUFFS ALONG RIGHT BANK (~RM 19.4)

loading the upper surface via irrigation or stormwater runoff, and below from trail encroachment, road maintenance, or channel overflow events impinging on the face of the bank. These events could produce mass wasting via slumps, slides or surface erosion that could threaten private property and cause a large sediment influx to the river impacting water quality, fish spawning grounds or other sensitive resources.

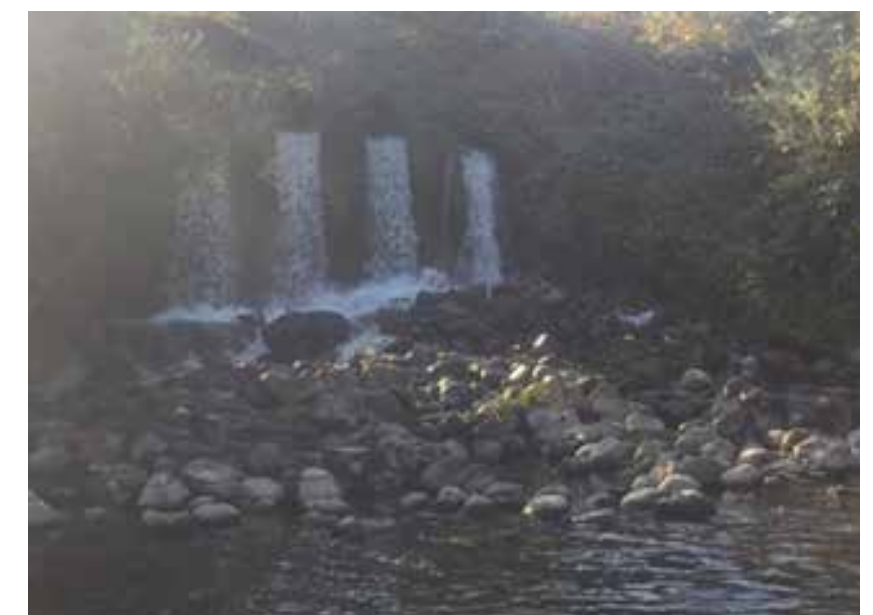
FIGURE 5-29 BUFFALO CREEK OUTFALL (~RM 19.5)

OUTFALLS: Along with stormwater outfalls, one of the larger tributaries to LAR, Buffalo Creek outfalls in Parkway Segment 5 (Figure 5-29).

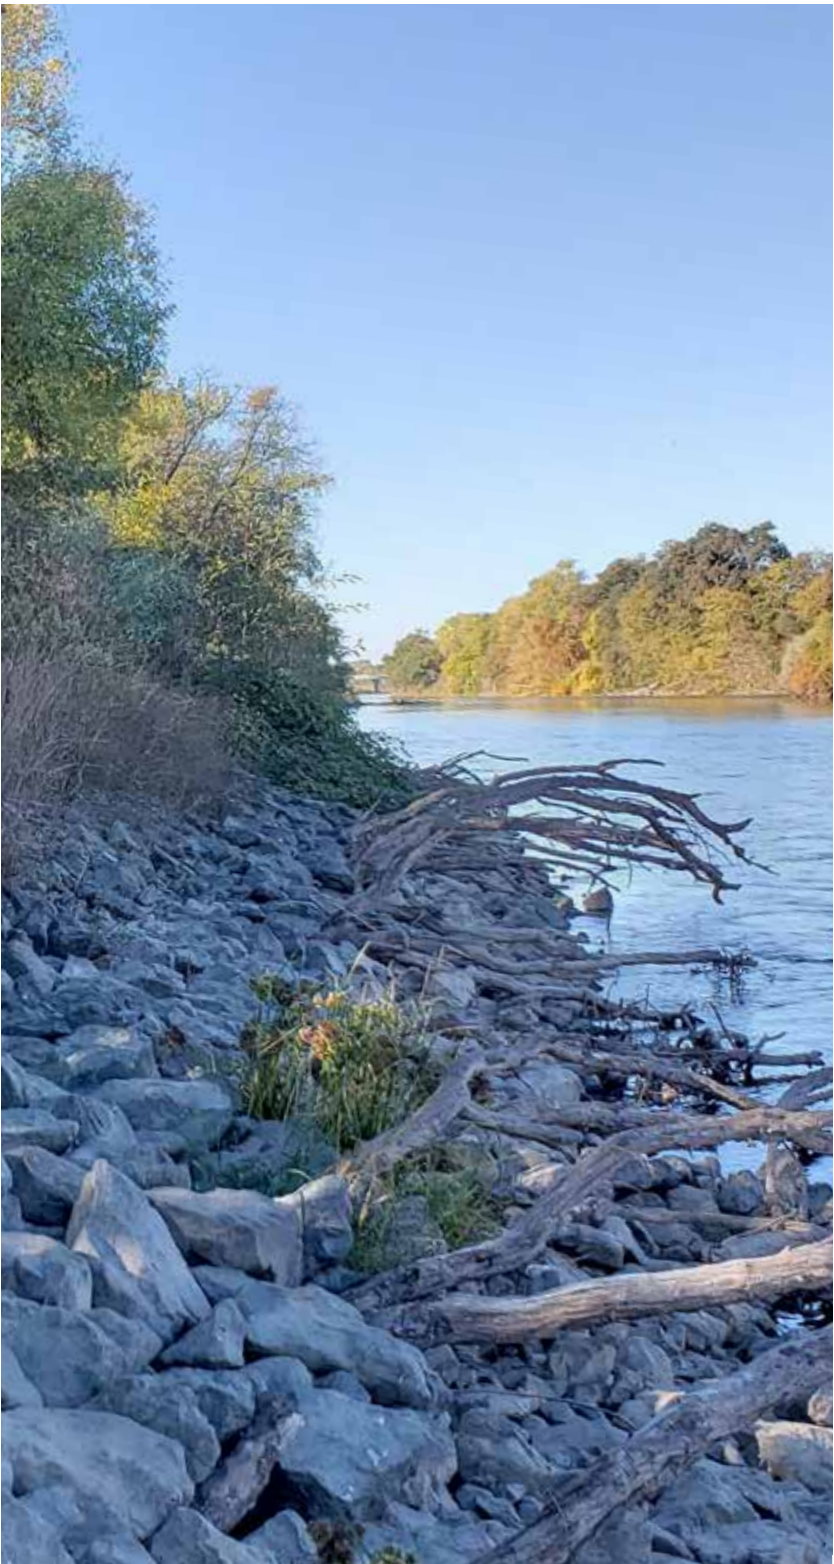
Revetment and riparian plantings along riverbank.
Photo Credit: KC Sorgen
