American River Parkway

NATURAL RESOURCES MANAGEMENT PLAN

SACRAMENTO
COUNTY

FINAL | JANUARY 2023

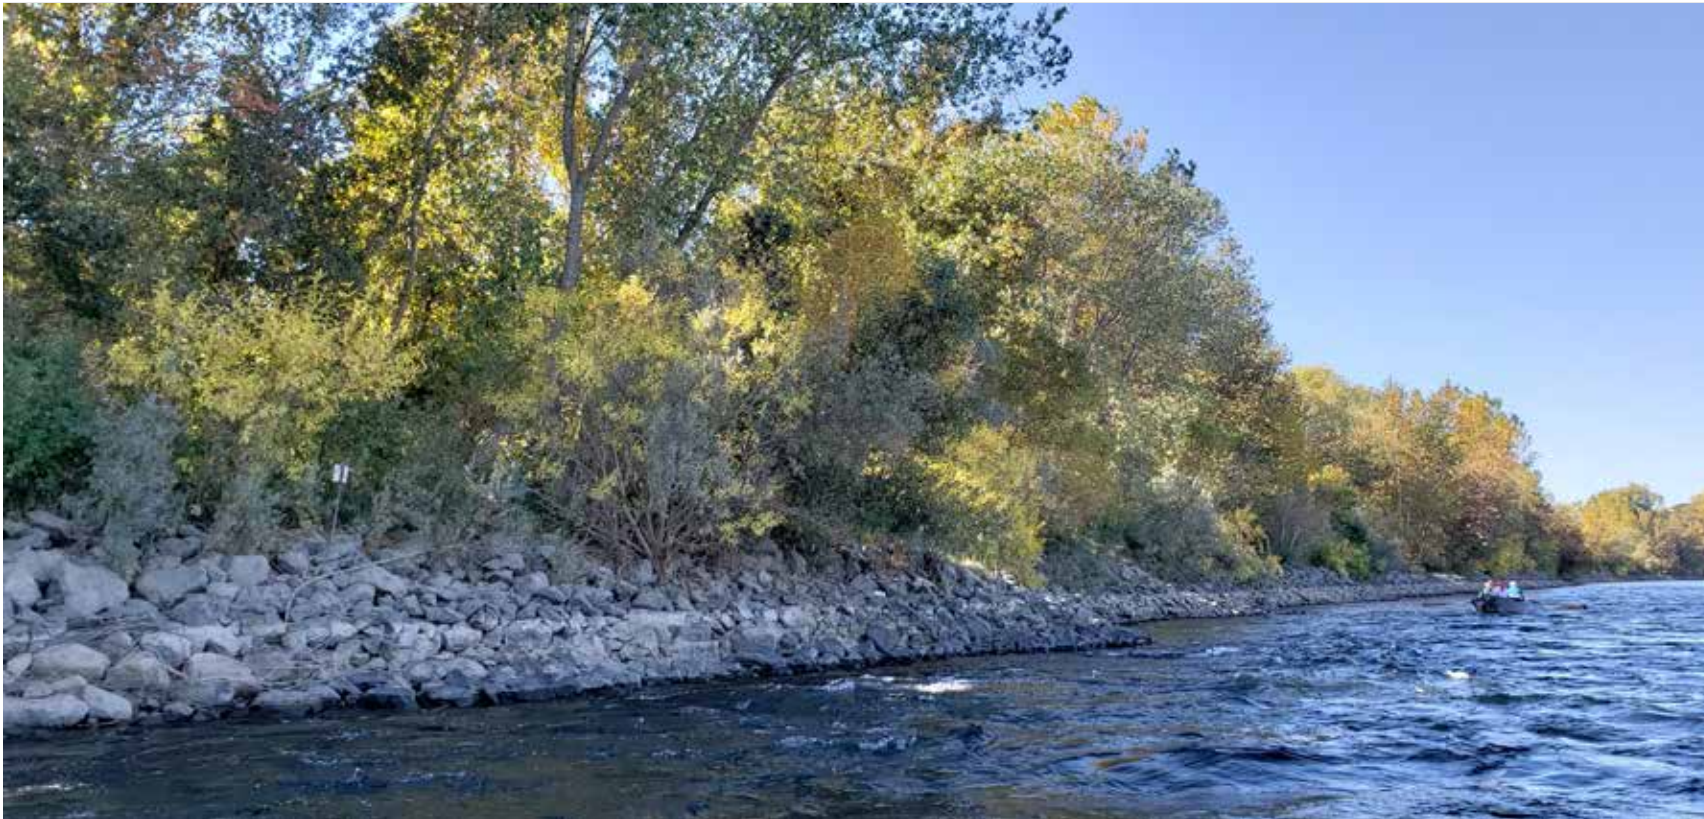
Revetment and riparian plantings along riverbank. Photo Credit: KC Sorgen

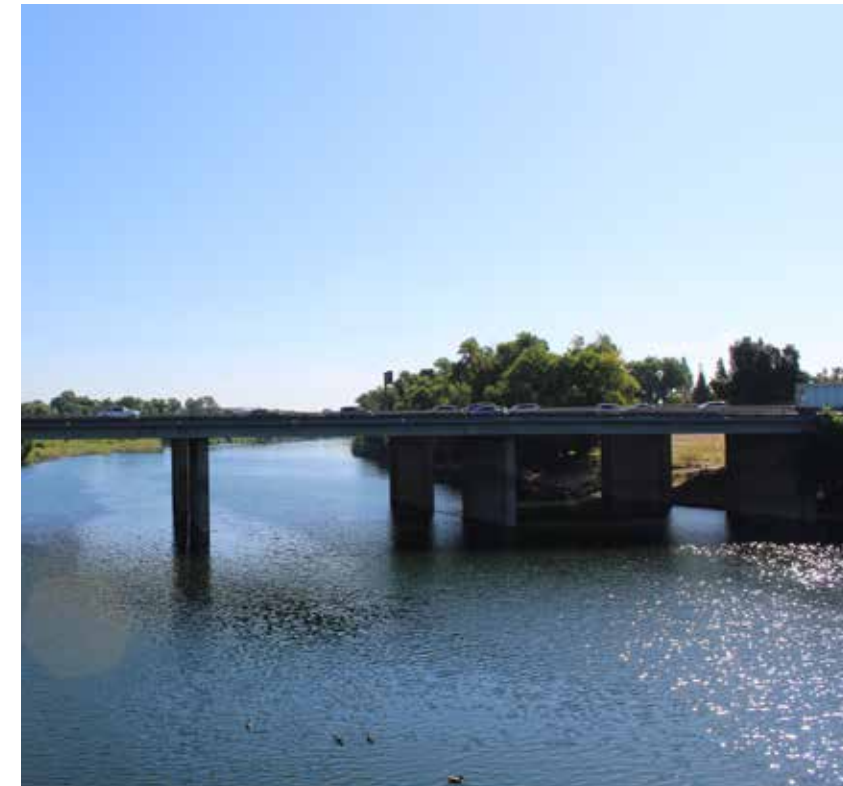
The I-5 American River Bridge in the Discovery Park Area. Photo Credit: MIG

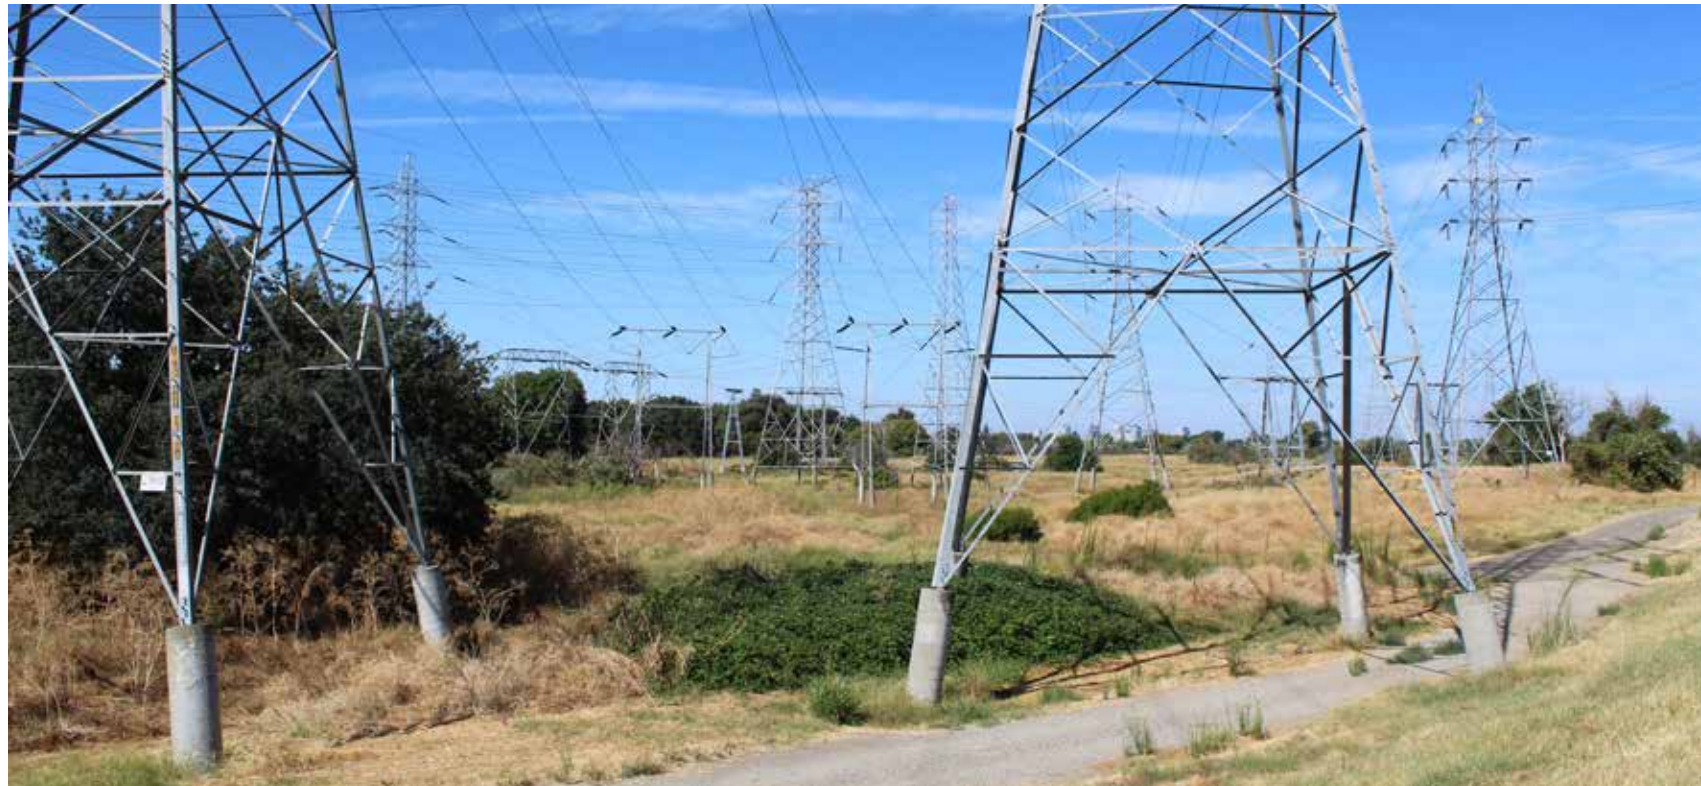
Electrical power transmission towers in the Cal Expo Area. Photo Credit: MIG

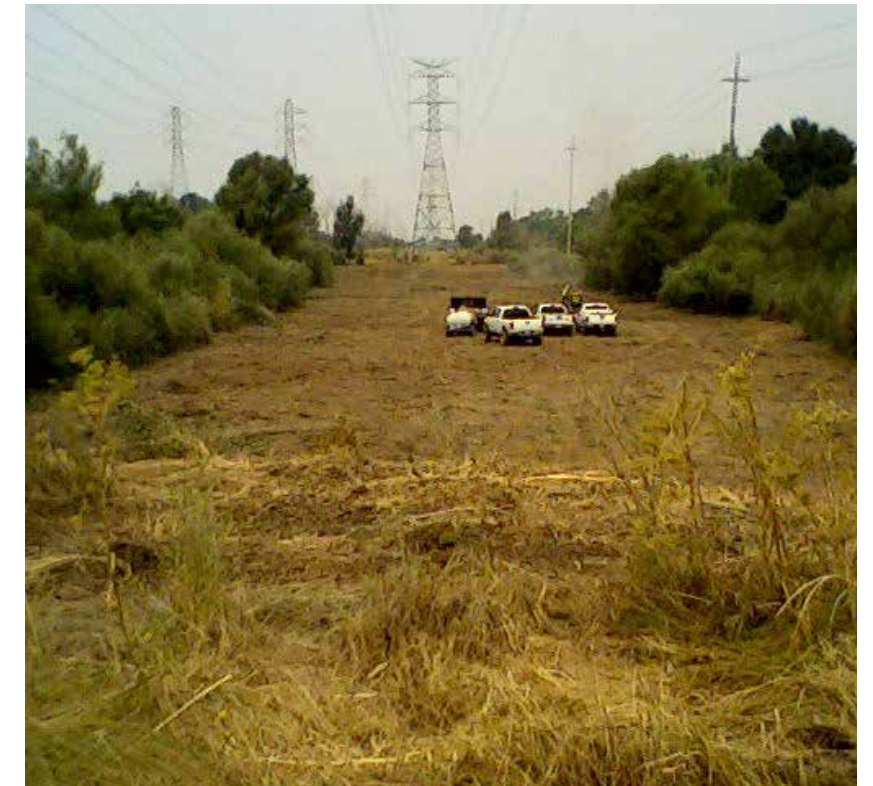
Vegetation clearing activities under WAPA powerlines in the Cal Expo Area. Photo Credit: Regional Parks

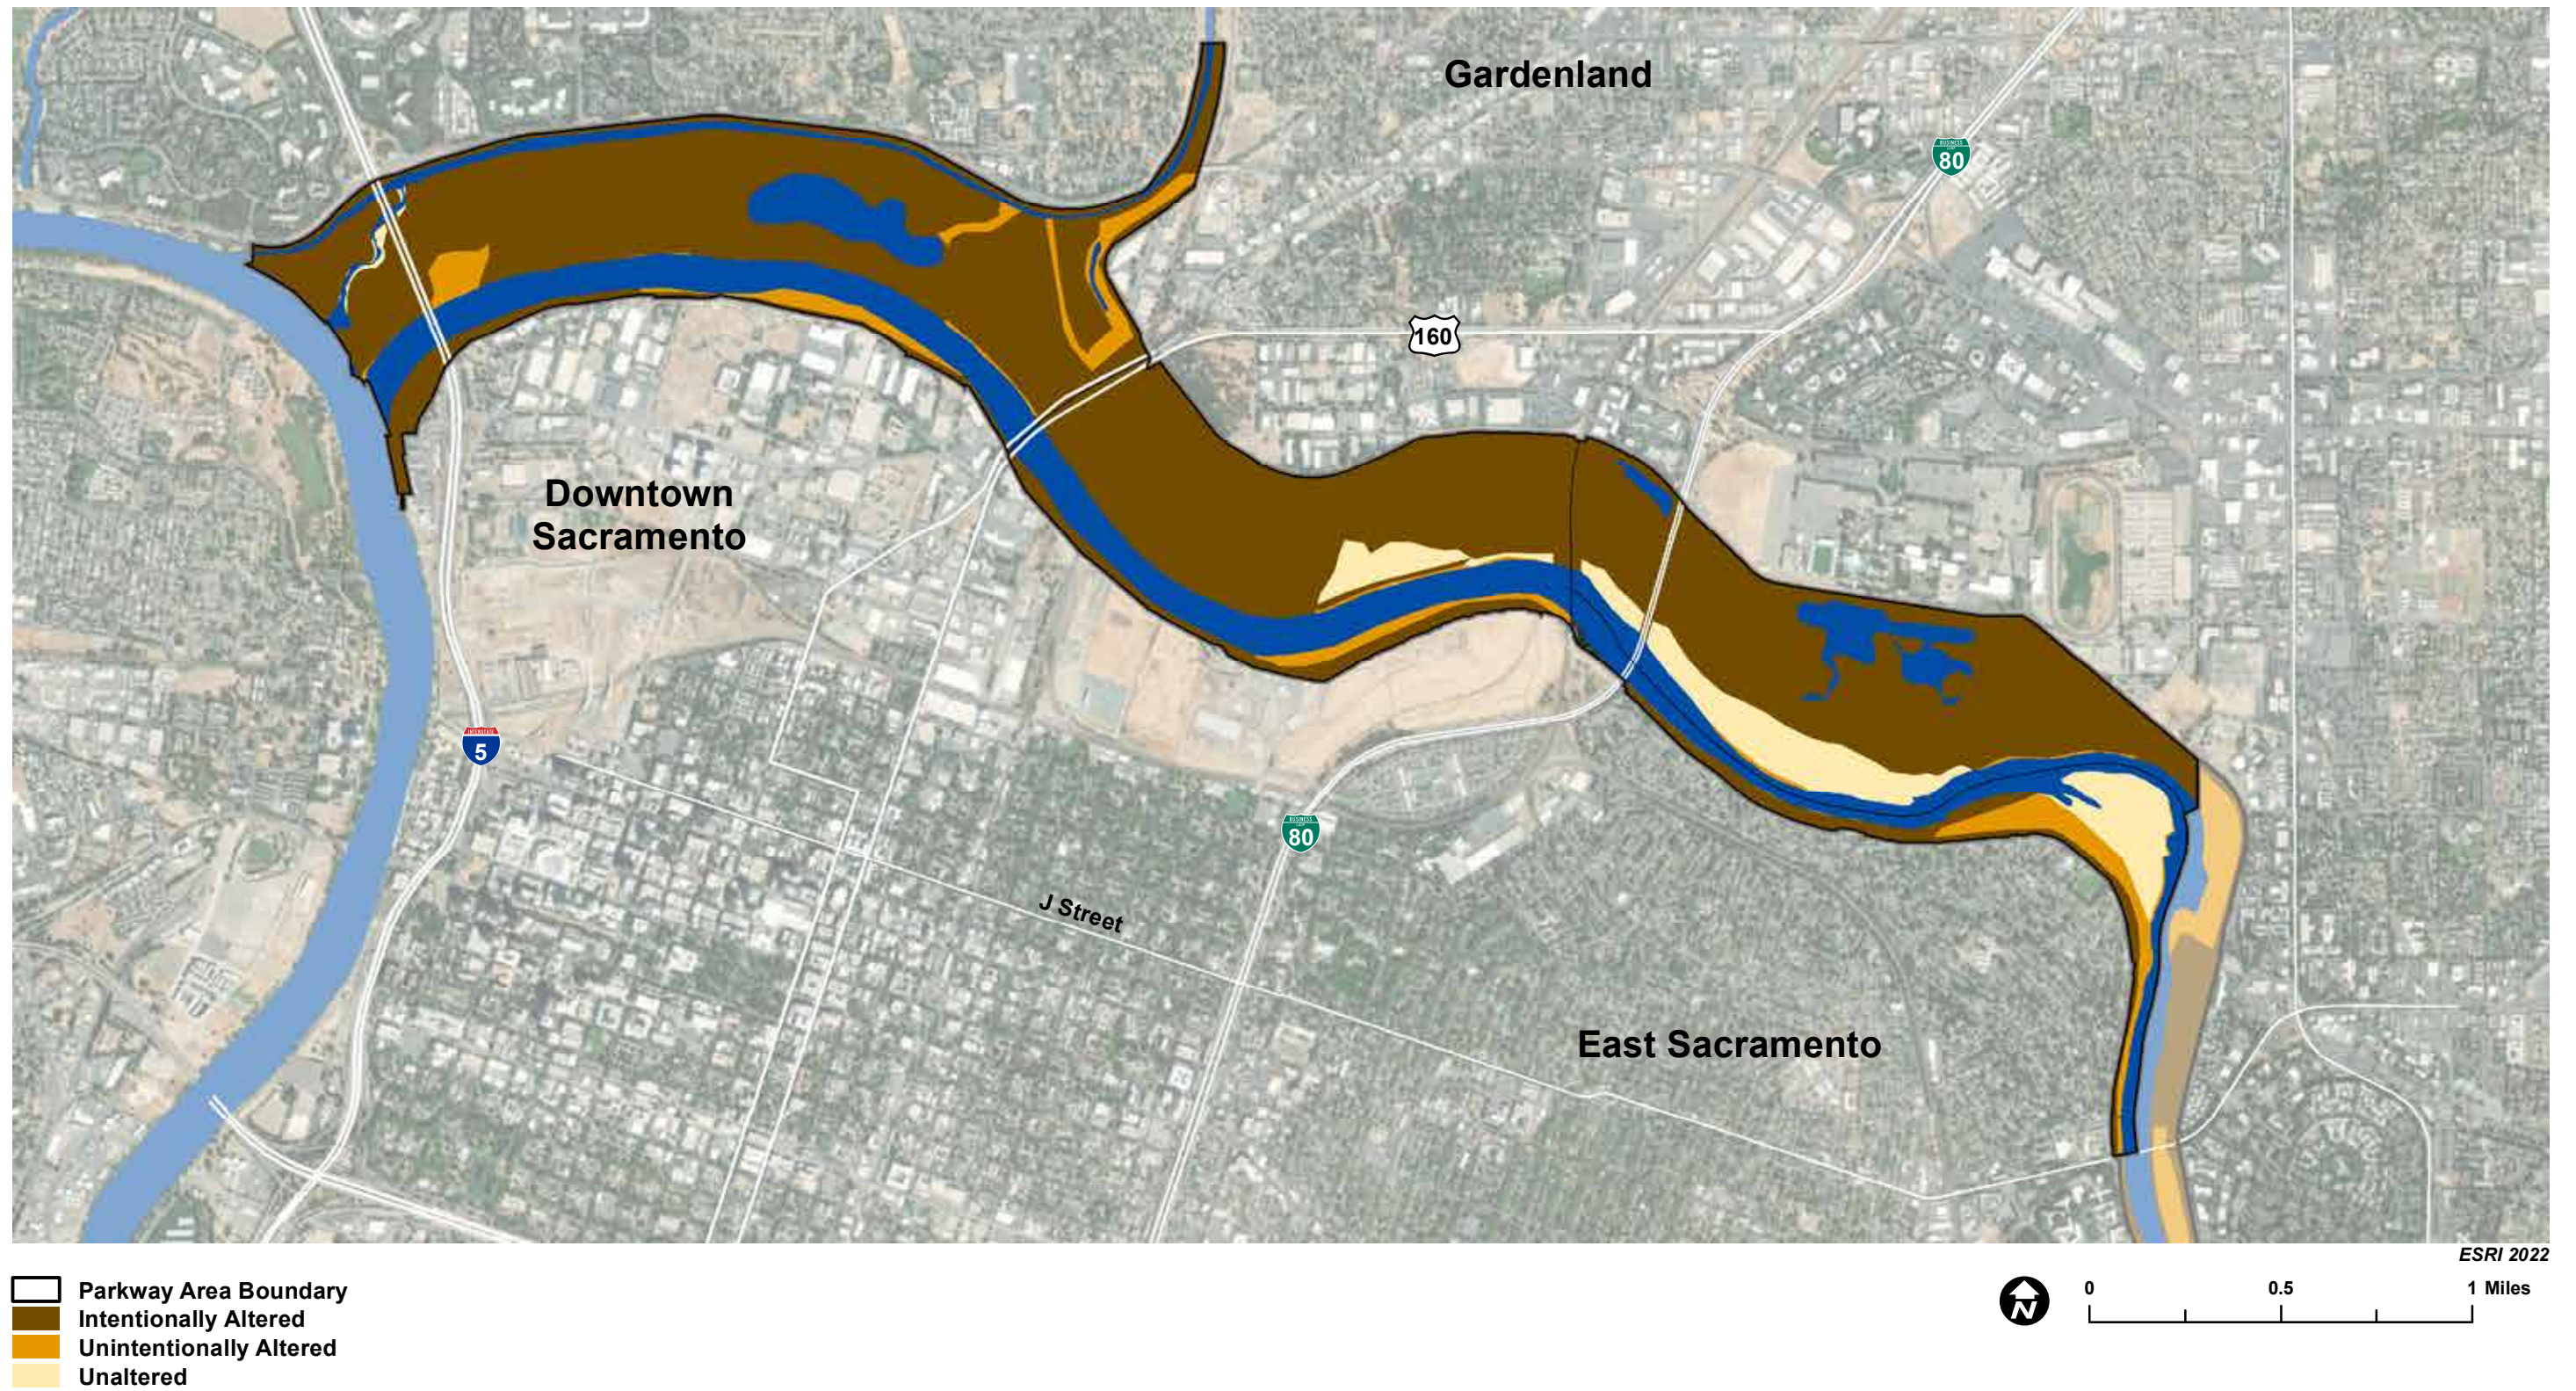
Figure 8-2
Lower Reach Alteration

- Understanding an areas level of alteration can help explain a site's current topography, inundation regime, vegetation patterns, etc. It can also help to better understand ongoing trends and what might be expected in the future. The high floodplains in the lower reach of the river serve as a good example, in that the past inundation regime allowed for the natural regeneration of cottonwood trees. However, since the riverbed lowered as the hydraulic mining debris was flushed out, while the adjacent overbank areas remained high, the cottonwoods no longer naturally regenerate in several overbank areas. This has resulted in the transition of vegetation in these areas from willows and cottonwoods to species better suited for drier conditions, like oaks. This trend is expected to continue and is important to inform future management actions.

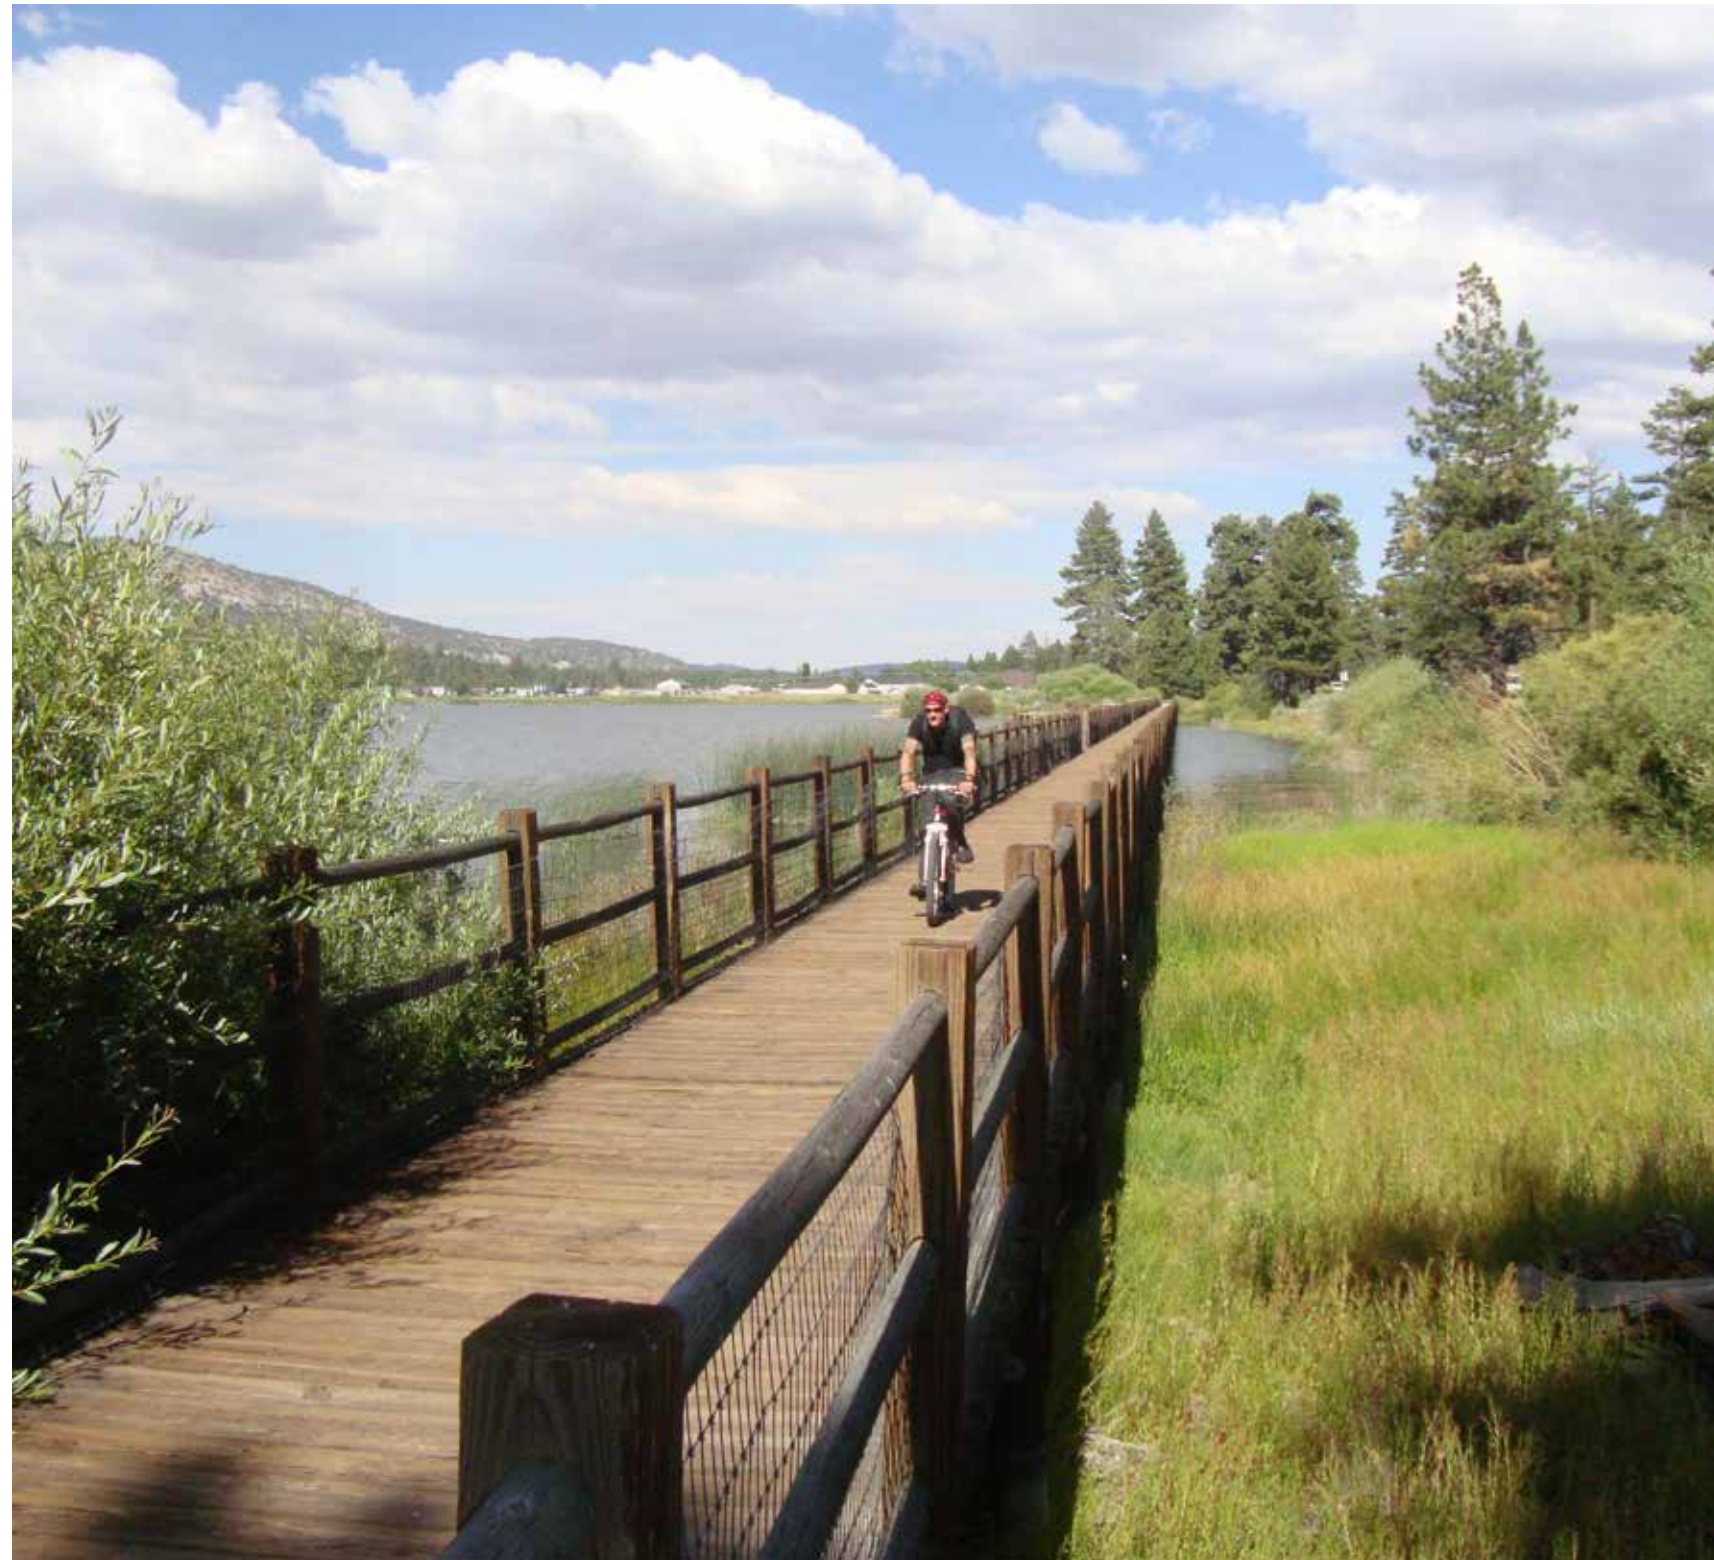
The Stanfield Marsh Boardwalk, located in the Stanfield Marsh and Waterfowl Preserve near Big Bear, California, is an example of environmentally-friendly raised platform trail design. Photo Credit: MIG

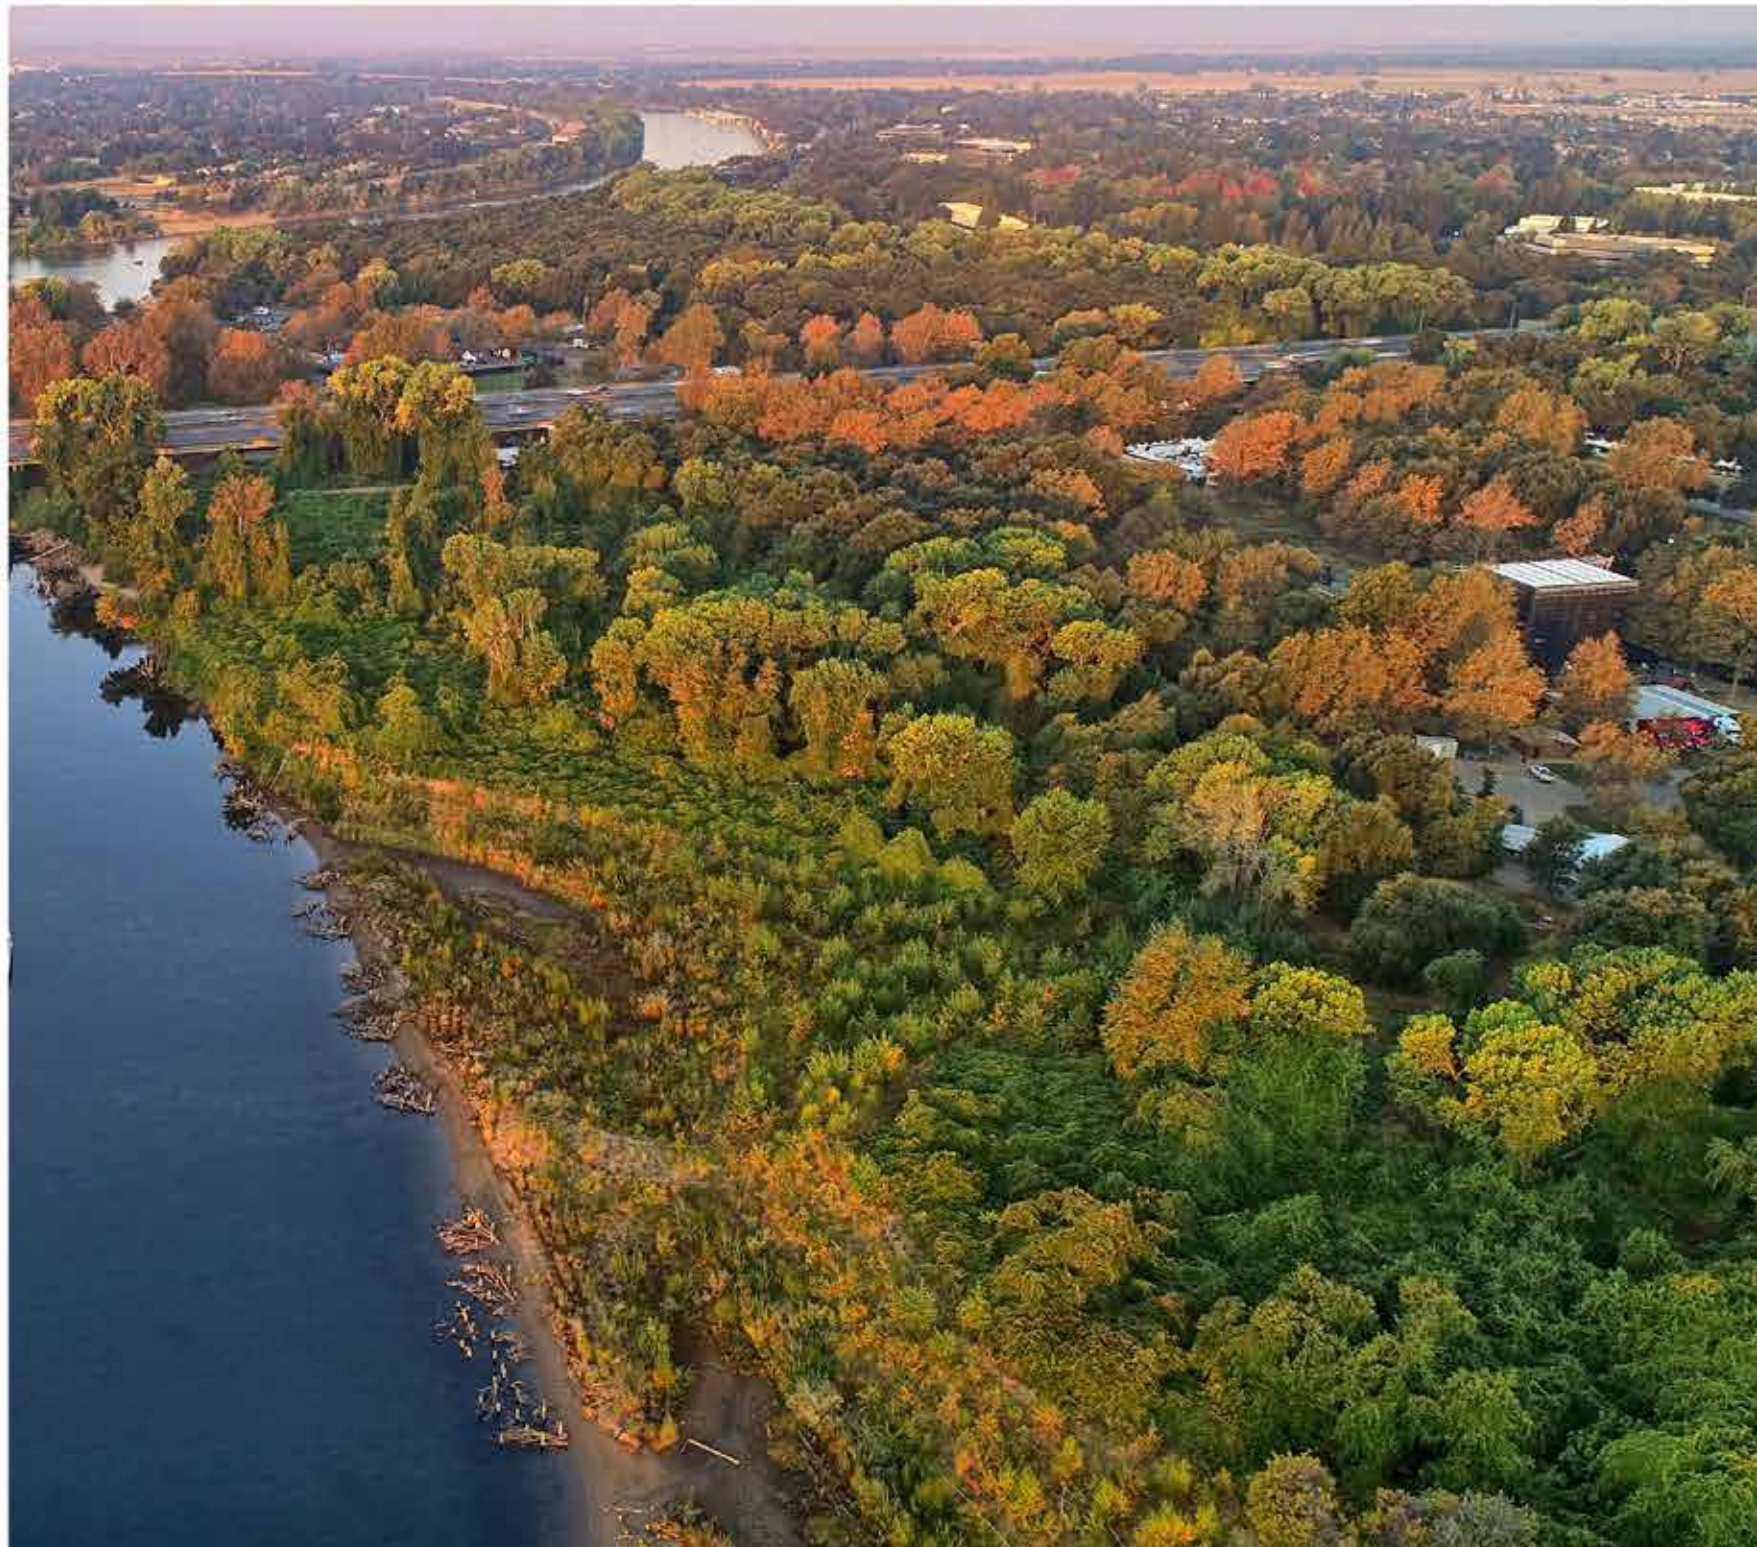
Figure 8-18
Area Plan 1 Discovery Park A

- 1 Establish low-growing native vegetation under power lines
- 2 Purchase and naturalize Urrutia property
- 3 Purchase and naturalize Riverdale mobile home park
- 4 Establish native riparian species / remove non-natives
- 5 Improve/Expand wildlife connectivity opportunities
- 6 Improve habitat at Camp Pollock
- 7 Develop Conceptual restoration plans for burned areas

Site-Specific Potential Resource Management Actions (Figures 8-18 and 8-19)

- 2. Purchase and naturalize Urrutia property:** Develop a Conceptual Naturalization Plan for the Urrutia Property if it is brought into public ownership. This should include the removal of rubble and restoration of the bank line in consideration of current and future conditions. Refer to the Parkway Plan.

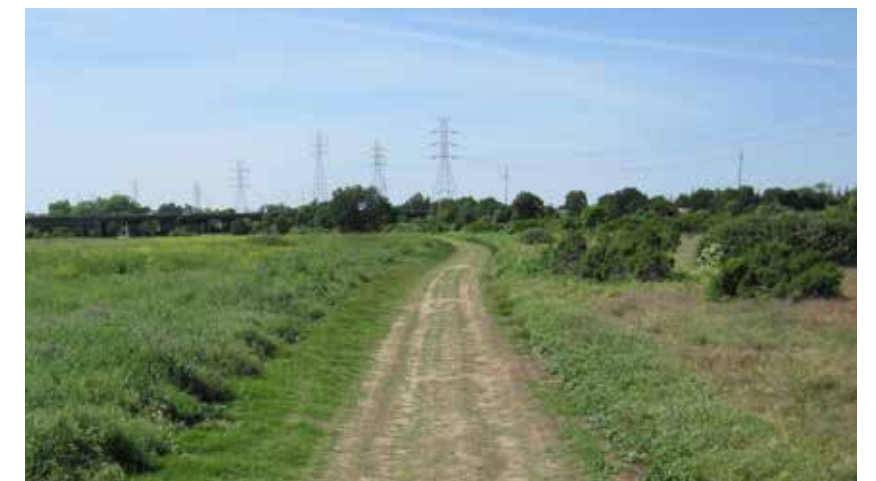
Firebreak and maintenance road located in the Cal Expo Area.
Photo Credit: Regional Parks

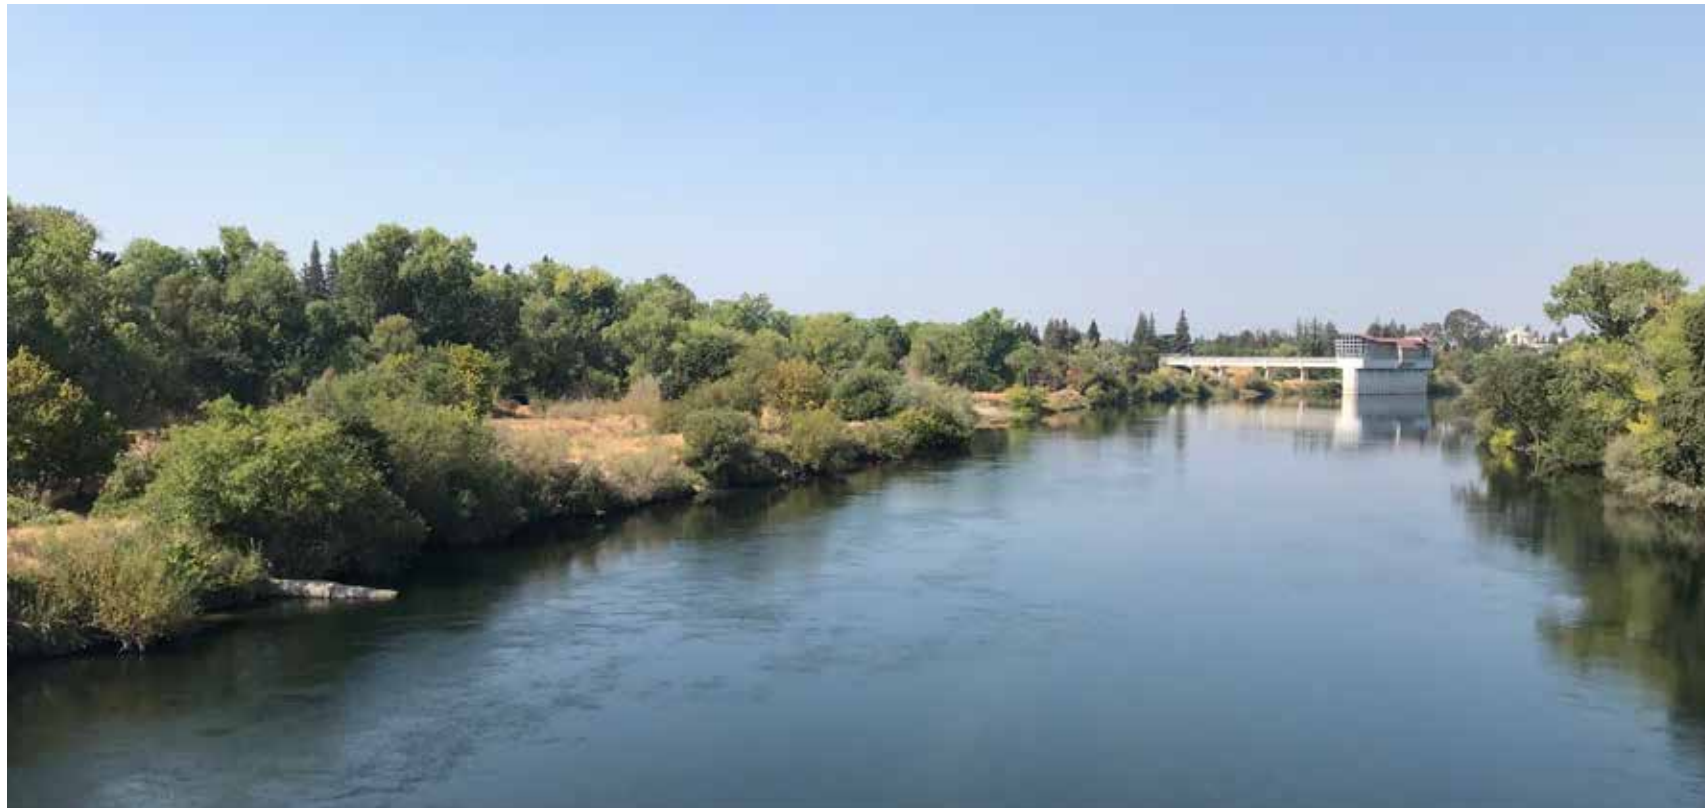
Aerial view of the E.A. Fairbairn Water Intake Station and Guy West Bridge in the Campus Commons Area. Photo Credit: Regional Parks

This narrow, levee-bounded area of Campus Commons is heavily impacted by infrastructure. Paved multi-use trails run the length of both RL and RR. Vehicle bridges flank both the upstream and downstream borders, with the Guy West pedestrian bridge bisecting roughly through the middle. The Fairbairn Water Intake structure and the developed Alumni Grove are located on RL adjacent to the CSUS campus (with its tall buildings overlooking the river). The somewhat

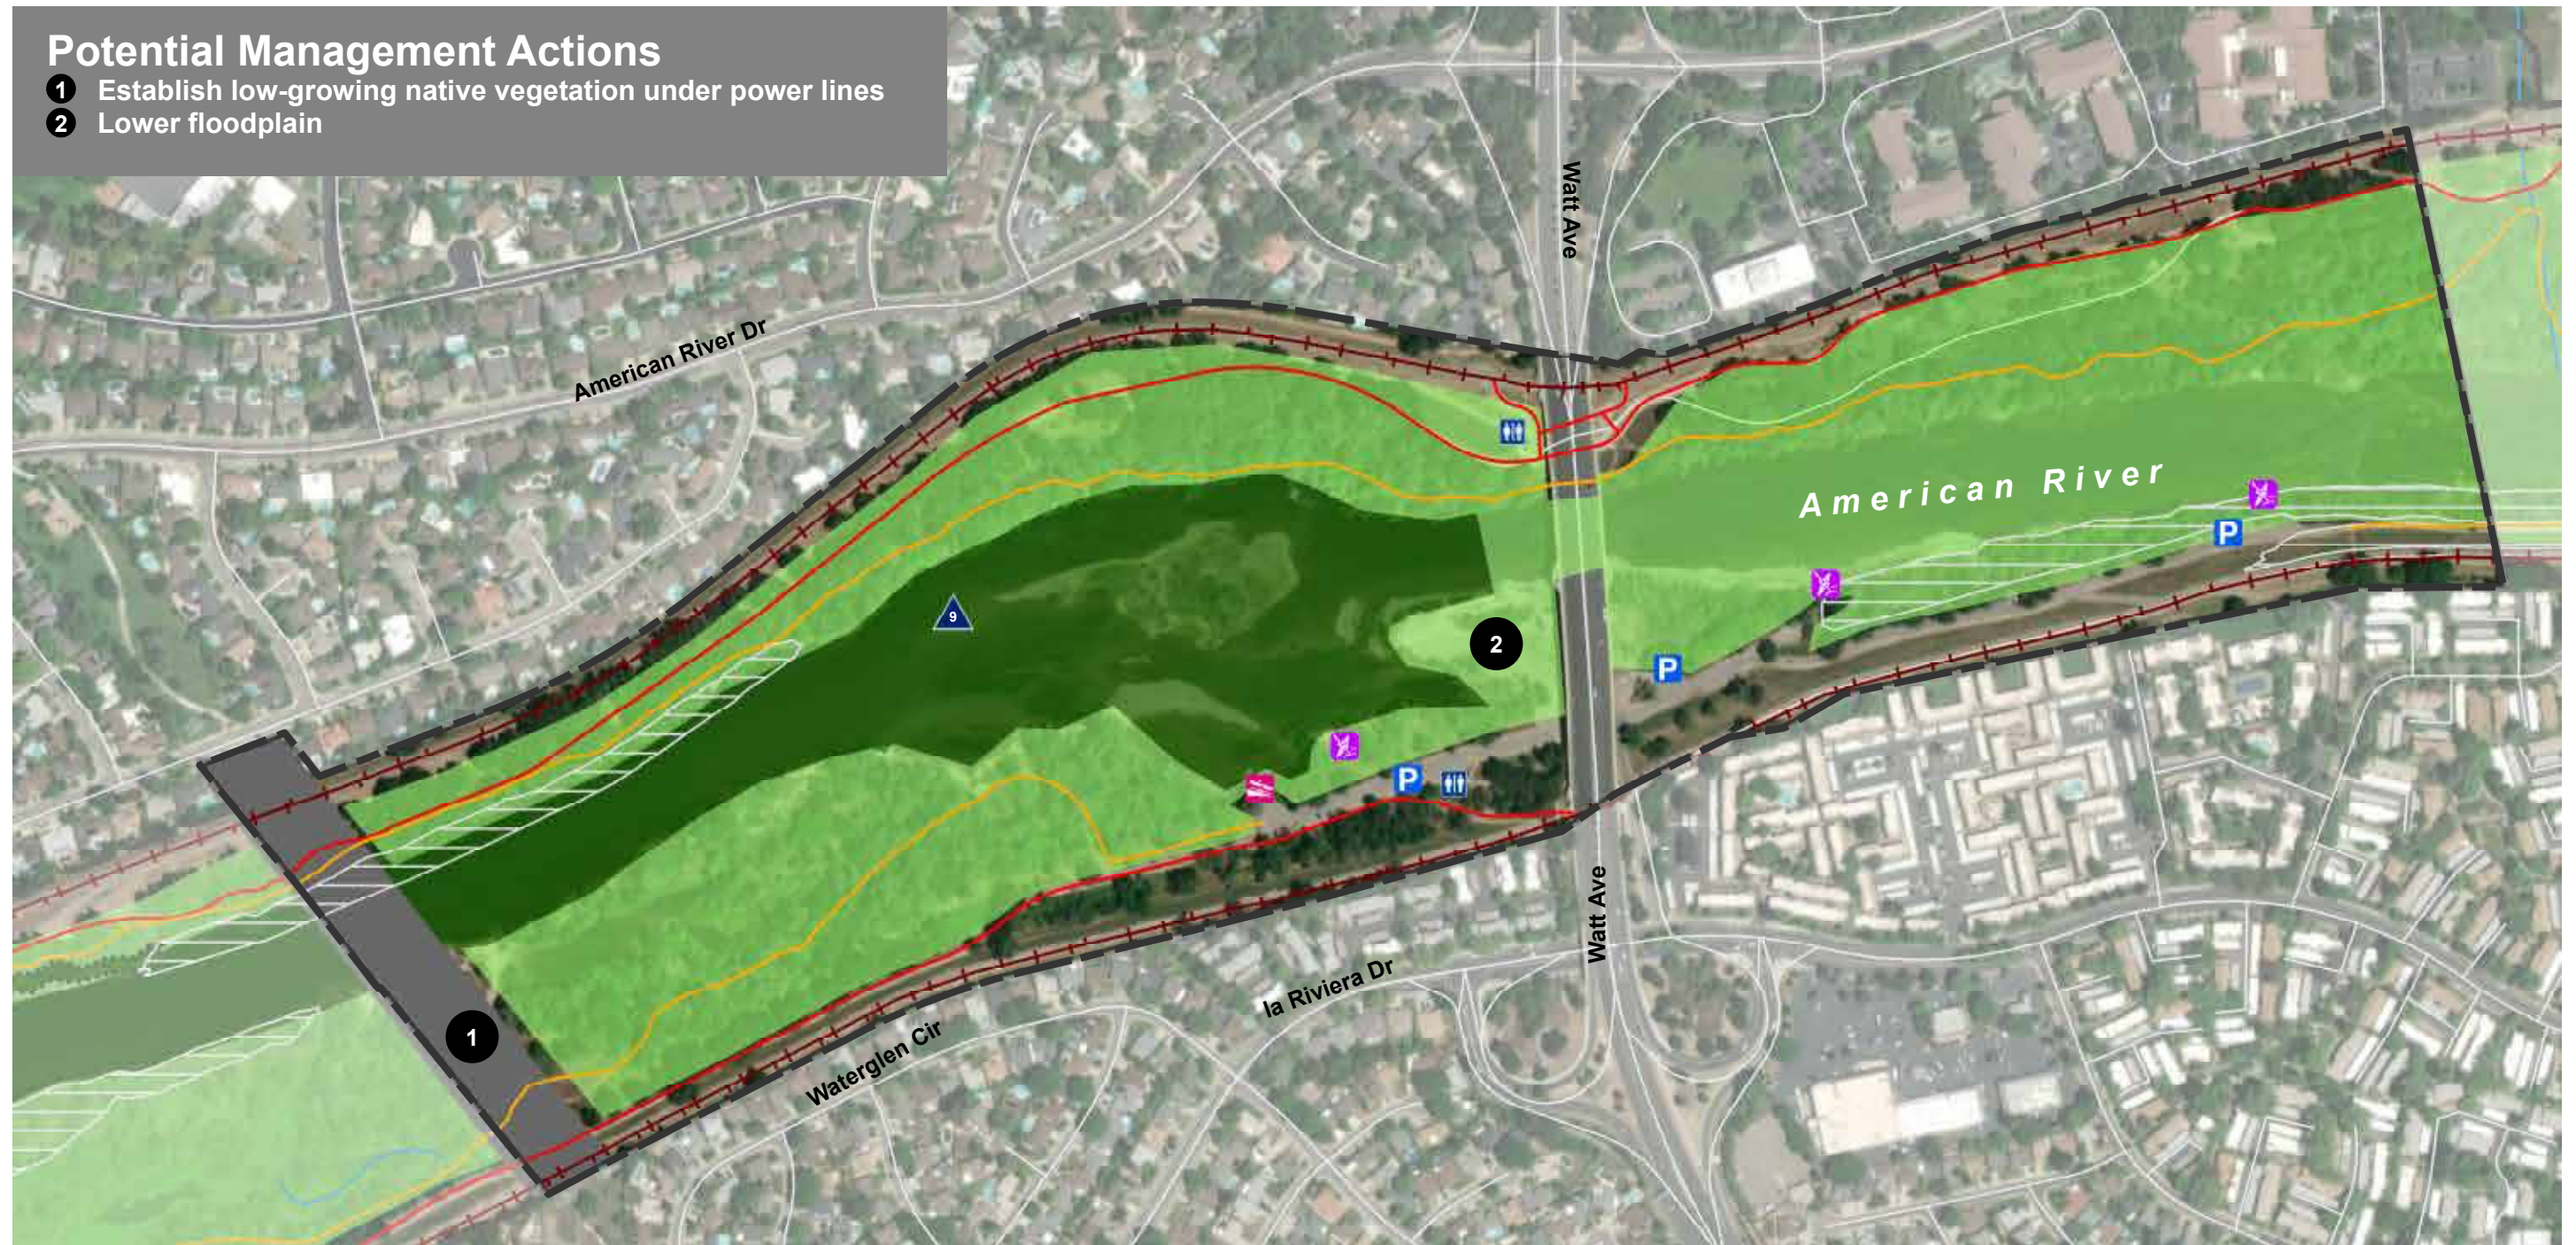
Potential Management Actions

- 1 Establish low-growing native vegetation under power lines
- 2 Lower floodplain

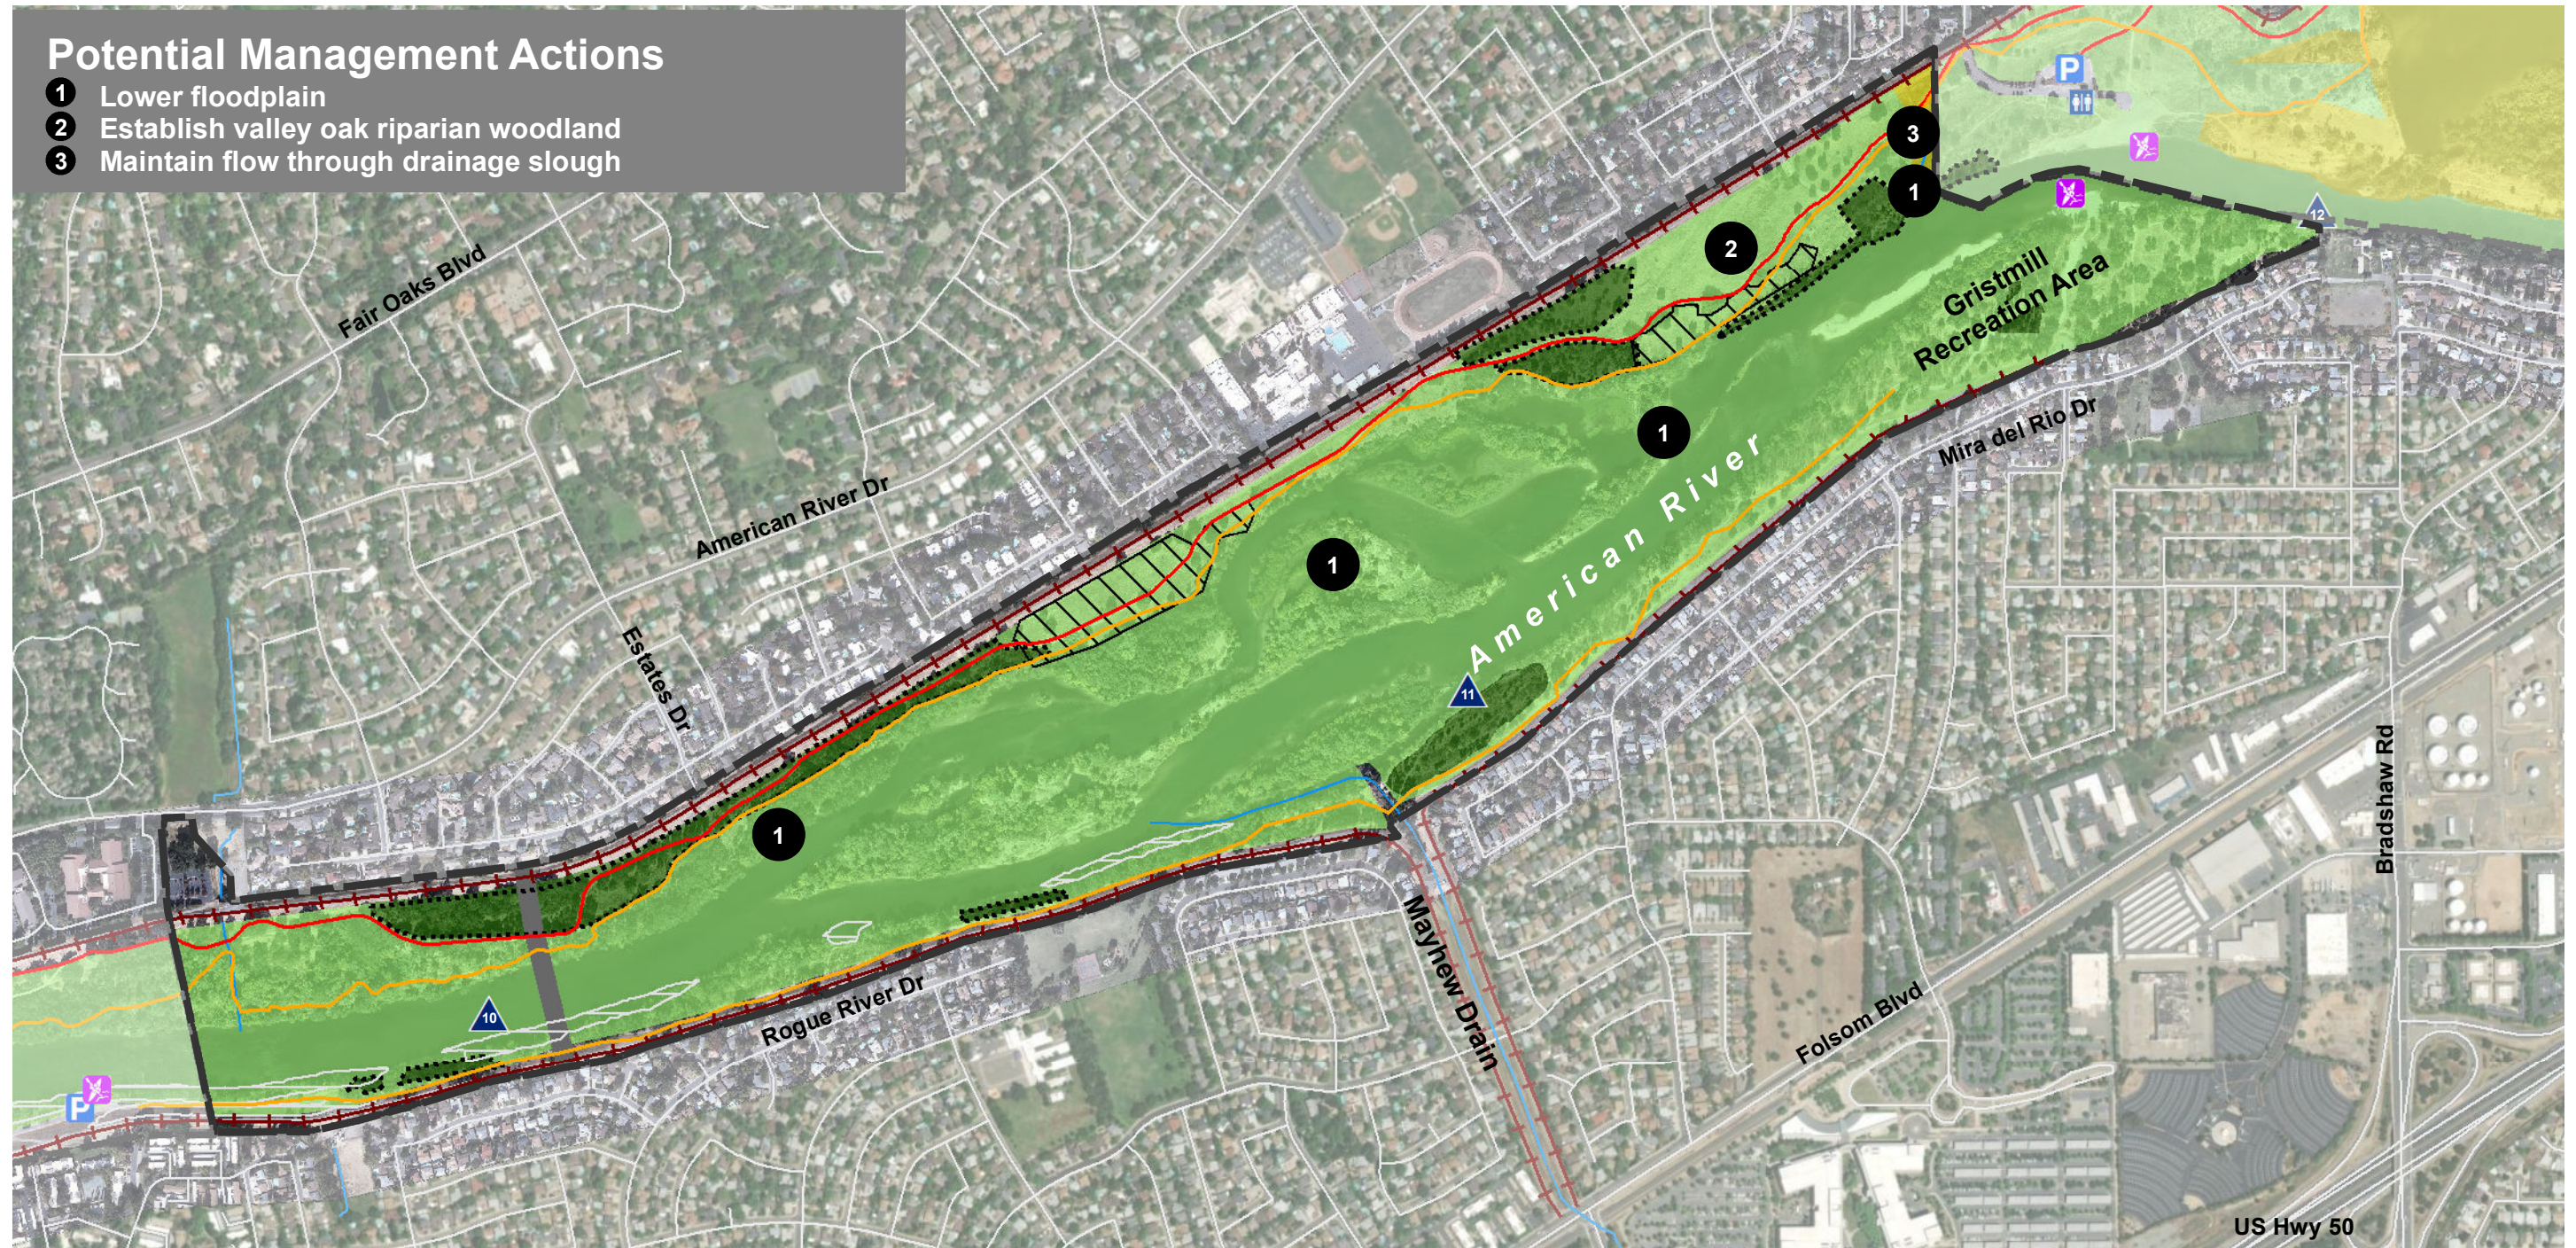
Potential Management Actions

- 1 Lower floodplain
- 2 Establish valley oak riparian woodland
- 3 Maintain flow through drainage slough
