American River Parkway

NATURAL RESOURCES MANAGEMENT PLAN

SACRAMENTO
COUNTY

FINAL | JANUARY 2023

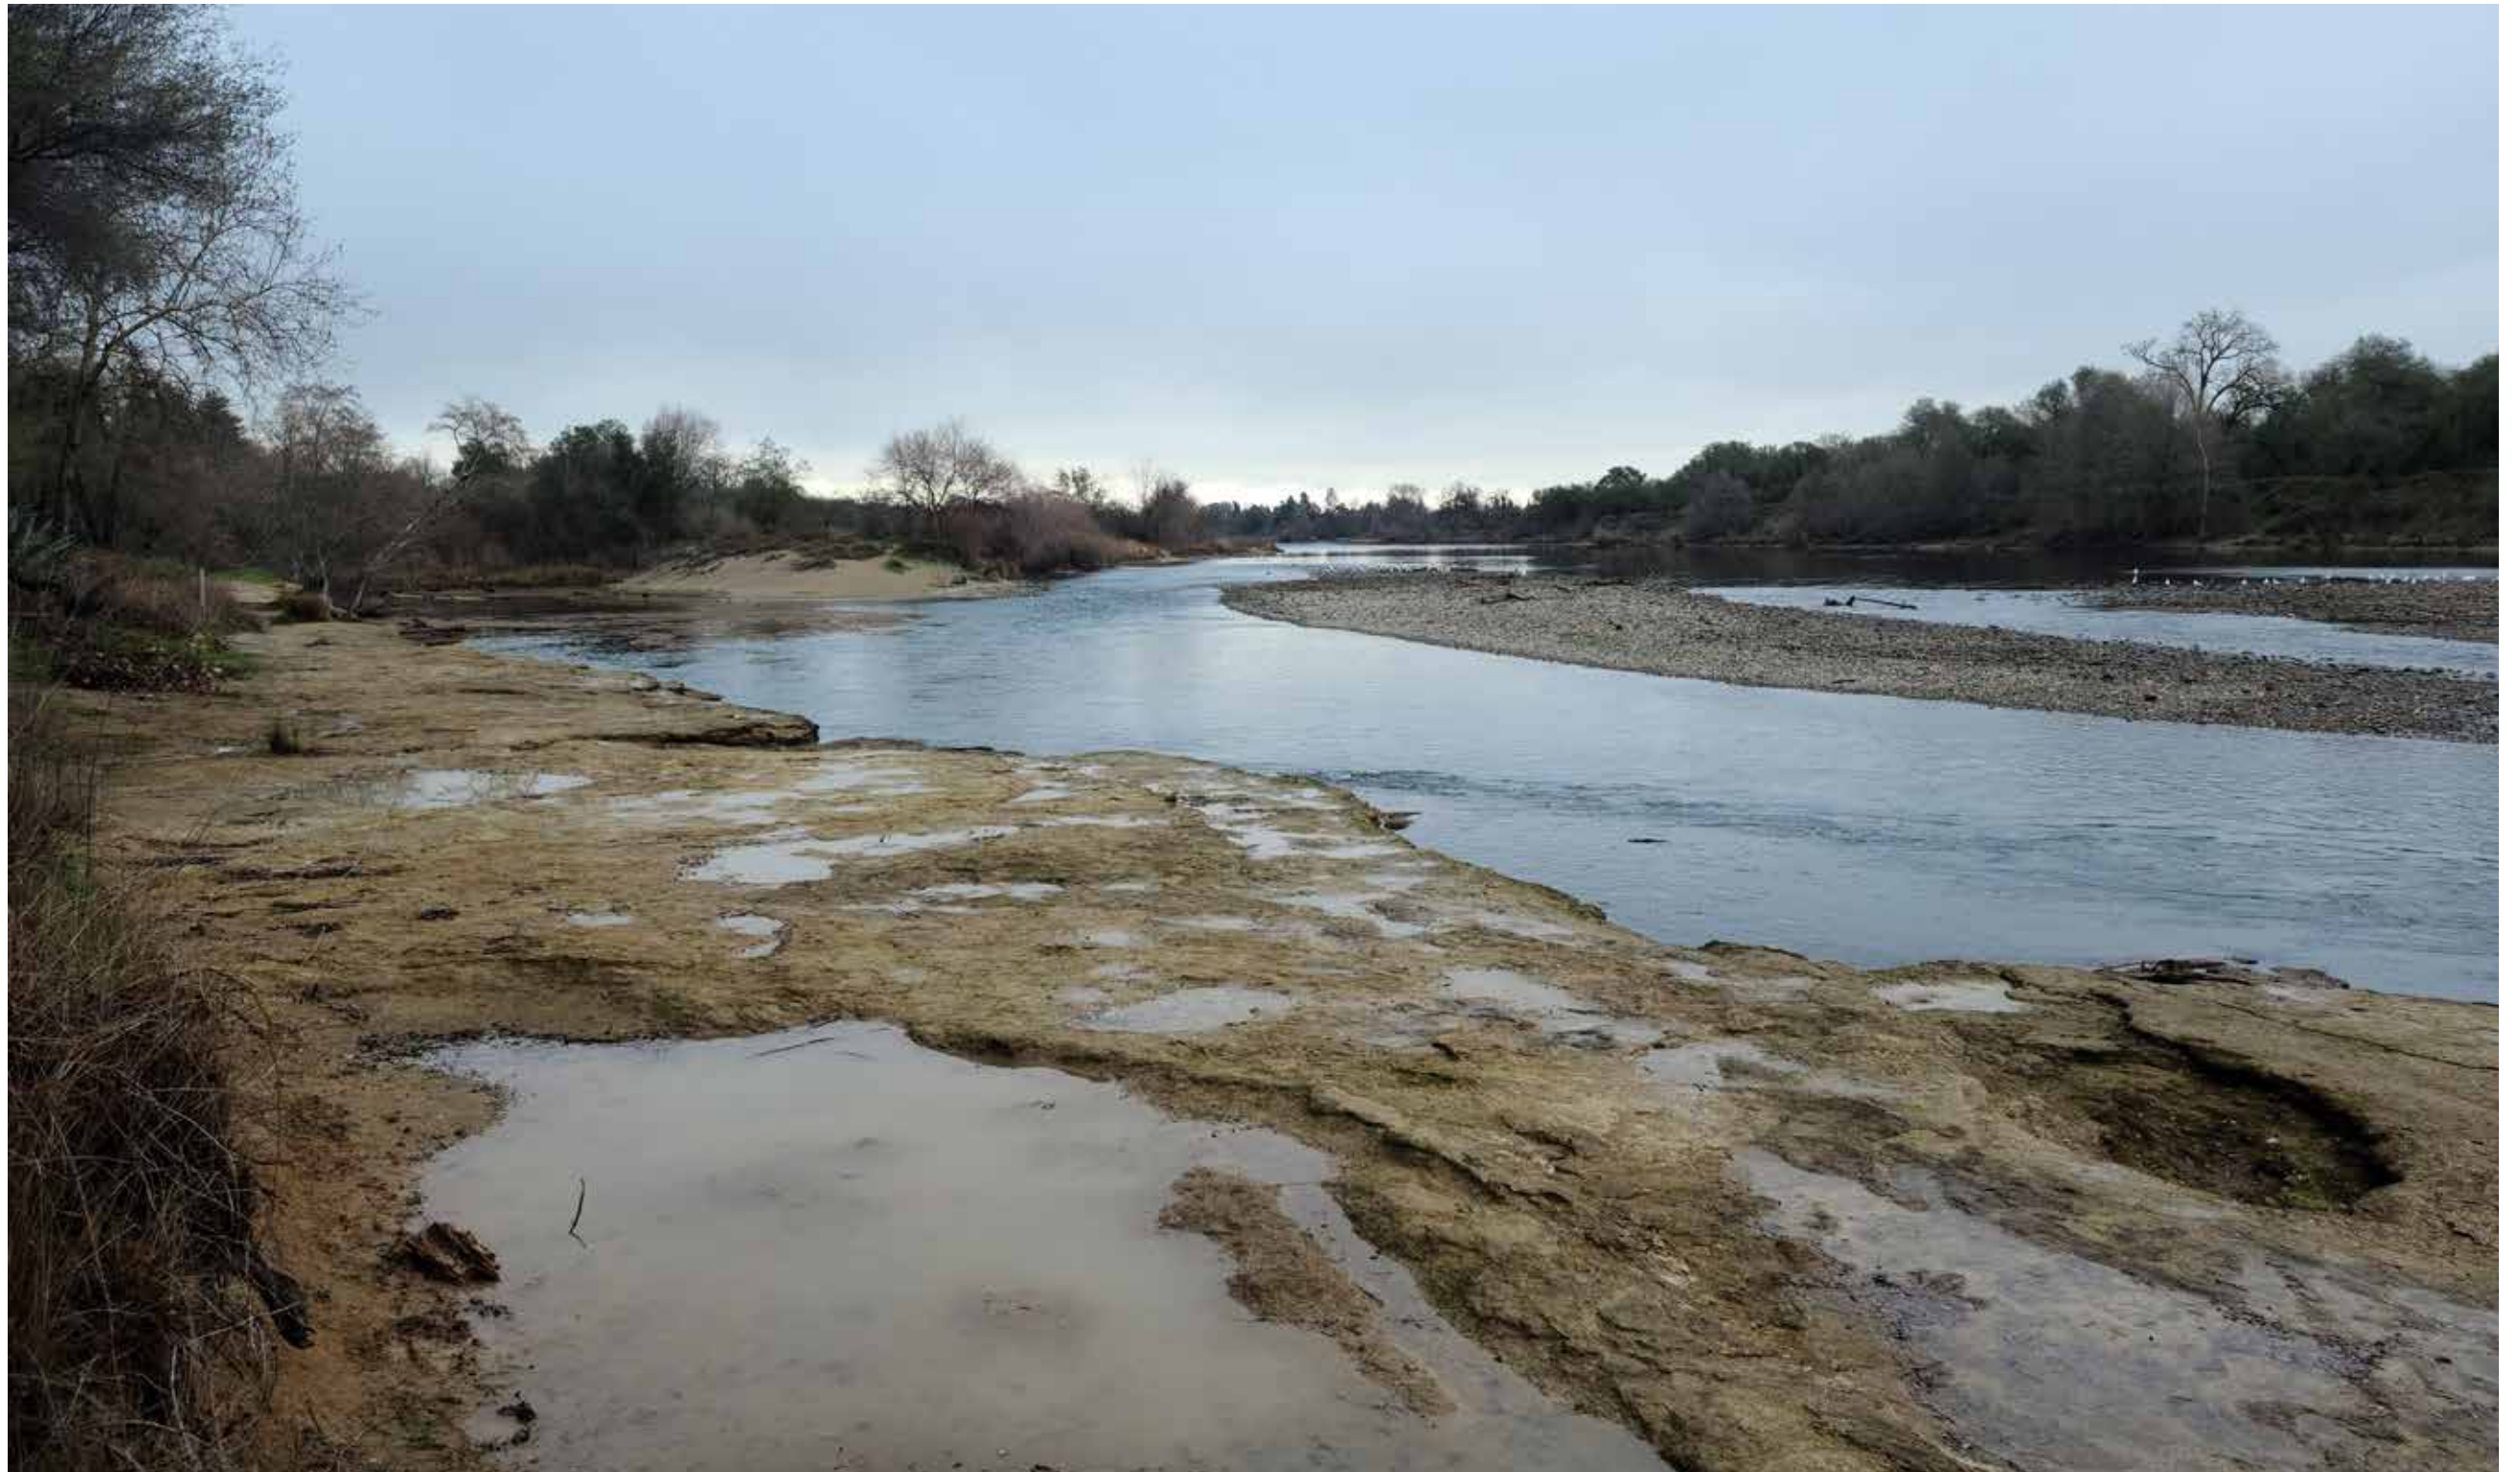
Clay banks and in-channel gravel bars in the Sarah Court Access Area. Photo credit: Regional Parks

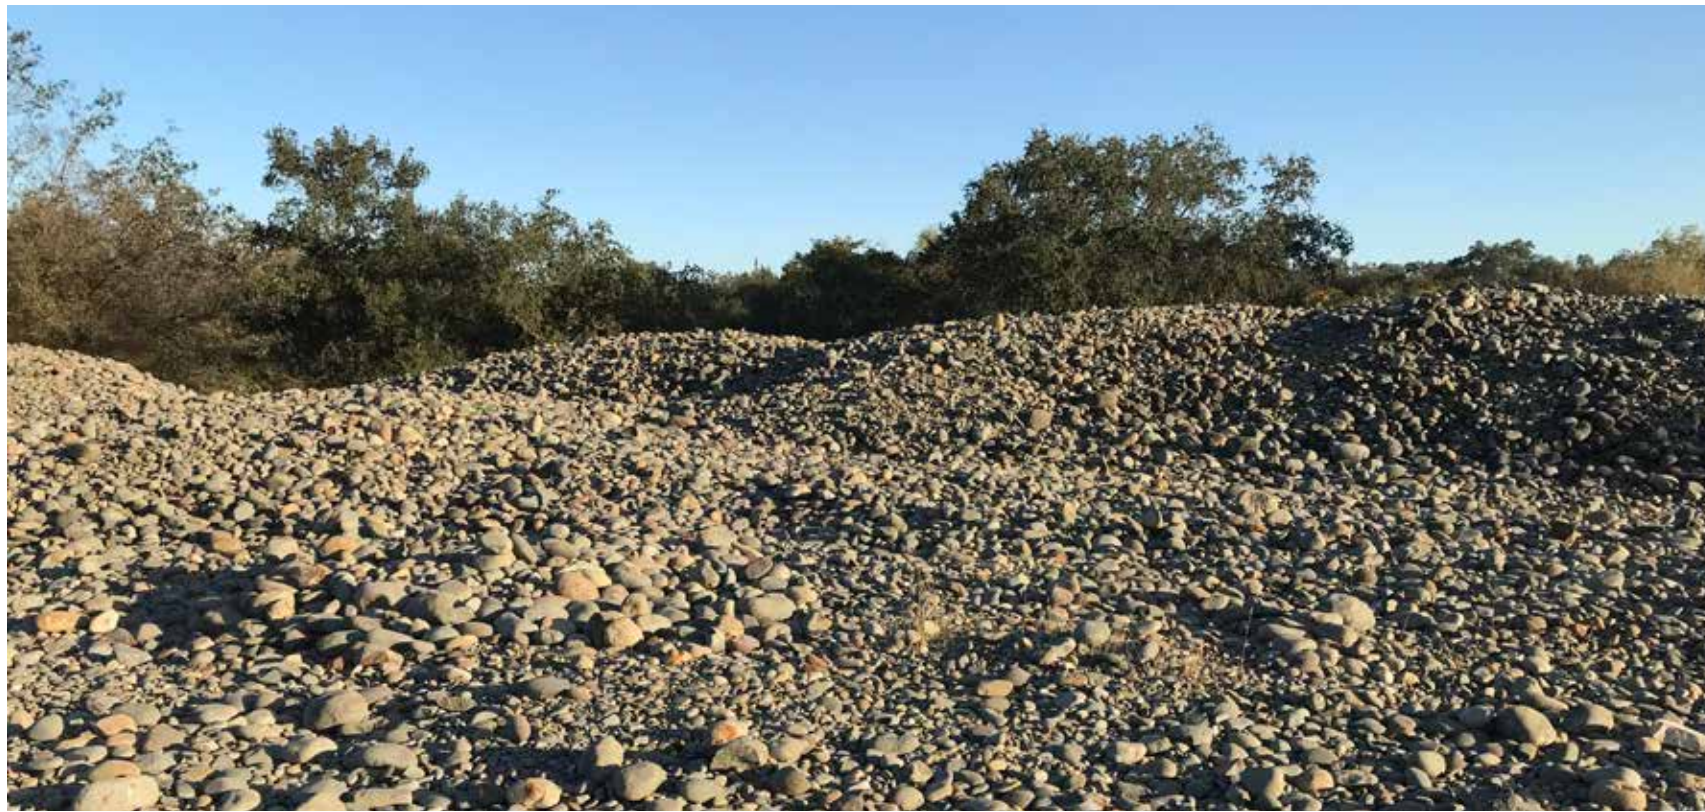
Mine tailings in the Sacramento Bar Area. Photo Credit: Regional Parks

Many of the gold dredge and aggregate mined areas remain unchanged from their post-mining condition. The pre-mining bypass channels continue to be disconnected as a result of the artificially high ground that separates their upstream ends from the main channel. Vegetation in areas

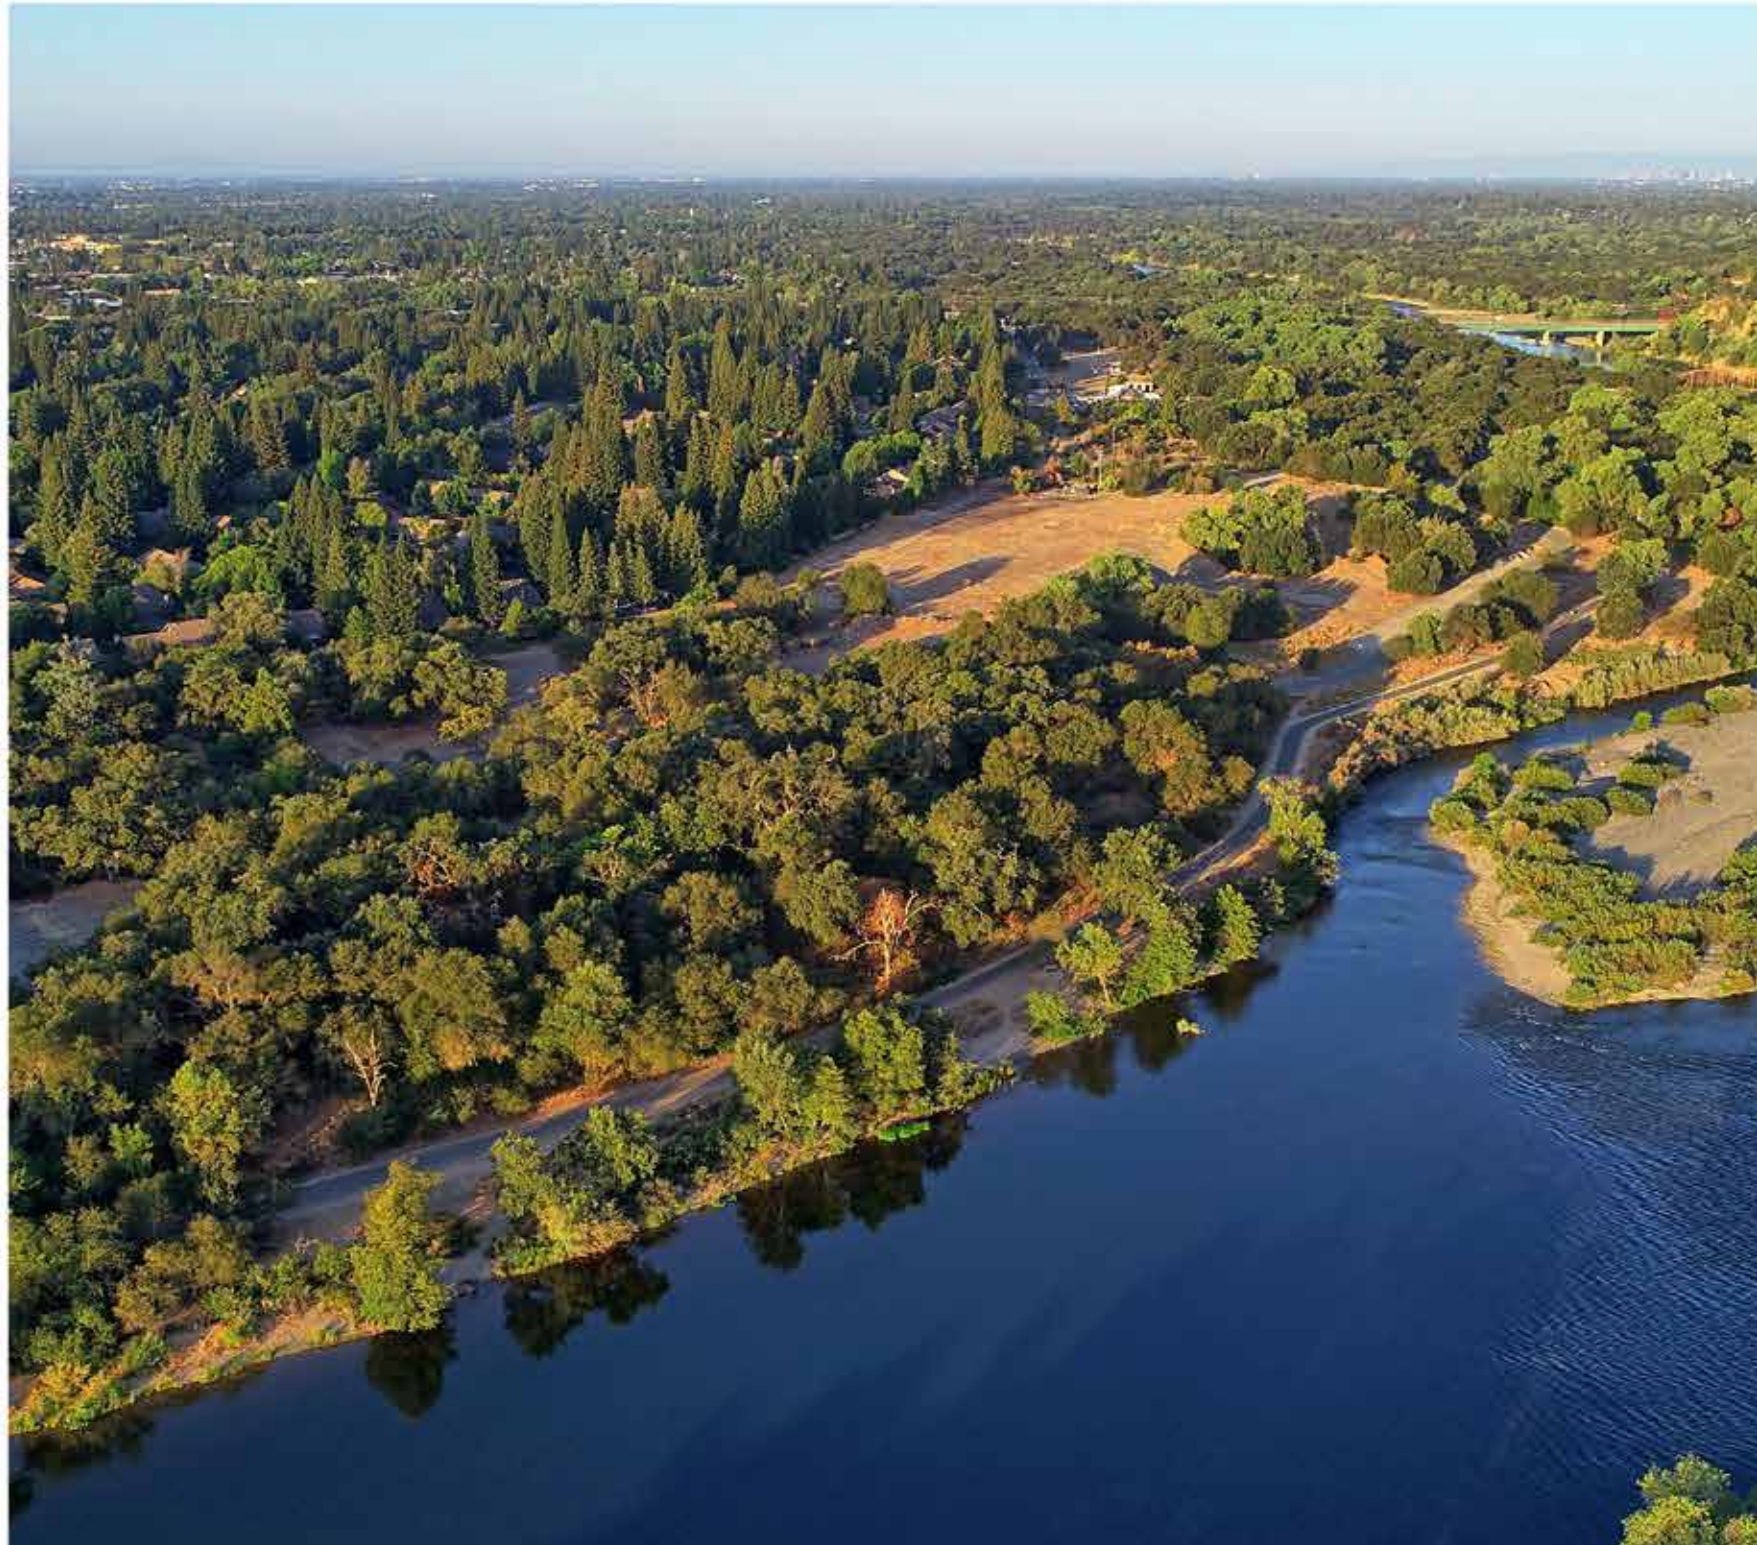
Figure 8-52
Area Plan 18 Upper Sunrise A

Site-Specific Potential Resource Management Actions (Figures 8-52 and 8-53)

- **Maintain created spawning and rearing habitat:** Conduct routine maintenance of previously constructed salmonid habitat including periodic replenishment of gravel to maintain suitable spawning habitat for salmonids.

- In connection with proposals to naturalize channel conditions in the Upper Sunrise area, consider ongoing natural processes and the propensity of the widened channel to capture materials as they are transported through the area during high flows.

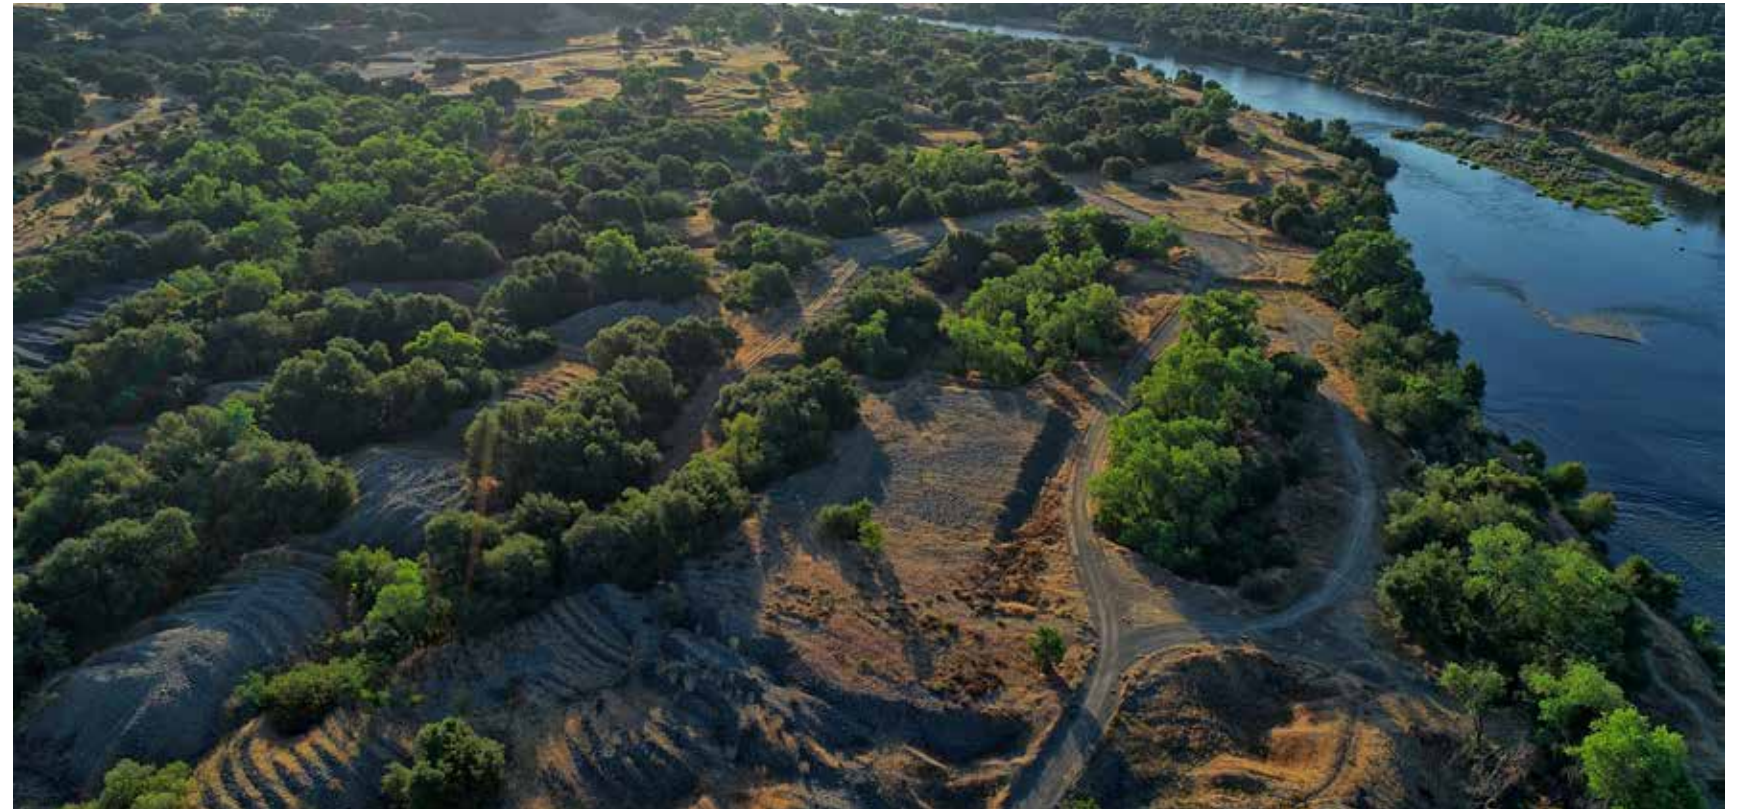
Aerial view of the Sailor Bar Area, including mine tailings (photo foreground). Photo Credit: John Hannon

Substantial mining activities, primarily dredger gold mining, covered a majority of the land area and significantly altered much of Sailor Bar. The dredger mining removed any existing vegetation and altered the topography and composition of the surface, leaving behind large piles of unvegetated cobble material. However, some of the surfaces that appear lower are natural surfaces supporting "pocket forests." Elevated mounds of dredger mine tailings persist in areas scattered throughout. Areas that were used for material handling but not mined are less damaged.

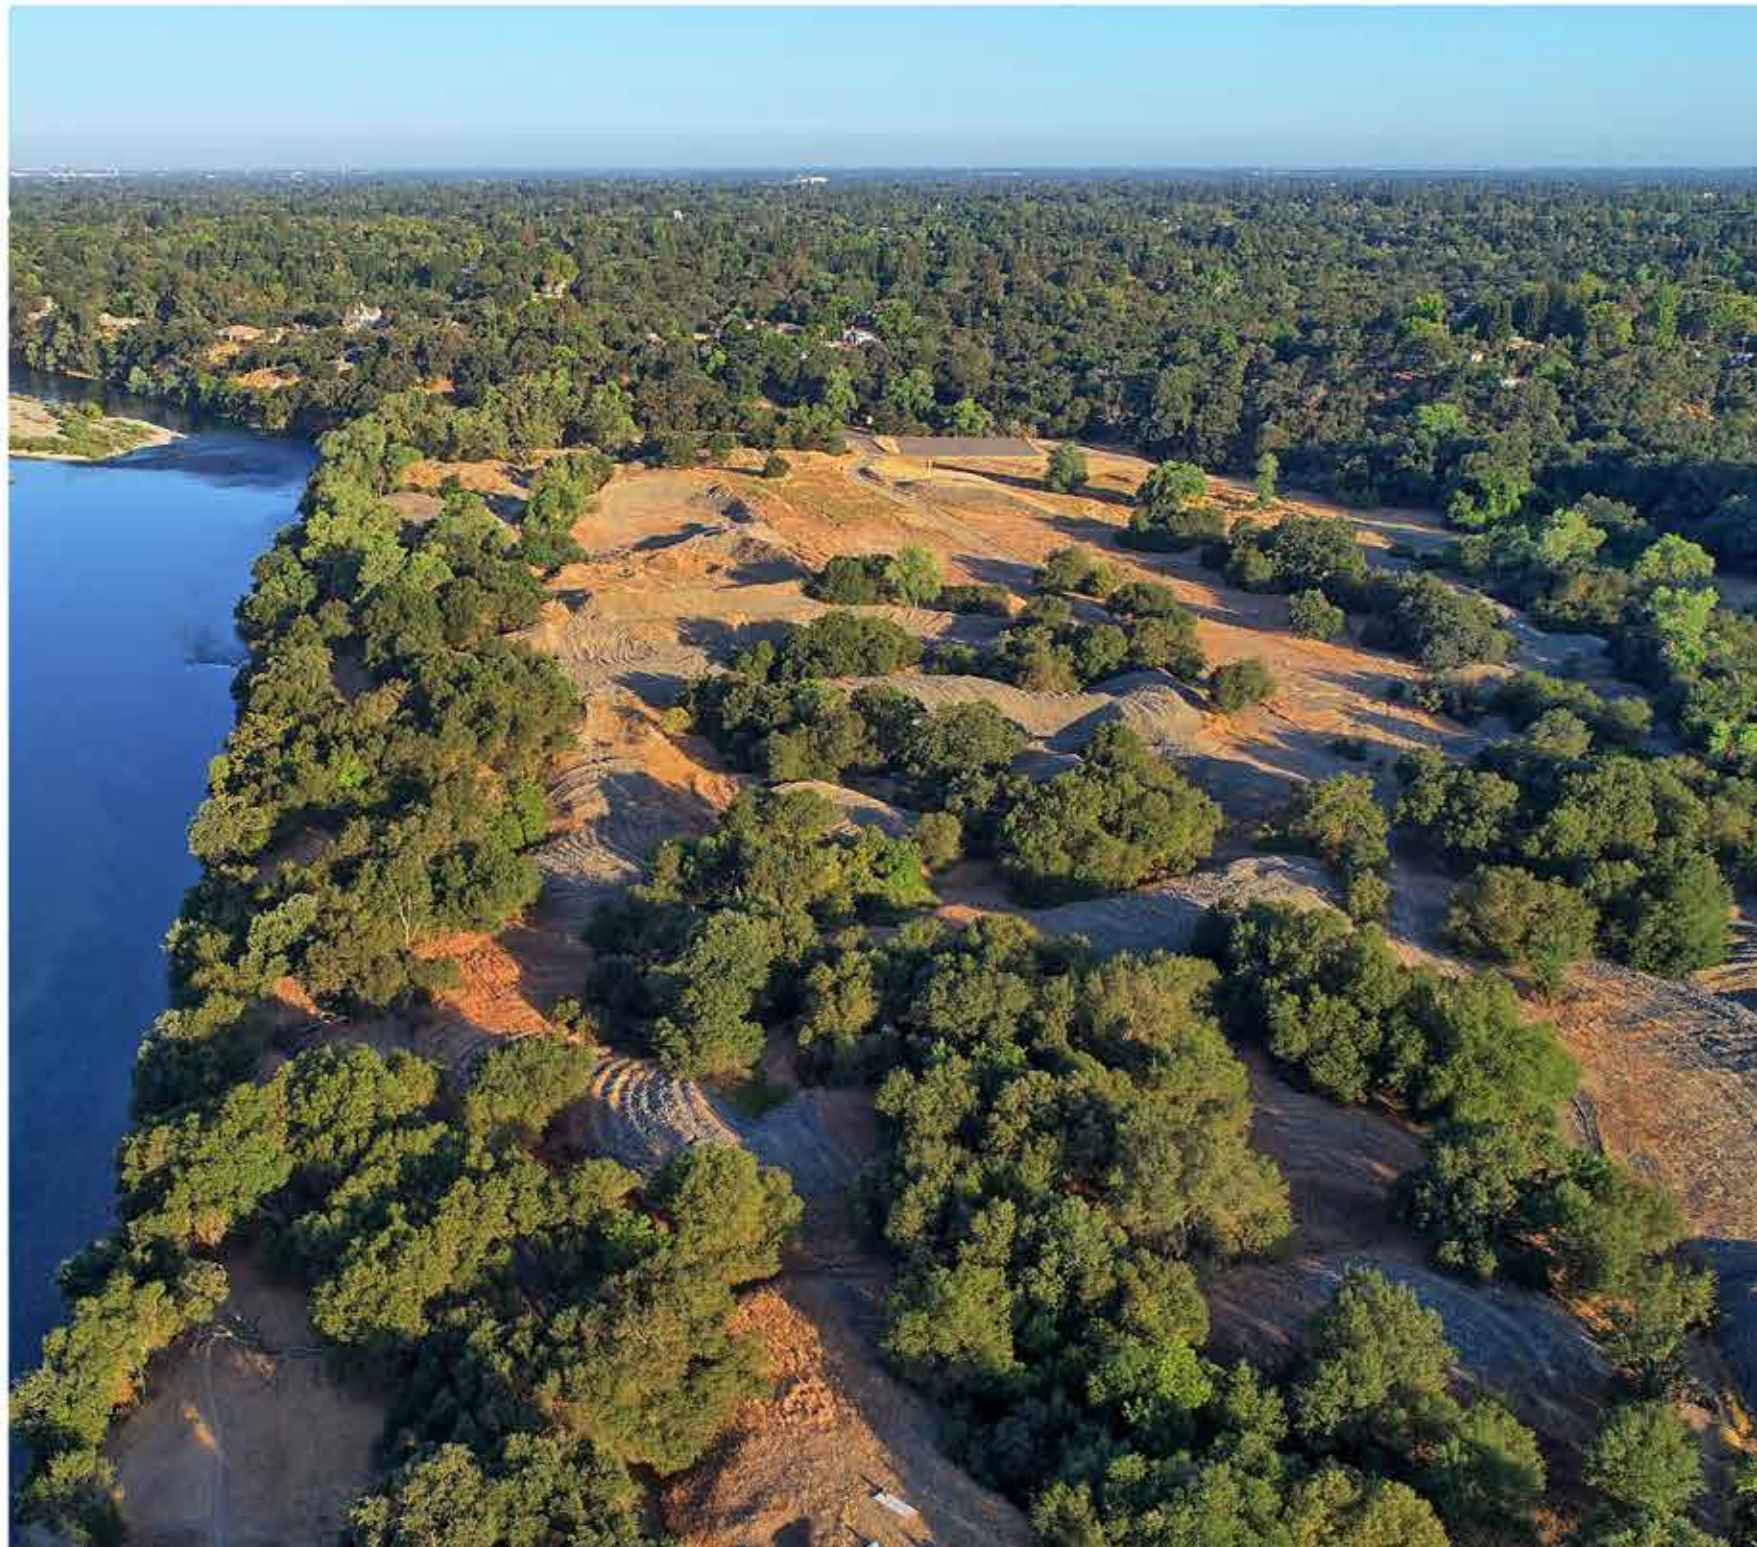
Figure 8-54
Area Plan 19 Sailor Bar A

Site-Specific Potential Resource Management Actions (Figures 8-54 and 8-55)

3. **Improve degraded riparian habitats:** In connection with proposals to naturalize channel conditions in the Sailor Bar area, consider ongoing natural processes and the widened channel and its propensity toward deposition of materials as they are transported through the area during high flows.

6. **Naturalize relict pools/remove gunite:** The former “pool” in the northwest corner could be naturalized into some type of lower elevation feature, but its low elevation doesn’t seem to help retain moisture. Consideration should be given to removal of bentonite/gunite layer.

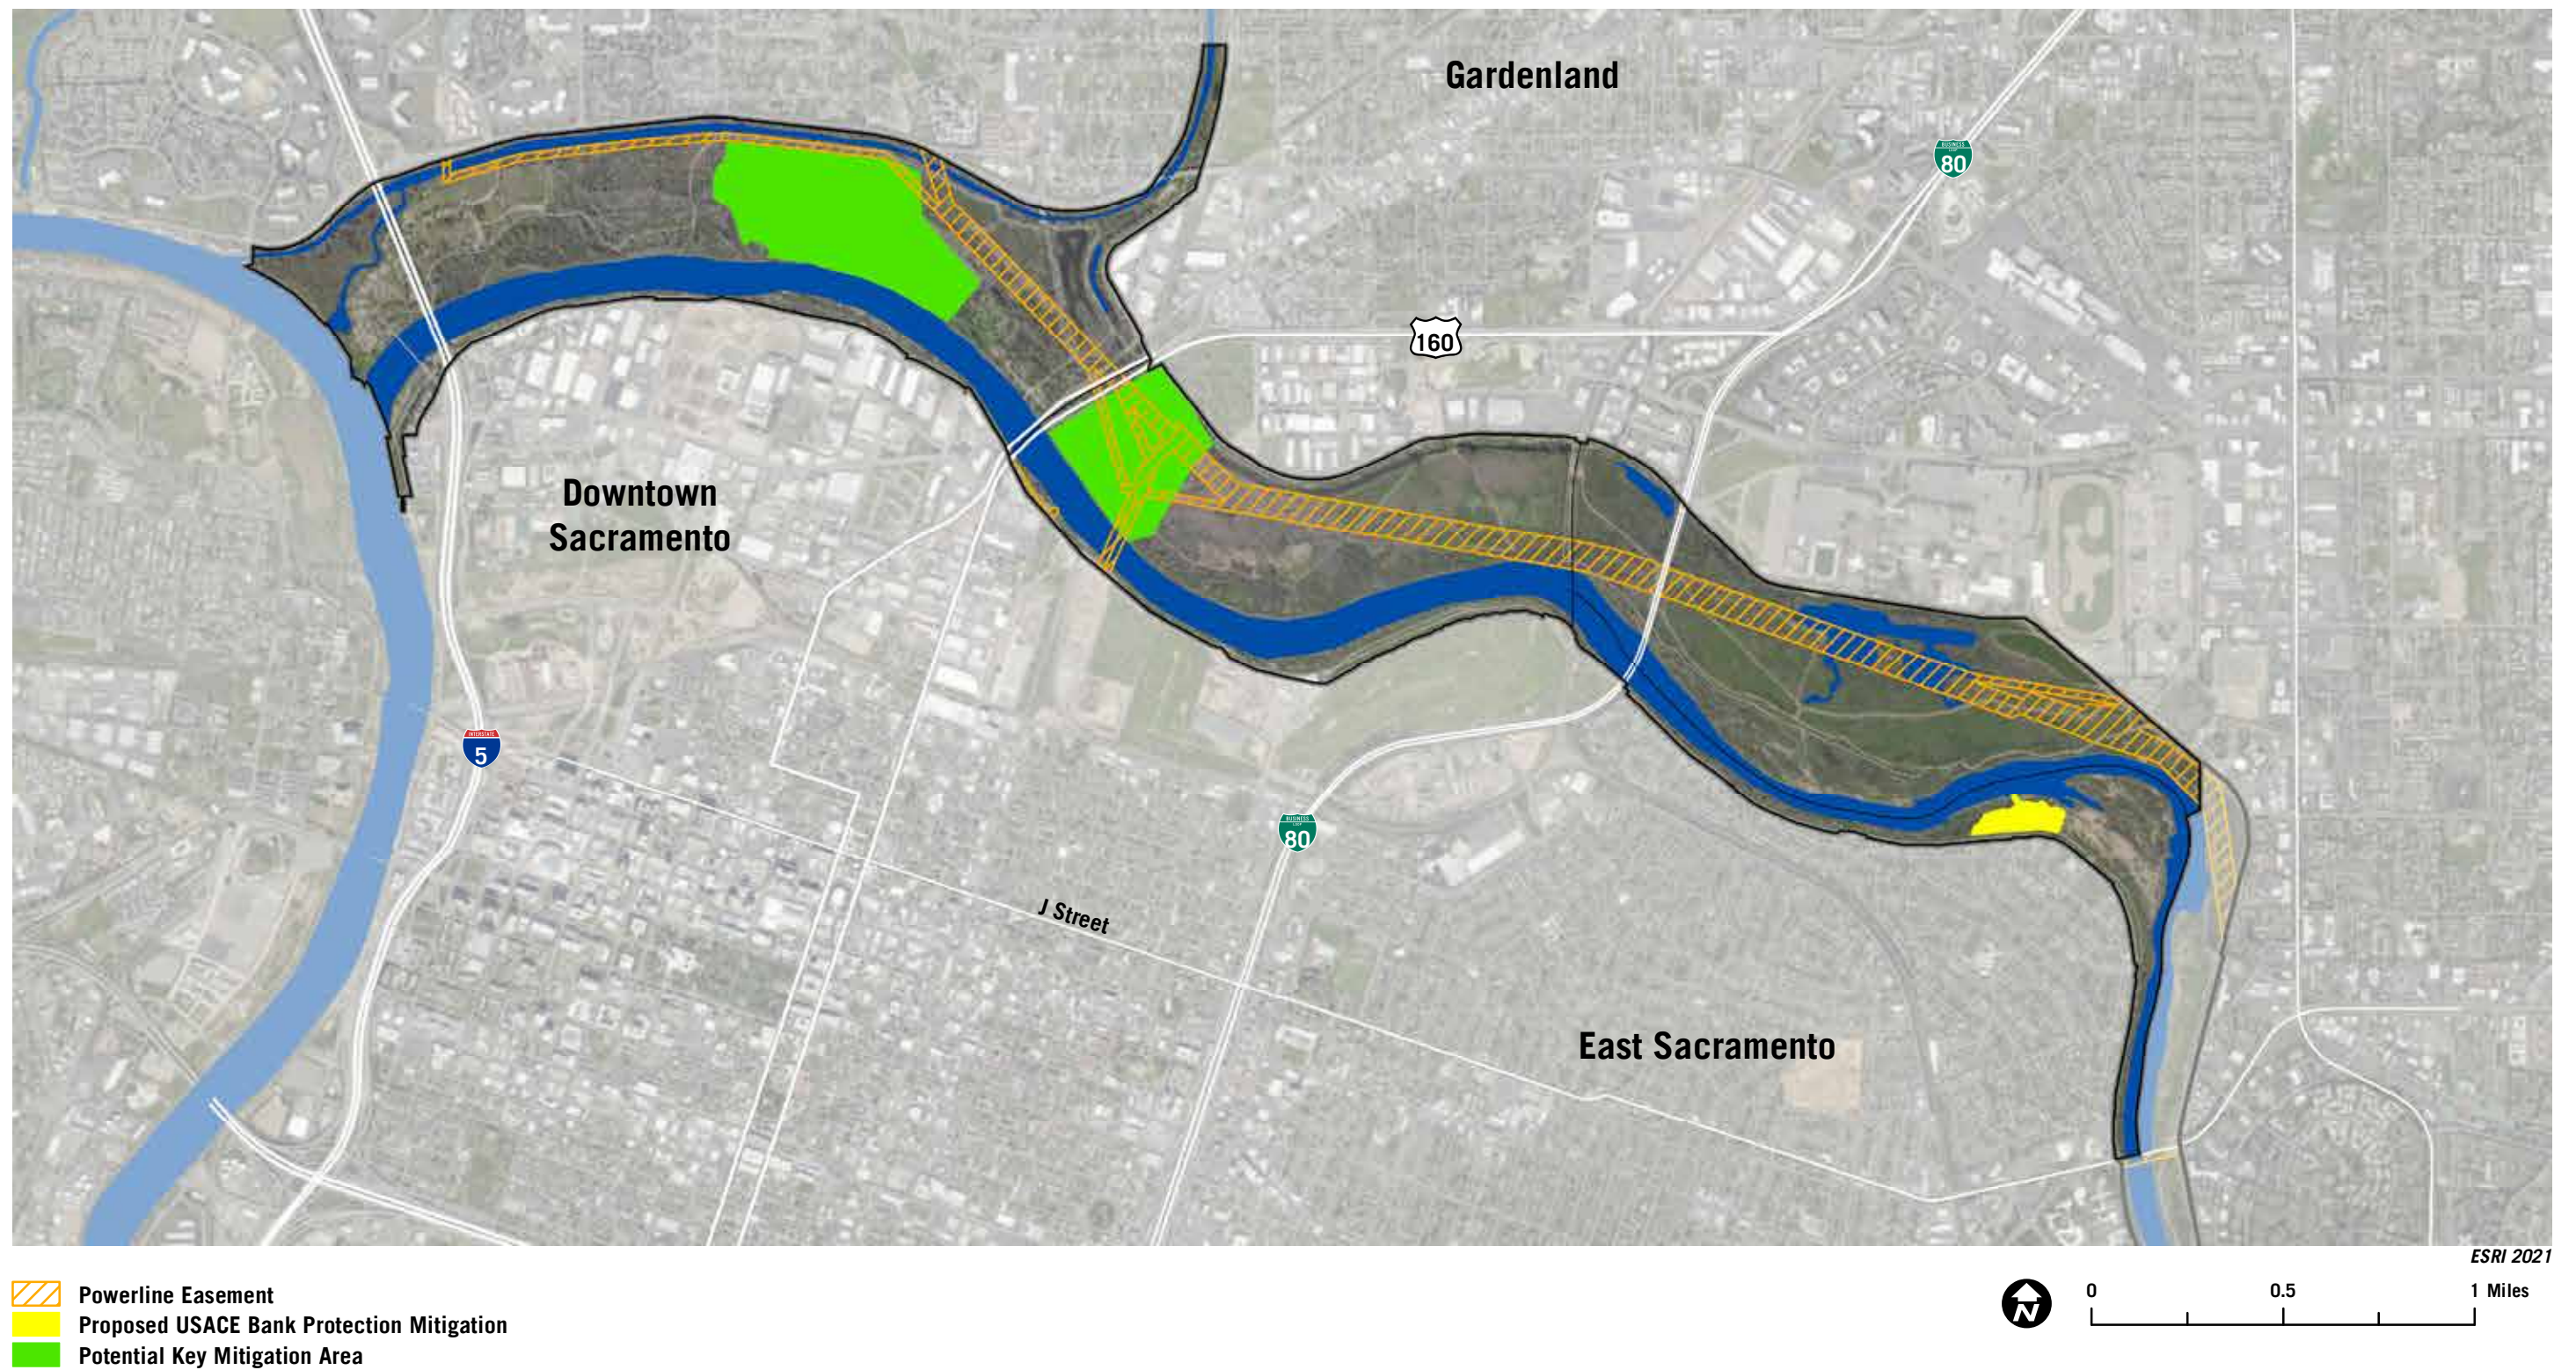
Figure 8-57
Lower Reach Potential Key Mitigation Areas

There are several past and future projects within the Parkway that require mitigation for their impacts to various Parkway resources. Example projects include flood control/bank protection projects, transportation/bridge projects, and utilities such as electric transmission and sewer. The aforementioned factors, including land use designations, level of alteration, frequency of inundation, existing vegetation communities, and wildlife habitat values, in combination with the assigned natural resource management categories (e.g., preservation, conservation, and naturalization) provide a framework for identifying locations in the Parkway that are likely suitable for mitigation purposes. Figures 8-56 through 8-59 show the Parkway-wide and by-reach locations of existing mitigation sites and potential mitigation areas. These areas and associated mitigation projects will require site-specific planning by project proponents and evaluation by Regional Parks. Additionally, other entities have previously identified several fish rearing habitat improvement projects that could potentially serve as mitigation projects. These projects involve actions such as lowering floodplains and increasing riparian vegetation and will require site-specific planning by project proponents and evaluation by Regional Parks and are shown in the Area Plan maps.

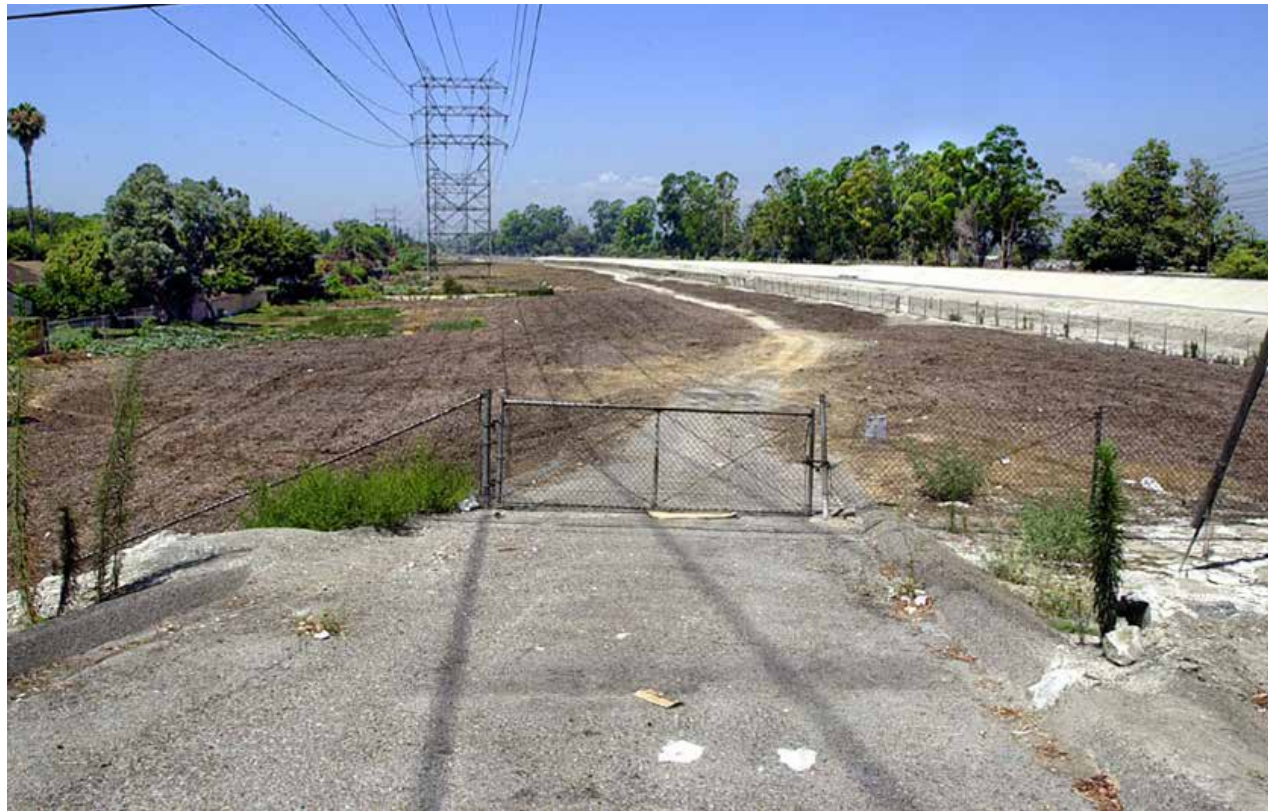
BEFORE Clear cut transmission corridor at the West San Gabriel River Parkway in Lakewood, CA.
Photo Credit: MIG

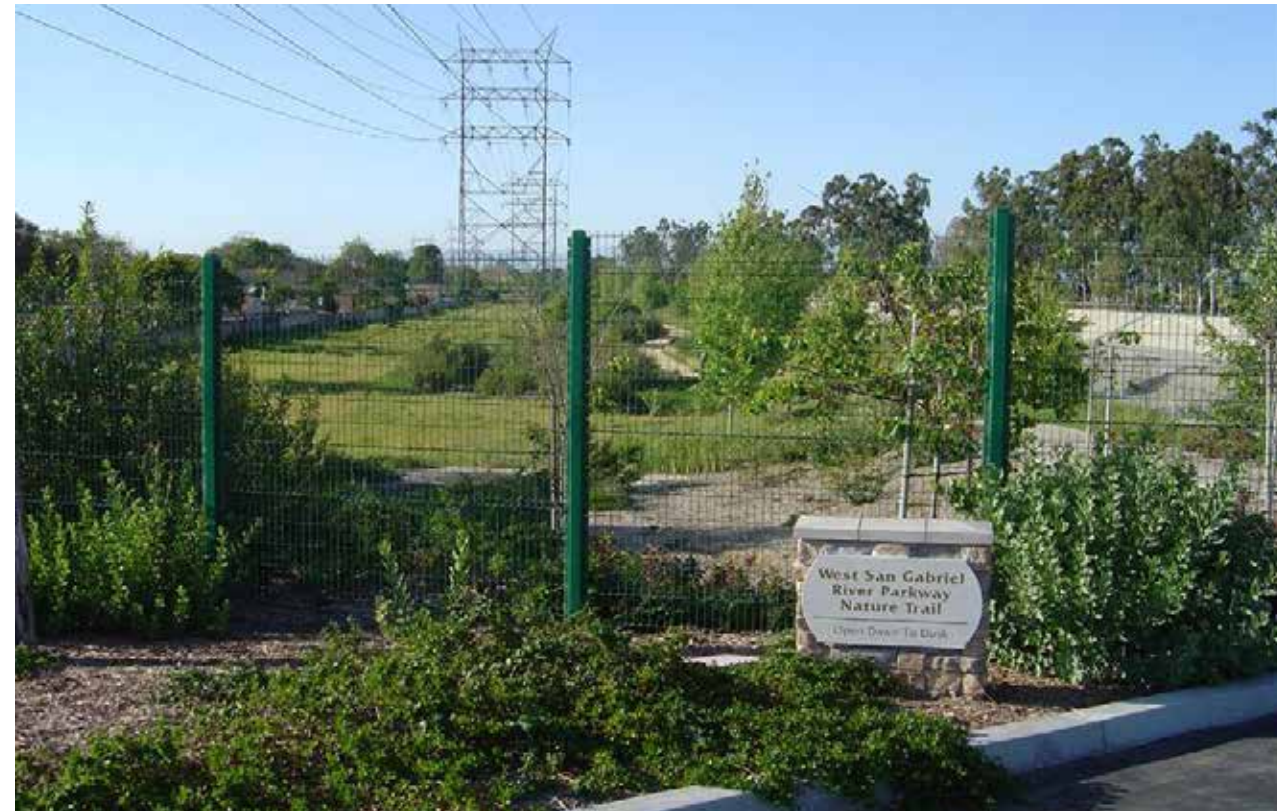
AFTER Replanted transmission corridor at the West San Gabriel River Parkway Nature Trail in Lakewood, CA.
Photo Credit: MIG
